## CONDITION REPORT

2017284338

| Manufacturer | VOLKSWAGEN | Registration Number | FS12CZGP |
| Model | POLO VIVO GP 1.4 63KW TRENDLINE 5-DR [2016-2018] | Register Number | |

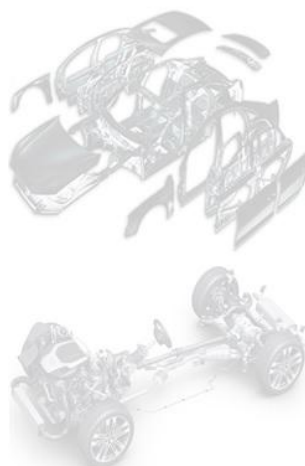
| Damage | Repair Way |
|---|---|
| Engine Wiring Defective | Repair |
| Air cleaner Damaged | Repair |
| Windscreen Wiper Worn | Replace |
| Tail Light Right Cracked | Replace |
| Fog Light Front Left Damaged | Replace |
| Wiring connections Defective | Repair |
| Headlight Right Defective | Repair |
| Seat Front Left Torn / Cut | Repair |
| Seat Front Right Torn / Cut | Repair |
| Side Mirror Left Damaged | Replace |
| Front Bumper Paintwork • Scratched | Repair |
| Grill Damaged | Repair |
| Bonnet Dented | Repair |
| Front Fender Left / Inner Tray Residual Traces of Repair | Repair |
| Door Front Left Paintwork • Scratched | Repair |
| Door Rear Left Paintwork • Scratched | Repair |
| Door Rear Right Paintwork • Scratched | Repair |
| Rear bumper Paintwork • Scratched | Repair |
| Shock Absorber Mounting Front Left Loose / Excessive Play | Repair |
| Shock Absorber Mounting Front Right Loose / Excessive Play | Repair |
| Control Arm Bush(es) Front Axle Right Cracked | Replace |
| Tyre Front Left Excessive Wear & Tear | Replace |
| Tyre Front Right Smooth | Replace |
| Rim Front Left Damaged | Replace |
| Bolt(s) / Nut(s) Rear Wheel Left Missing | Replace |
| Bolt(s) / Nut(s) Rear Wheel Right Missing | Replace |
| Gearbox Oil Leak | Repair |
| CV Joint(s) Boot(s) Front Left (inner/outer) Damaged | Replace |
| Engine Performance Idling / Hunting | Repair |
| Engine Noise Excessive | Repair |
| Gearbox Noise Excessive | Repair |
| Warning lights illuminated | Repair |
| Body exterior | Signs of spray work done on body panels |
| Boot does not open, electric malfunction. | Repair |
| Vehicle electronics malfunction. | Electric fan keep running. |
| Vehicle misfire | Repair |
| ABS warning lights illuminated | Repair |

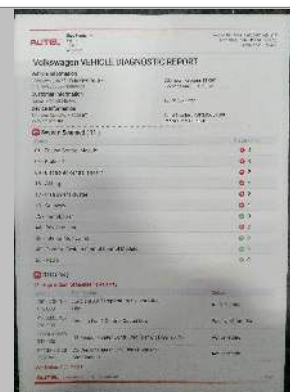
Diagnostic test

During the diagnostic the following error messages were detected: (See also attached Diagnostic Report. For more information regarding the Fault Codes (DTC) and the recommended rectifications please contact the workshops of the vehicle manufacture).
