CONDITION REPORT

Report No: 2016204981

MFC Auction House
M57 Pretoria Rd, Glenmarais, KEMPTON PARK
Gauteng

Vehicle Type	PASSENGER VEHICLE	Registered Owner	MFC
Manufacturer	VOLKSWAGEN	Registration Number	NB10655
Model	POLO VIVO	Register Number	
VIN	AAVZZZ6SZHU033010	Date Of First Licensing	
Engine Number		Last COR	
Doors	5	License Expiry Date	31/12/2018
Color	GOLDEN	Power / Displacement	
Year Model		Paint Finish	M - METALLIC
Km Reading	228,322 KM	Fuel	PETROL
Cab / Body Type	HATCHBACK	Transmission	MANUAL

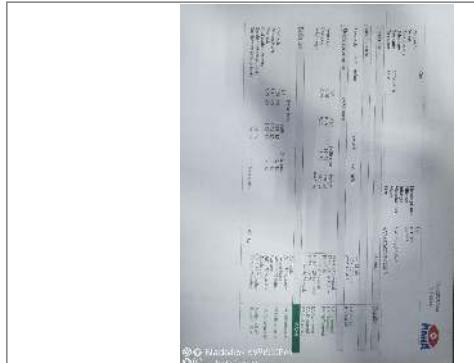
Shock and brake report

Left	Right	Axle Weight [KG]	Deceleration [m/s ²]
	Braking Force [kN]	Braking Force [kN]		
Front	2.3	2.1	-	
Rear	1.1	1.2	-	
Emergency / Parking	1.4	1.4	-

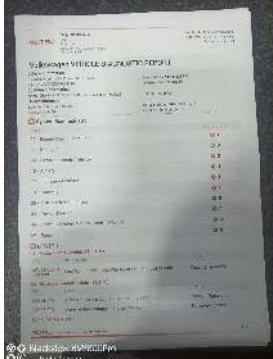
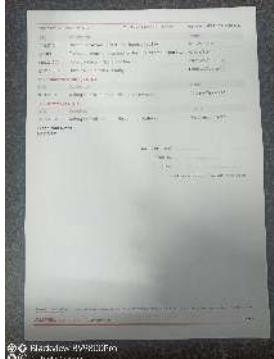
Diagnostic report

During the diagnostic no active error messages were detected. (See also attached Diagnostic Report. For more information regarding the Fault Codes (DTC) and the recommended rectifications please contact the workshops of the vehicle manufacture).

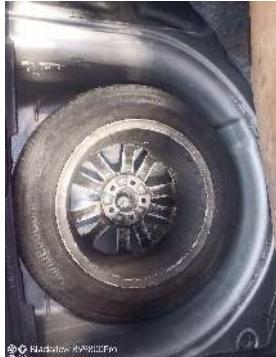
Spare wheel fitted

Size	Load/Speed Index	Manufacture	Model	Type*	Production Date	Tread Depth (mm)
Front Left	185/60R14	82H	Continental	Contact	V	1622	3 mm
Front Right	175/70R14	84H	Dunlop	Sp sport	V	4516	2 mm
Rear Left	175/65R14	82T	Continental	Contact	V	0920	2 mm
Rear Right	185/60R14	82H	Continental	Contact	V	0921	3 mm
Spare	185/60R14	82H	Continental	Contact	V	////	1 mm
