## CONDITION REPORT

Report No: 2016175427

| Manufacturer | VOLKSWAGEN | Registration Number | JS82PDGP |
| Model | POLO TSI | Register Number | |

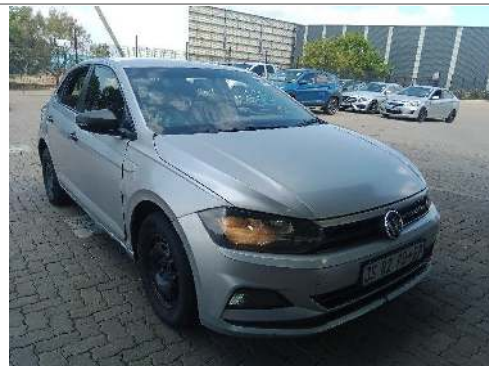
FRONT RIGHT CORNER

| Damage | Repair Way |
|---|---|
| Front Fender Right Damaged | Repair |
| Door Front Right Damaged | Repair |

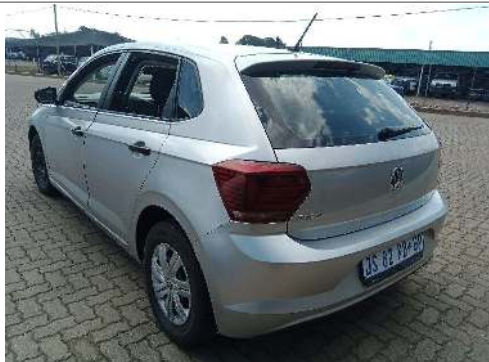
REAR LEFT CORNER

| Damage | Repair Way |
|---|---|
| Rear bumper Damaged | Repair |
| Sill Panel Left Welded | Replace |

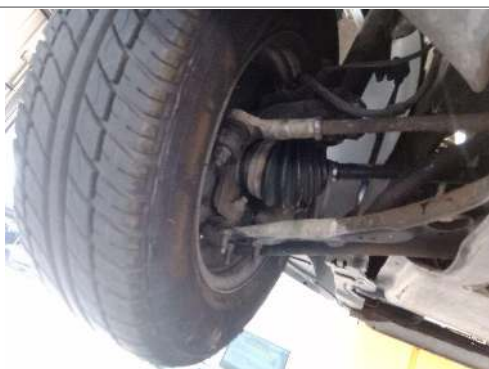
LF TYRE TREAD

| | Size | Load/Speed Index | Manufacture | Model | Type* | Production Date | Tread Depth (mm) |
|---|---|---|---|---|---|---|---|
| Front Left | 185/70R14 | 88H | Symmetry | SY101 | V | 1721 | 6 mm |

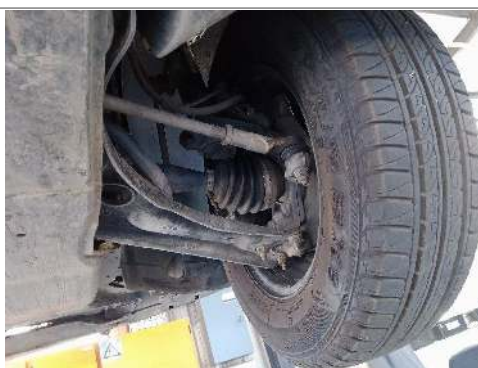
RF TYRE TREAD

| | Size | Load/Speed Index | Manufacture | Model | Type* | Production Date | Tread Depth (mm) |
|---|---|---|---|---|---|---|---|
| Front Right | 185/70R14 | 88H | Joyroad | Tour | V | 1528 | 6 mm |

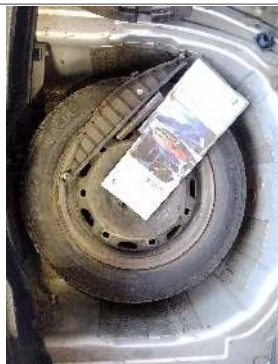
Sparewheel

| | Size | Load/Speed Index | Manufacture | Model | Type* | Production Date | Tread Depth (mm) |
|---|---|---|---|---|---|---|---|
| Spare | 175/65R14 | 82T | Velocity | Reacta | V | //// | 4 mm |
