## CONDITION REPORT

Report No:  
2017298878  
DATE  
15/09/2026

| Manufacturer | CHEVROLET | Registration Number | BY72RVGP |
| Model | SPARK 1.2 LS 5-DR [2012-2013] | Register Number | |

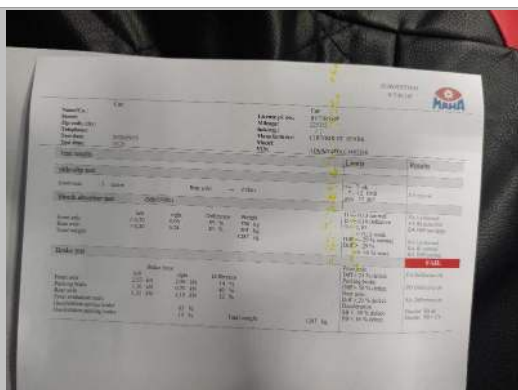
Shock and brake

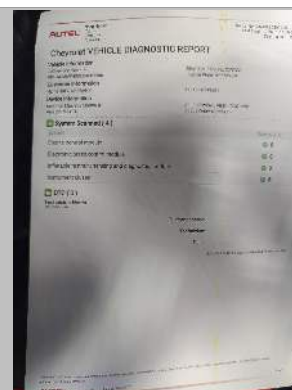
During the diagnostic no active error messages were detected. (See also attached Diagnostic Report. For more information regarding the Fault Codes (DTC) and the recommended rectifications please contact the workshops of the vehicle manufacture).

Diagnostics report

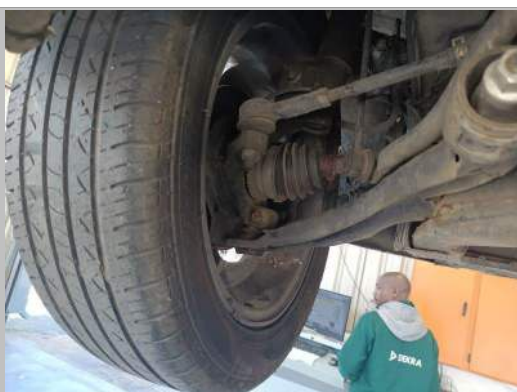
LF TYRE TREAD

| | Size | Load/Speed Index | Manufacture | Model | Type* | Production Date | Tread Depth (mm) |
|---|---|---|---|---|---|---|---|
| Front Left | 185/55R15 | 82V | Hilo | Genesys | V | 2223 | 5 mm |

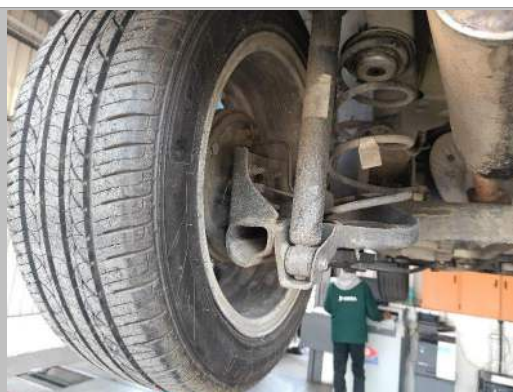
LR TYRE TREAD

| | Size | Load/Speed Index | Manufacture | Model | Type* | Production Date | Tread Depth (mm) |
|---|---|---|---|---|---|---|---|
| Rear Left | 185/55R15 | 82V | Hilo | Genesys | V | 4723 | 5 mm |

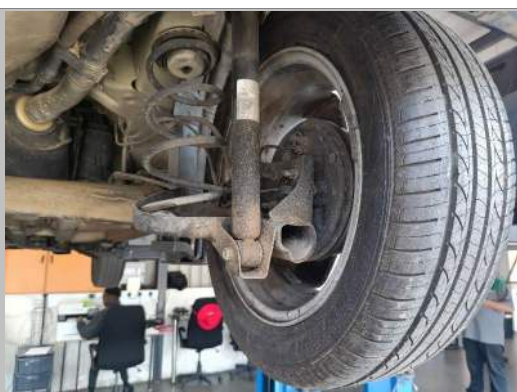
RR TYRE TREAD

| Damage | Repair Way |
|---|---|
| Tyre Rear Right Damaged | Replace |

| | Size | Load/Speed Index | Manufacture | Model | Type* | Production Date | Tread Depth (mm) |
|---|---|---|---|---|---|---|---|
| Rear Right | 185/55R15 | 82V | Hilo | Genesys | V | 2123 | 6 mm |

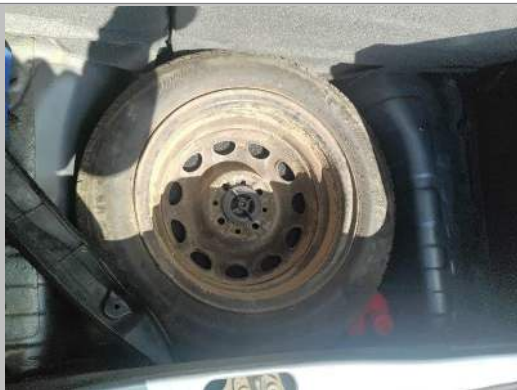
Sparewheel

| | Size | Load/Speed Index | Manufacture | Model | Type* | Production Date | Tread Depth (mm) |
|---|---|---|---|---|---|---|---|
| Spare | 175/65R14 | 82H | Firestone | Touring | V | 0000 | 3 mm |

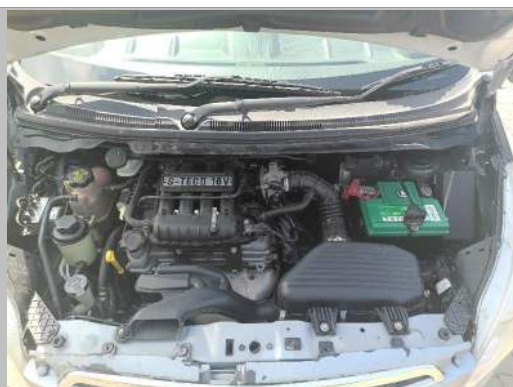
ENGINE 1

| Damage | Repair Way |
|---|---|
| Engine Oil Leak | Repair |
