CONDITION REPORT

Report No: 2016239725

MFC Auction House
M57 Pretoria Rd, Glenmarais, KEMPTON PARK
Gauteng

Vehicle Type	LIGHT LOAD VEHICLE	Registered Owner	MFC AUCTION HOUSE
Manufacturer	NISSAN	Registration Number	JG71SSGP
Model	NP200	Register Number	
VIN	ADNUSN1D5U0170273	Date Of First Licensing	
Engine Number		Last COR	
Doors	2	License Expiry Date	30/06/2024
Color	WHITE	Power / Displacement	
Year Model		Paint Finish	C - COMMON
Km Reading	162,480 KM	Fuel	PETROL
Cab / Body Type	SINGLE CAB	Transmission	MANUAL

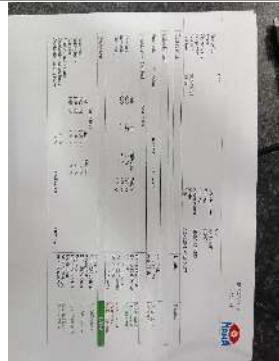
Shock and brake report

Left	Right	Axle Weight [KG]	Deceleration [m/s ²]
	Braking Force [kN]	Braking Force [kN]		
Front	2.9	3.0	-	
Rear	1.4	1.3	-	
Emergency / Parking	1.1	0.8	-

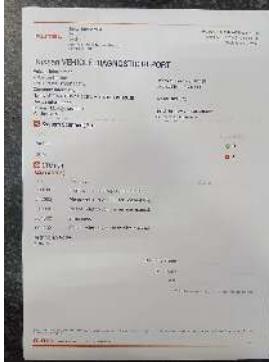
Diagnostic test

During the diagnostic no active error messages were detected. (See also attached Diagnostic Report. For more information regarding the Fault Codes (DTC) and the recommended rectifications please contact the workshops of the vehicle manufacture).

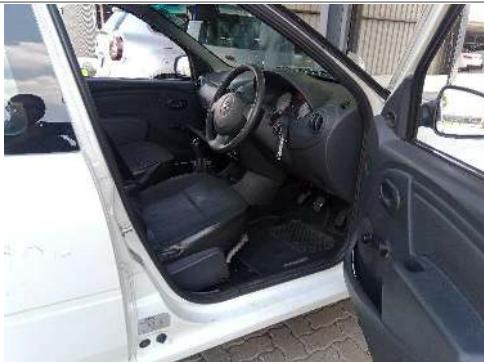
INTERIOR (FRONT DRIVER DOOR)

General Comments: ACCORDING TO THE AGE AND MILEAGE OF THE VEHICLE, NORMAL WEAR AND TEAR MARKS ARE VISIBLE ON THE INTERIOR, EXTERIOR, ELECTRICAL AND MECHANICAL PARTS. Interior: Driver window malfunction.
Body • Exterior: Minor dents scratches and stone chips on som

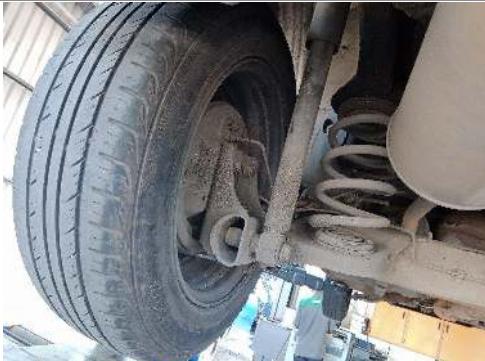
LR TYRE TREAD

Size	Load/Speed Index	Manufacture	Model	Type*	Production Date	Tread Depth (mm)
Front Left	185/65R15	88H	Firestone	Touring		4121	1 mm
Front Right	185/65R15	88T	Continental	Contact	V	2222	2 mm
Rear Left	185/65R15	92H	Blackhwak	Street	V	1821	3 mm
Rear Right	185/65R15	92T	Barum	Brilliantis	V	0423	5 mm
Spare	185/65R15	92H	Sumitomo	HTR	V	//////	3 mm
