MFC Auction House
M57 Pretoria Rd, Glenmarais, KEMPTON PARK
Gauteng

DEKRA MFC
M57 Pretoria Rd - 1619
KEMPTON PARK - GT
08610 33572

VEHICLE INSPECTION

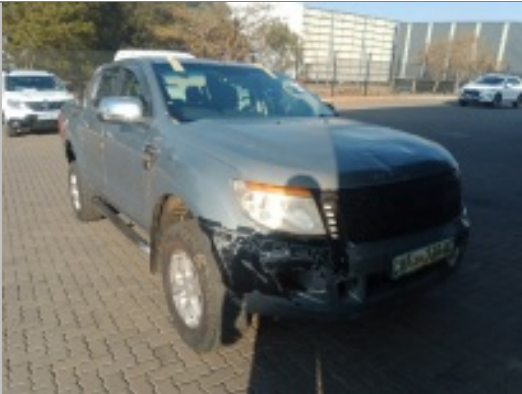
FRONT RIGHT CORNER

| Damage | Repair Way |
|--|---|
| Body and exterior | Signs of impact damage to front of vehicle |

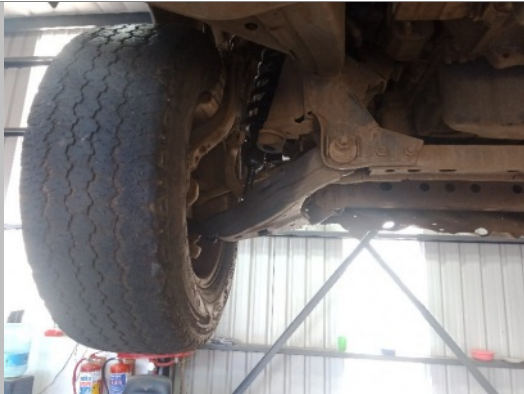
LF TYRE TREAD

| Damage | Repair Way |
|--|---|
| Tyre Front Left Worn | Replace |

| | Size | Load/Speed Index | Manufacture | Model | Type* | Production Date | Tread Depth (mm) |
|---|---|---|---|---|---|---|---|
| Front Left | 265/65R17 | 112S | Goodyear | Wrangler | V | 1517 | 0 mm |

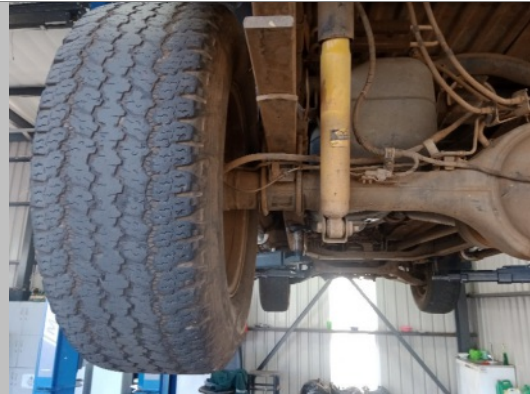
LR TYRE TREAD

| | Size | Load/Speed Index | Manufacture | Model | Type* | Production Date | Tread Depth (mm) |
|---|---|---|---|---|---|---|---|
| Rear Left | 265/65R17 | 112T | Goodyear | Wrangler | V | 1517 | 1 mm |

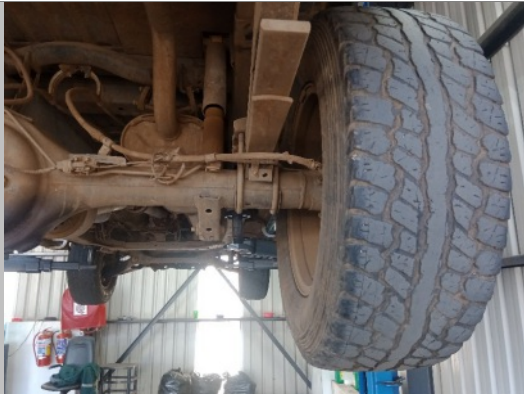
RR TYRE TREAD

| | Size | Load/Speed Index | Manufacture | Model | Type* | Production Date | Tread Depth (mm) |
|---|---|---|---|---|---|---|---|
| Rear Right | 265/65R17 | 120R | Dunlop | Grandtrek | V | 2719 | 1 mm |

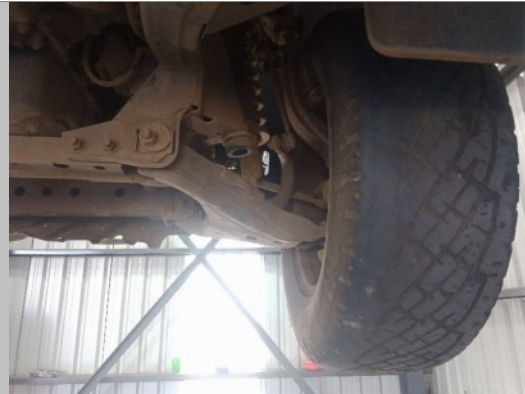
RF TYRE TREAD

| Damage | Repair Way |
|--|---|
| Tyre Front Right Worn | Replace |

| | Size | Load/Speed Index | Manufacture | Model | Type* | Production Date | Tread Depth (mm) |
|---|---|---|---|---|---|---|---|
| Front Right | 265/65R17 | 112T | General | Radial | V | 4416 | 0 mm |

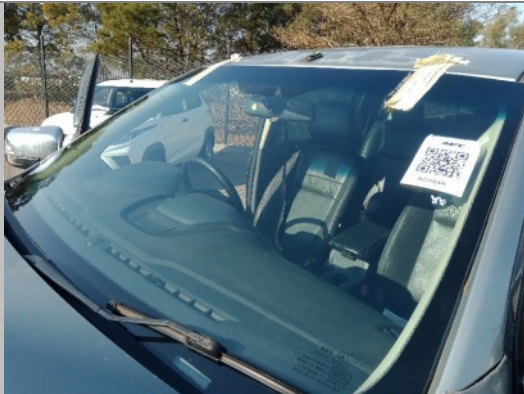
NO LICENSE DISC
