CONDITION REPORT

Report No:  
2017297912  
DATE  
11/09/2026

MFC Auction House  
M57 Pretoria Rd, Glenmarais, KEMPTON PARK  
Gauteng

| Manufacturer | TOYOTA | Registration Number | MD92JFGP |

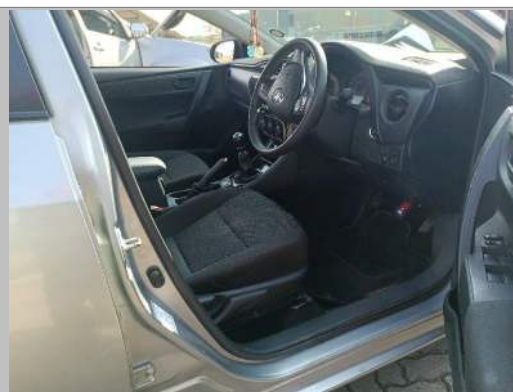
INTERIOR (FRONT DRIVER DOOR)

| Seat Front Right Torn / Cut | Repair |

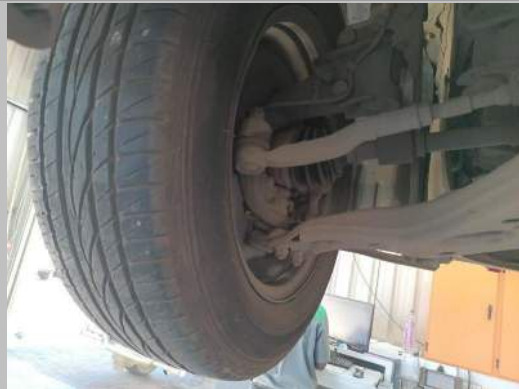
LF TYRE TREAD

| | Size | Load/Speed Index | Manufacture | Model | Type* | Production Date | Tread Depth (mm) |
|---|---|---|---|---|---|---|---|
| Front Left | 195/65R15 | 91V | Sumitomo | BC100 | V | 0725 | 5 mm |

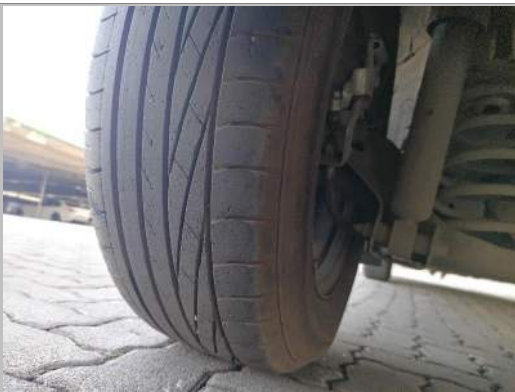
LR TYRE TREAD

| | Size | Load/Speed Index | Manufacture | Model | Type* | Production Date | Tread Depth (mm) |
|---|---|---|---|---|---|---|---|
| Rear Left | 195/65R15 | 91H | Goodyear | Excellence | V | 4023 | 6 mm |

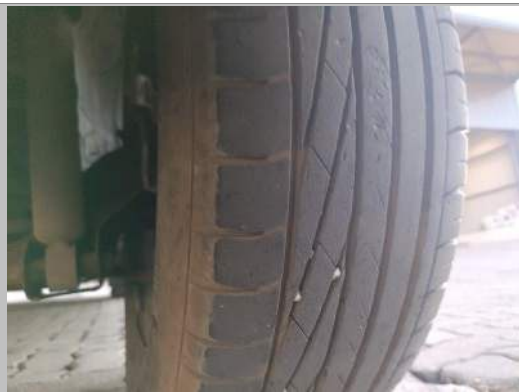
RR TYRE TREAD

| | Size | Load/Speed Index | Manufacture | Model | Type* | Production Date | Tread Depth (mm) |
|---|---|---|---|---|---|---|---|
| Rear Right | 195/65R15 | 91H | Goodyear | Excellence | V | 4023 | 5 mm |

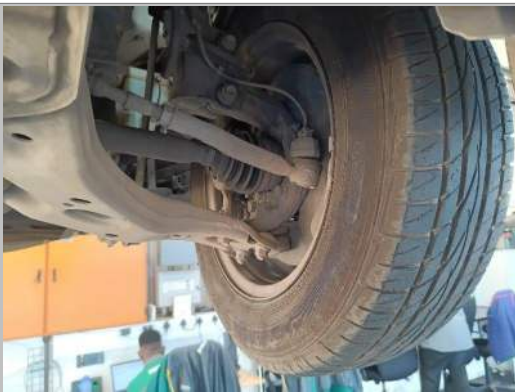
RF TYRE TREAD

| | Size | Load/Speed Index | Manufacture | Model | Type* | Production Date | Tread Depth (mm) |
|---|---|---|---|---|---|---|---|
| Front Right | 195/65R15 | 91V | Sumitomo | BC100 | V | 0725 | 5 mm |

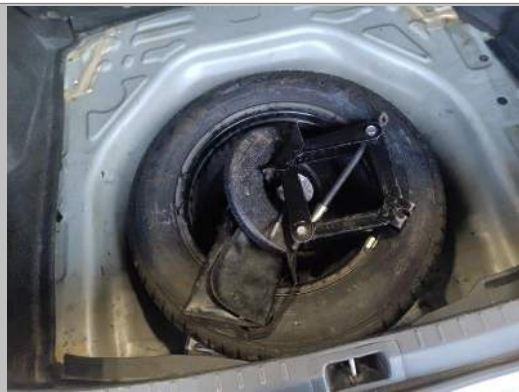
Sparewheel

| | Size | Load/Speed Index | Manufacture | Model | Type* | Production Date | Tread Depth (mm) |
|---|---|---|---|---|---|---|---|
| Spare | 195/65R15 | 91H | Goodyear | Excellence | V | 0000 | 6 mm |
