CONDITION REPORT

Report No:  
2017296906  
DATE  
10/09/2026

| Manufacturer | TOYOTA | Registration Number | LDZ937NW |
| Model | COROLLA QUEST 1.8 PLUS [2022-2025] | Register Number | |

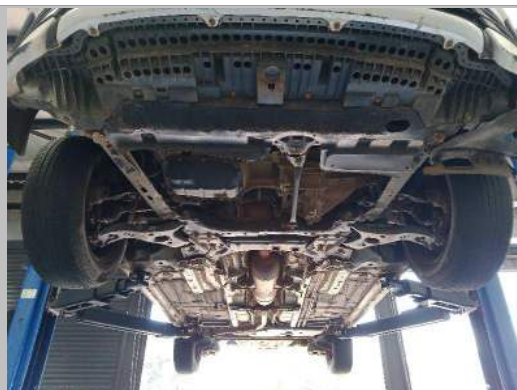
Front chassis

| Cross Member Rear Left Damaged | Repair |
| Cross Member Rear Right Damaged | Repair |
| Radiator Cradle Damaged | Repair |

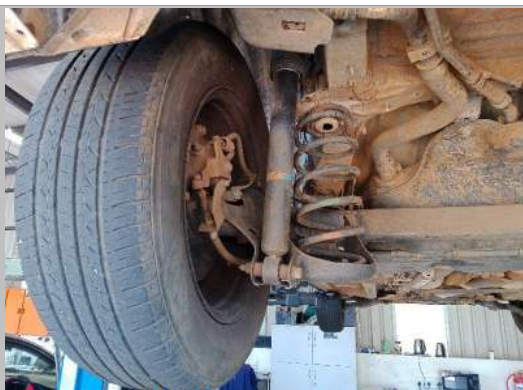
LR TYRE TREAD

| | Size | Load/Speed Index | Manufacture | Model | Type* | Production Date | Tread Depth (mm) |
|---|---|---|---|---|---|---|---|
| Rear Left | 195/65R15 | 91H | Hilo | Genesys | V | 4123 | 2 mm |

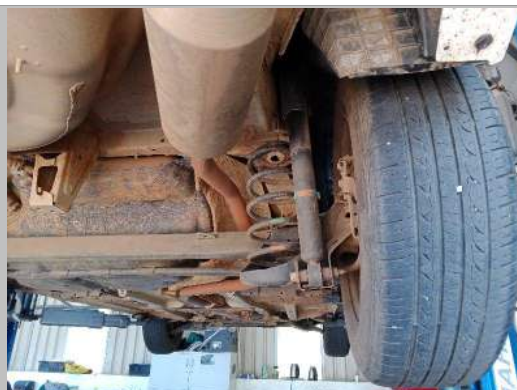
RR TYRE TREAD

| | Size | Load/Speed Index | Manufacture | Model | Type* | Production Date | Tread Depth (mm) |
|---|---|---|---|---|---|---|---|
| Rear Right | 195/65R15 | 91H | Hilo | Genesys | V | 4123 | 2 mm |
