MFC Auction House  
M57 Pretoria Rd, Glenmarais, KEMPTON PARK  
Gauteng

**Assignment**

**Vehicle Data**

**VEHICLE INSPECTION**

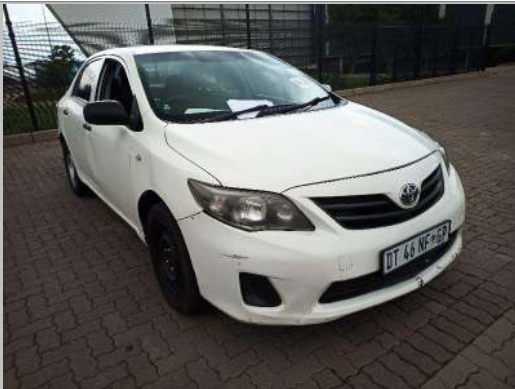
FRONT RIGHT CORNER

Body • Exterior: Minor dents and scratches and stone chips to some body panels. Signs of repair work done to some body panels. Signs of impact damage to front of vehicle. Poor alignment to some body panels. Vehicle body in poor condition. Repair work done to vehicle below-standard.
