## CONDITION REPORT

Report No:  
2017288390  
DATE  
24/08/2026

| Manufacturer | TOYOTA | Registration Number | LW04FCGP |
| Model | HI-ACE 2.5 SESFIKILE 16-S DSL MINIBUS<br>[2021-2024] | Register Number | |

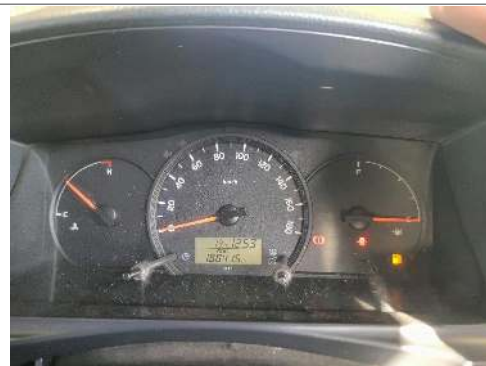
DASHBOARD (W/ ENGINE RUNNING)

| Warning lights illuminated | Report |

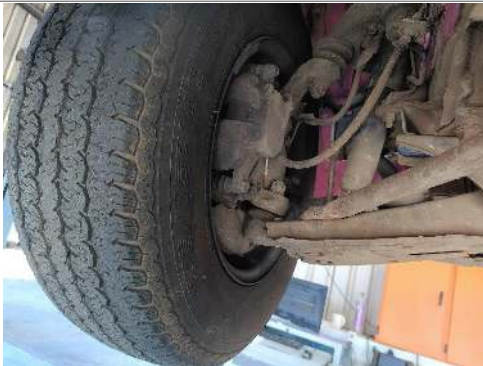
LF TYRE TREAD

| | Size | Load/Speed Index | Manufacture | Model | Type* | Production Date | Tread Depth (mm) |
|---|---|---|---|---|---|---|---|
| Front Left | 205/75R14 | 109/107S | Yokohama | Steel | V | 3325 | 3 mm |

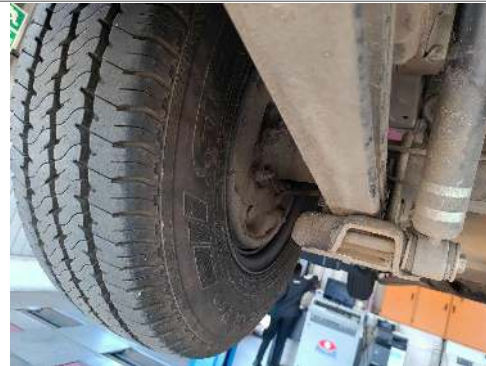
LR TYRE TREAD

| | Size | Load/Speed Index | Manufacture | Model | Type* | Production Date | Tread Depth (mm) |
|---|---|---|---|---|---|---|---|
| Rear Left | 205/75R14 | 109/107S | Gt radial | Maxmiller | V | 2125 | 5 mm |

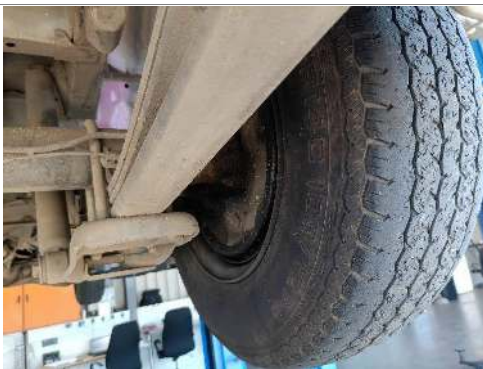
RR TYRE TREAD

| | Size | Load/Speed Index | Manufacture | Model | Type* | Production Date | Tread Depth (mm) |
|---|---|---|---|---|---|---|---|
| Rear Right | 205/75R14 | 109/107S | Yokohama | Steel | V | 2425 | 1 mm |

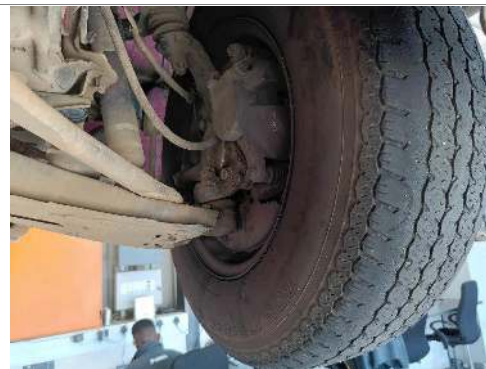
RF TYRE TREAD

| | Size | Load/Speed Index | Manufacture | Model | Type* | Production Date | Tread Depth (mm) |
|---|---|---|---|---|---|---|---|
| Front Right | 205/75R14 | 109/107S | Yokohama | Steel | V | 0524 | 1 mm |

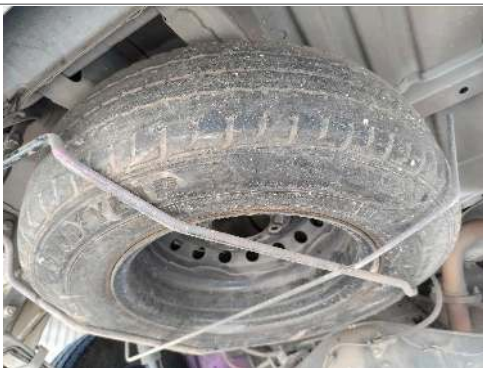
Sparewheel

| Spare Tyre Smooth | Replace |

| | Size | Load/Speed Index | Manufacture | Model | Type* | Production Date | Tread Depth (mm) |
|---|---|---|---|---|---|---|---|
| Spare | 195R15 | 106/104S | Goodyear | Efficient | V | 0000 | 0 mm |

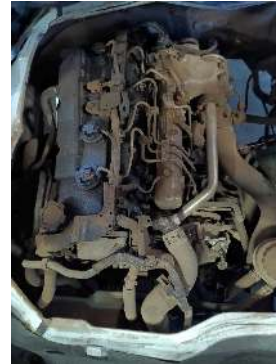
ENGINE 1

| Engine Oil Leak | Repair |
| Engine Wiring Defective | Repair |
