CONDITION REPORT

Report No:  
2017292773  
DATE  
01/09/2026

| Manufacturer | JETOUR | Registration Number | MB72SGGP |
| Model | X70 | Register Number | |

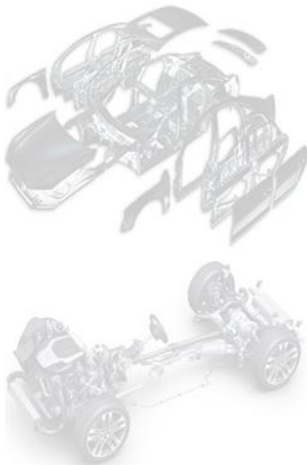
| Damage | Repair Way |
|---|---|
| Switch Electrical Window Winder front right Defective | Repair |
| Carpet Front Torn / Cut | Repair |
| Door Front Left Paintwork • Scratched | Repair |
| Door Rear Left Paintwork • Scratched | Repair |
| Brake disc 2. Axle left Corrosion | Replace |
| Brake disc 2. Axle right Corrosion | Replace |
