CONDITION REPORT

Report No:  
2017297260  
DATE  
10/09/2026

| Manufacturer | MAZDA | Registration Number | ML26GCGP |
| Model | CX-5 2.0L DYNAMIC AT [2022-2024] | Register Number | |

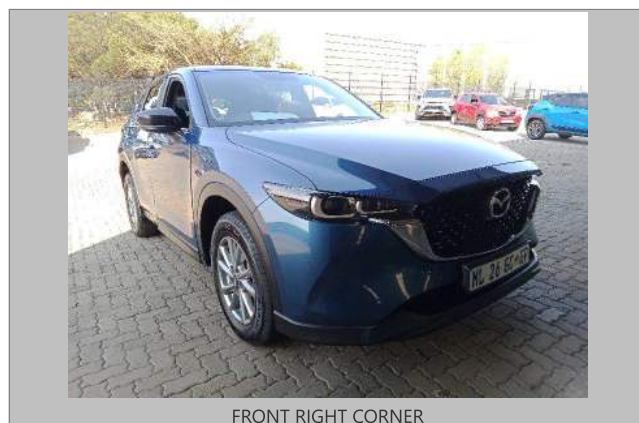
FRONT RIGHT CORNER

| Front Fender Right Residual Traces of Repair | Repair |

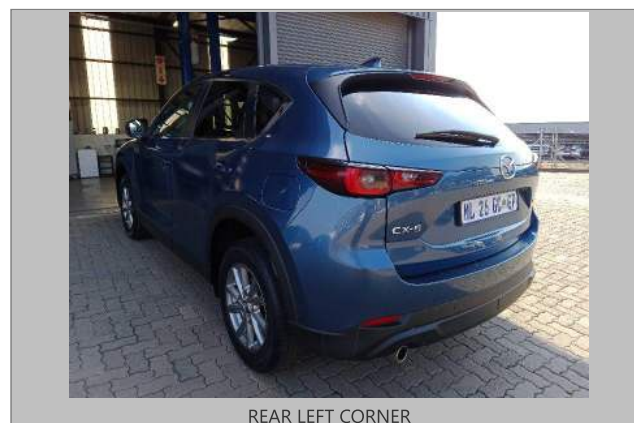
REAR LEFT CORNER

| Rear Fender Left Residual Traces of Repair | Repair |

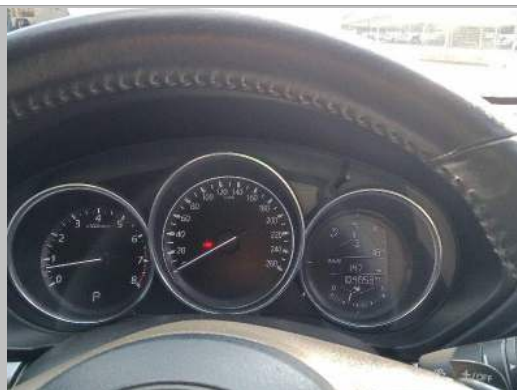
DASHBOARD (W/ ENGINE RUNNING)

| Warning lights illuminated on dashboard | Repair |
| Airbag warning light intermittent | Repair |

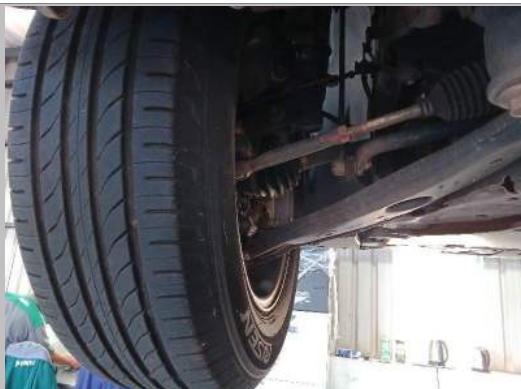
LF TYRE TREAD

| | Size | Load/Speed Index | Manufacture | Model | Type* | Production Date | Tread Depth (mm) |
|---|---|---|---|---|---|---|---|
| Front Left | 225/65 R17 | 102H | Risten | Radial | V | 4425 | 4 mm |

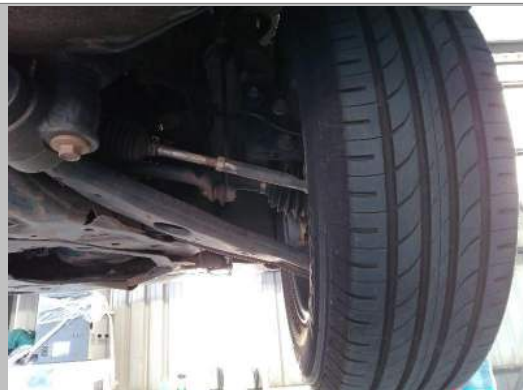
RF TYRE TREAD

| | Size | Load/Speed Index | Manufacture | Model | Type* | Production Date | Tread Depth (mm) |
|---|---|---|---|---|---|---|---|
| Front Right | 225/65 R17 | 102H | Risten | Radial | V | 4425 | 4 mm |

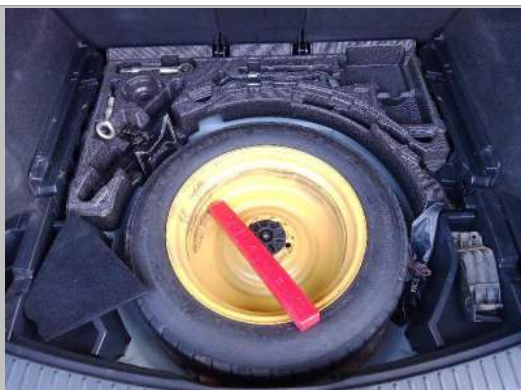
Spare Wheel and Accessories

| | Size | Load/Speed Index | Manufacture | Model | Type* | Production Date | Tread Depth (mm) |
|---|---|---|---|---|---|---|---|
| Spare | T155/80 R17 | 100M | Bridgestone | Temporary | V | 1222 | 4 mm |
