CONDITION REPORT

Report No: 2016201689

MFC Auction House
M57 Pretoria Rd, Glenmarais, KEMPTON PARK
Gauteng

Vehicle Type	PASSENGER VEHICLE	Registered Owner	MFC
Manufacturer	TOYOTA	Registration Number	FXH701L
Model	STARLET	Register Number	
VIN	JTDGWC52S00669303	Date Of First Licensing	
Engine Number		Last COR	
Doors	5	License Expiry Date	30/11/2023
Color	GREY	Power / Displacement	
Year Model		Paint Finish	TWO COAT METALLIC
Km Reading	36,047 KM	Fuel	PETROL
Cab / Body Type	HATCHBACK	Transmission	AUTOMATIC

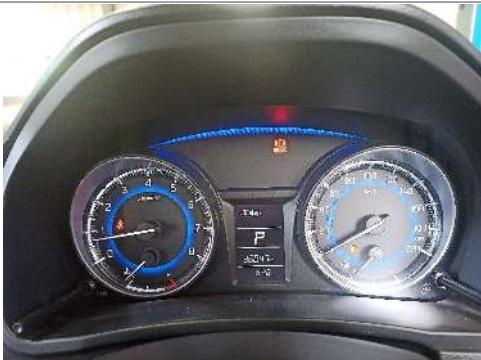
DASHBOARD (W/ ENGINE RUNNING)

During the diagnostic no active error messages were detected. (See also attached Diagnostic Report. For more information regarding the Fault Codes (DTC) and the recommended rectifications please contact the workshops of the vehicle manufacture).

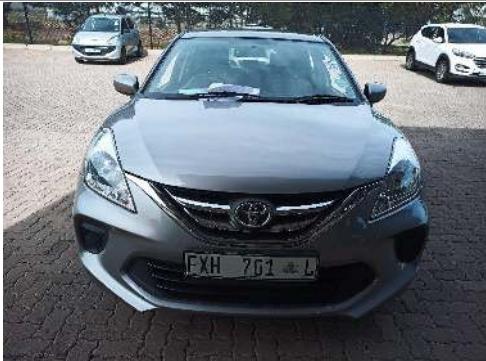
90 DEGREE FRONT

Damage	Repair Way
Front Bumper Damaged	Repair
Bonnet Damaged	Repair
Door Front Left Damaged	Repair
Door Front Right Damaged	Repair
Door Rear Left Damaged	Repair
Door Rear Right Damaged	Repair
Rear bumper Damaged	Repair

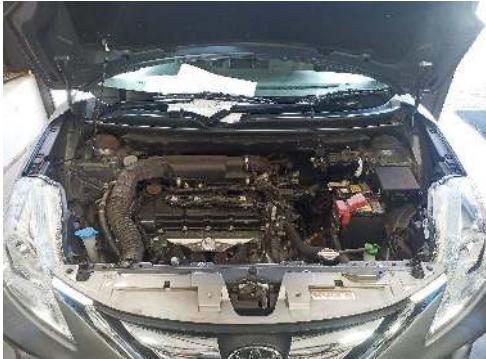
ENGINE 1

Engine number – not possible to verify engine number (not visible without dismantling)
