## CONDITION REPORT

Report No:  
2017300801  
DATE  
18/09/2026

MFC Auction House  
M57 Pretoria Rd, Glenmarais, KEMPTON PARK  
Gauteng

| Manufacturer | KIA | Registration Number | HC37GHGP |

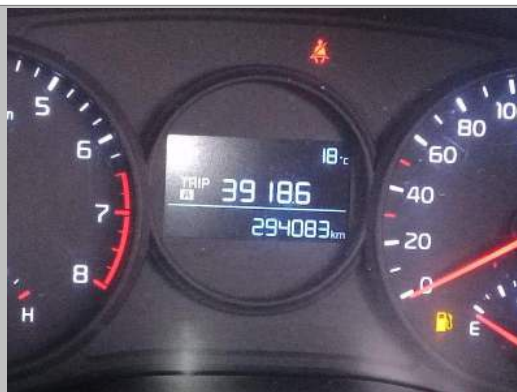
ODOMETER

| Km Reading | 294,083 KM | Fuel | PETROL |

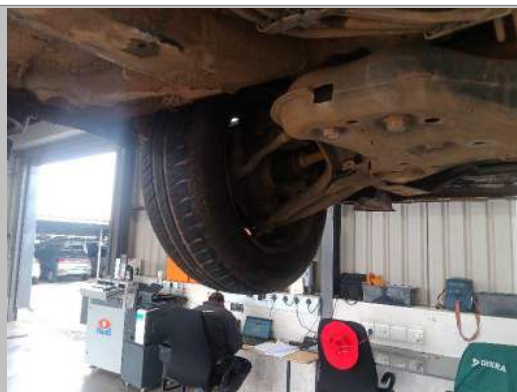
LF TYRE TREAD

| | Size | Load/Speed Index | Manufacture | Model | Type* | Production Date | Tread Depth (mm) |
|---|---|---|---|---|---|---|---|
| Front Left | 165/65R14 | 79T | Goodyear | Efficient gr | V | 1821 | 2 mm |

| Damage | Repair Way |
|---|---|
| Rear and Front tyres size differs | Replace |

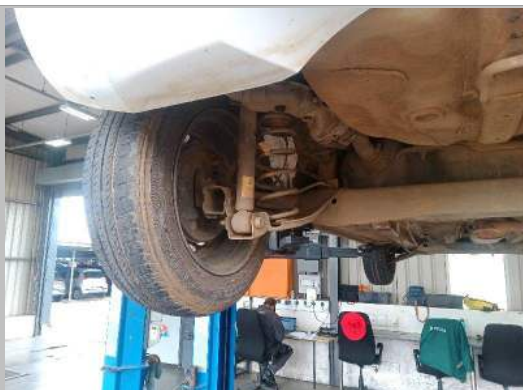
LR TYRE TREAD

| | Size | Load/Speed Index | Manufacture | Model | Type* | Production Date | Tread Depth (mm) |
|---|---|---|---|---|---|---|---|
| Rear Left | 165/70R14 | 81S | MRF | Zvtv | V | 1719 | 2 mm |

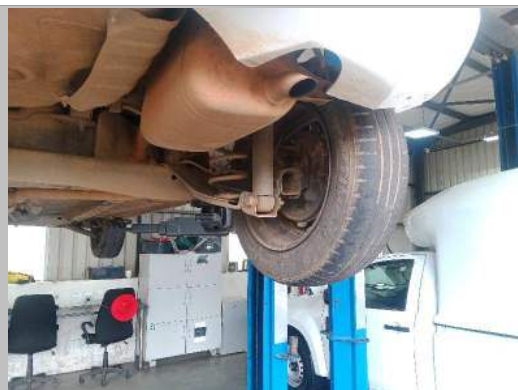
RR TYRE TREAD

| Damage | Repair Way |
|---|---|
| Tyre Rear Right Damaged | Replace |

| | Size | Load/Speed Index | Manufacture | Model | Type* | Production Date | Tread Depth (mm) |
|---|---|---|---|---|---|---|---|
| Rear Right | 175/65R14 | 82T | Hankook | Optimo | V | 1519 | 0 mm |

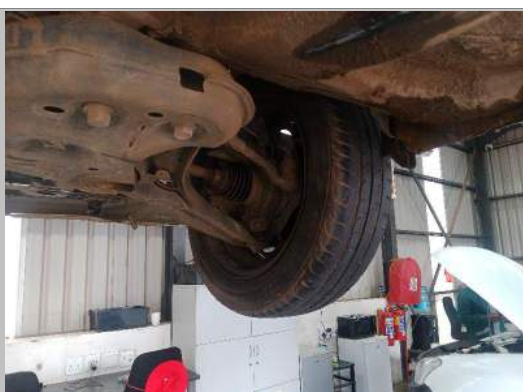
RF TYRE TREAD

| | Size | Load/Speed Index | Manufacture | Model | Type* | Production Date | Tread Depth (mm) |
|---|---|---|---|---|---|---|---|
| Front Right | 165/60R14 | 75H | Encore | Reflex 202 | V | 5220 | 2 mm |
