CONDITION REPORT

Report No: 2016209948

MFC Auction House  
M57 Pretoria Rd, Glenmarais, KEMPTON PARK  
Gauteng

| Manufacturer | KIA | Registration Number | KN02HNGP |

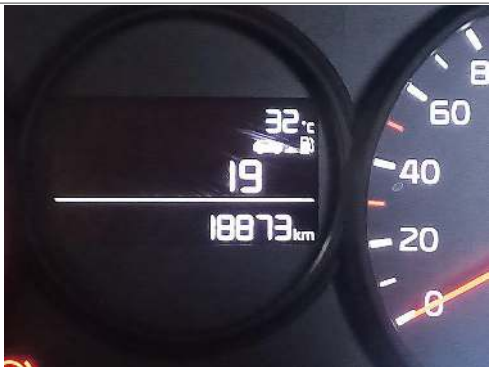
ODOMETER

| Km Reading | 18,873 KM | Fuel | PETROL |
