CONDITION REPORT

Report No: 2016202101

MFC Auction House
M57 Pretoria Rd, Glenmarais, KEMPTON PARK
Gauteng

Vehicle Type	PASSENGER VEHICLE	Registered Owner	MFC
Manufacturer	KIA	Registration Number	DT97FYGP
Model	RIO	Register Number	
VIN	KNADN512LF6560805	Date Of First Licensing	
Engine Number		Last COR	
Doors	5	License Expiry Date	30/11/2022
Color	SILVER	Power / Displacement	
Year Model		Paint Finish	M - METALLIC
Km Reading	168,237 KM	Fuel	PETROL
Cab / Body Type	HATCHBACK	Transmission	MANUAL

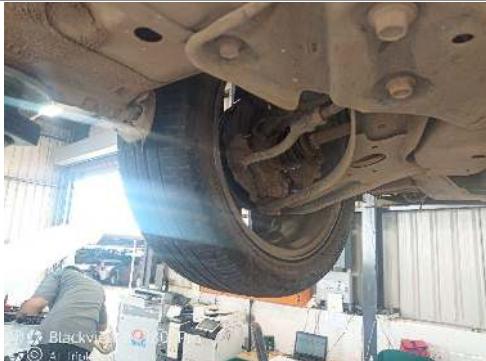
LF TYRE TREAD

Size	Load/Speed Index	Manufacture	Model	Type*	Production Date	Tread Depth (mm)
Front Left	225/45R17	94W	Voyager	Hp	V	0419	1 mm
Front Right	225/45R17	91W	Continental	Contact	V	1316	1 mm
Rear Left	225/45R17	94W	Invovic	EI601	V	3616	1 mm
Rear Right	215/50R17	91W	Sava	Intensa	V	1916	2 mm

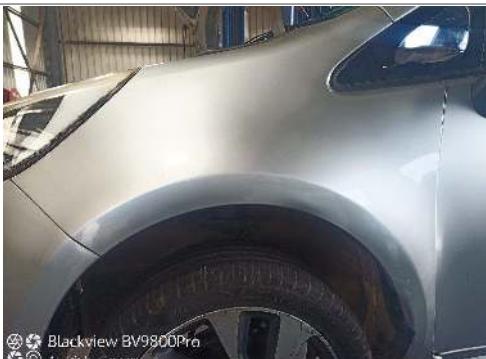
Front Fender Left

Clutch Operation Insufficient	Repair
Boot not opening cannot see spare wheel	Repair
L/F fender line missing	Replace
Steering wheel noisy	Repair
