CONDITION REPORT

Report No: 2016218798

MFC Auction House  
M57 Pretoria Rd, Glenmarais, KEMPTON PARK  
Gauteng

| Manufacturer | HAVAL | Registration Number | KW26LWGP |

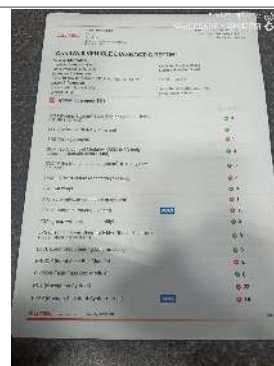
## Brake report

| Damage | Repair Way |
|---|---|
| Parking Brake Performance Left / Right Difference out of legal range | Repair |

| | Left | Right | | |
|---|---|---|---|---|
| Emergency / Parking | 0.3 | 0.7 | - | |

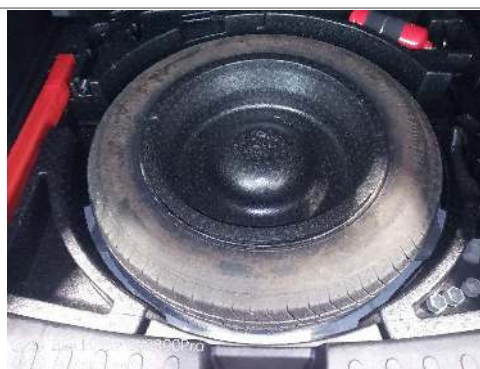
Spare wheel

| | Size | Load/Speed Index | Manufacture | Model | Type* | Production Date | Tread Depth (mm) |
|---|---|---|---|---|---|---|---|
| Spare | T135/90R17 | 104M | Sailun | Temporary | V | 0000 | 5 mm |

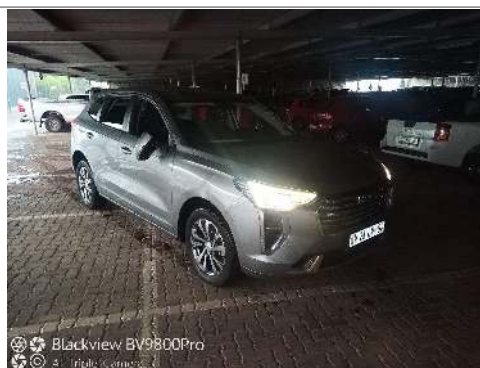
FRONT RIGHT CORNER

| Damage | Repair Way |
|---|---|
| Front Bumper Paintwork • Scratched | Repair |
| Front Fender Right Dented | Repair |

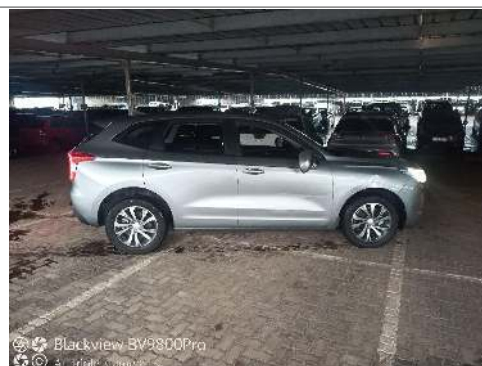
90 DEGREE RIGHT

| Damage | Repair Way |
|---|---|
| Side Mirror Right Damaged | Repair |
| Rear Fender Right Dented | Repair |
| Door Front Right Dented | Repair |
| Door Rear Right Paintwork • Scratched | Repair |
