MFC Auction House  
M57 Pretoria Rd, Glenmarais, KEMPTON PARK  
Gauteng

Vehicle Type	LIGHT LOAD VEHICLE	Registered Owner	
Manufacturer	CHANGAN	Registration Number	JW70FMGP
Model	STAR III SC 1.3 STD [2017-2021]	Register Number	
VIN	LSCAB13RXKG805521	Date Of First Licensing	
Engine Number		Last COR	
Doors	2	License Expiry Date	31/01/2022
Color	SILVER	Power / Displacement	
Year Model	2020	Paint Finish	M - METALLIC
Km Reading	81,002 KM	Fuel	PETROL
Cab / Body Type	SINGLE CAB	Transmission	MANUAL

## CONDITION REPORT

Report No: 2016606537

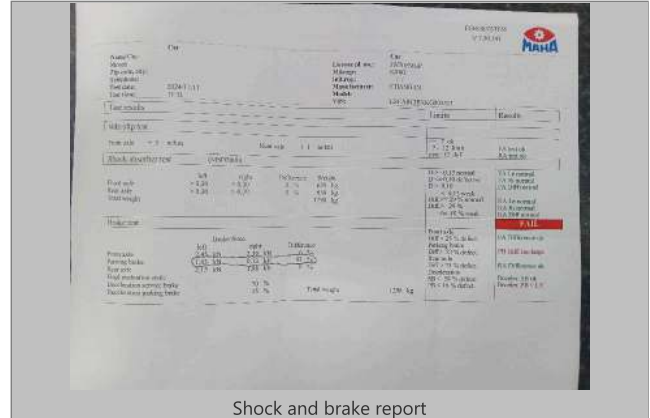
Shock and brake report

Left	Right	Axle Weight [KG]	Deceleration [m/s <sup>2</sup> ]
	Braking Force [KN]	Braking Force [KN]		
Front	2.4	2.3	-	
Rear	2.1	1.9	-	
Emergency / Parking	1.8	0.1	-

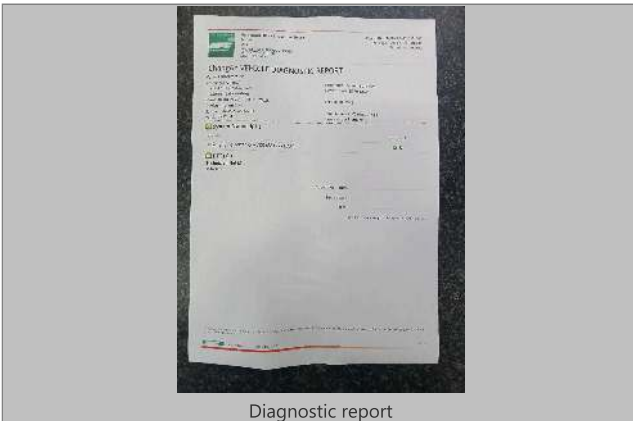
Diagnostic report

During the diagnostic no active error messages were detected. (See also attached Diagnostic Report. For more information regarding the Fault Codes (DTC) and the recommended rectifications please contact the workshops of the vehicle manufacture).

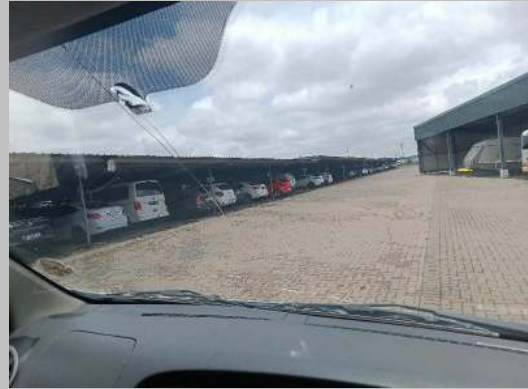
Damage	Repair Way
Interior Mirror Missing	Replace
Side Mirror Left Paintwork • Scratched	Repair
Side Mirror Right Paintwork • Scratched	Repair
Front Bumper Paintwork • Scratched	Repair
Bonnet Paintwork • Chipmarks	Repair
A • Pillar Right Dented	Repair
B • Pillar Left Paintwork • Scratched	Repair
Front Fender Left Paintwork • Scratched	Repair
Door Front Left Paintwork • Discoloured	Repair
Door Front Right Paintwork • Discoloured	Repair
Tailgate Paintwork • Scratched	Repair
Load Body Paintwork • Scratched	Repair
Windscreen Cracked	Replace
Parking Brake Performance Left / Right Difference out of legal range	Repair
Belly plates Damaged	Replace
Body exterior	Vehicle got minor scratches, stone chips and dents
Body exterior	Discoloring on some body panels
Windscreen washers not working	Repair
Body exterior	Signs of spray work done on some body panels
Canopy door missing	Replace
Body exterior	Signs of branding on some body panels
