## CONDITION REPORT

2017154923

| Manufacturer | VOLVO | Registration Number | MB33SKGP |
| Model | XC40 B4 2.0 MHEV PLUS DARK GEARTRONIC [2022-2023] | Register Number | |

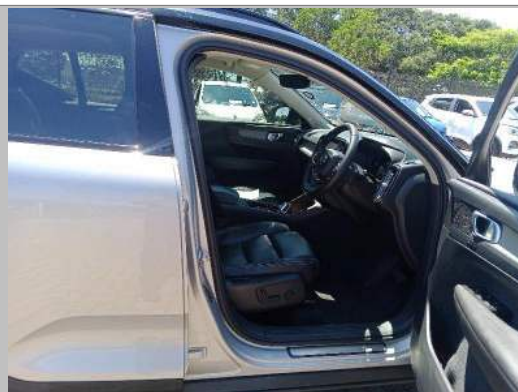
INTERIOR (FRONT DRIVER DOOR)

| Damage | Repair Way |
|---|---|
| Interior | Driver's interior B pillar plastic cover loose |

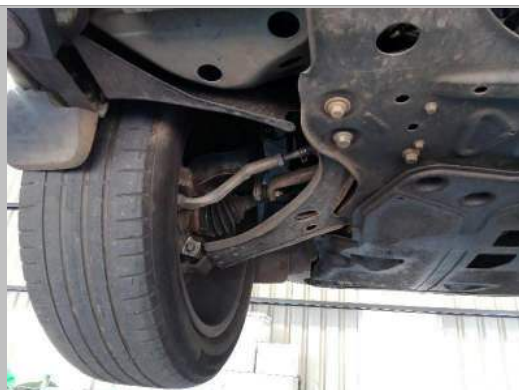
LF TYRE TREAD

| Damage | Repair Way |
|---|---|
| Tyre Front Left Torn / Cut | Replace |

| | Size | Load/Speed Index | Manufacture | Model | Type* | Production Date | Tread Depth (mm) |
|---|---|---|---|---|---|---|---|
| Front Left | 235/50 R19 | 99V | Pirelli | Pzero | V | 0322 | 1 mm |

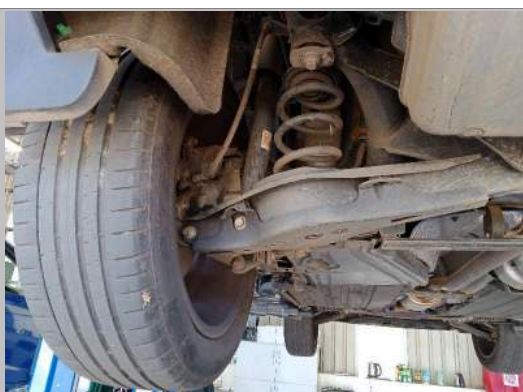
LR TYRE TREAD

| | Size | Load/Speed Index | Manufacture | Model | Type* | Production Date | Tread Depth (mm) |
|---|---|---|---|---|---|---|---|
| Rear Left | 235/50 R19 | 99V | Pirelli | Scorpion | V | 0422 | 2 mm |

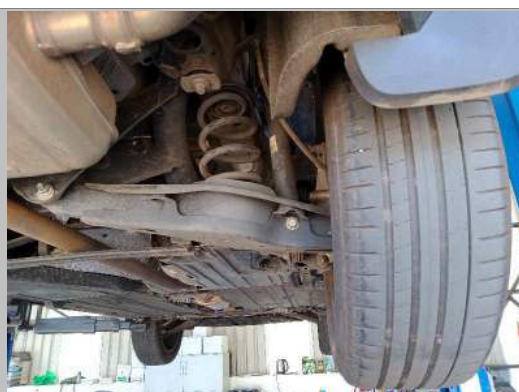
RR TYRE TREAD

| | Size | Load/Speed Index | Manufacture | Model | Type* | Production Date | Tread Depth (mm) |
|---|---|---|---|---|---|---|---|
| Rear Right | 235/50 R19 | 99V | Pirelli | Pzero | V | 0322 | 2 mm |

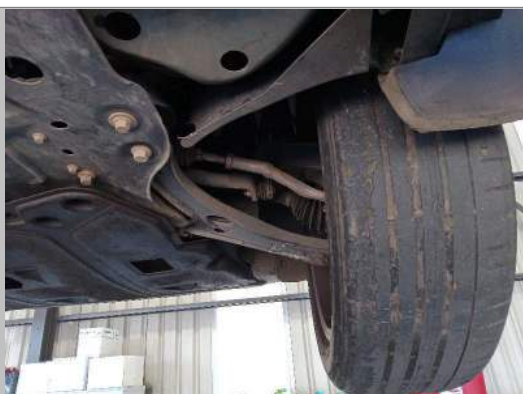
RF TYRE TREAD

| Damage | Repair Way |
|---|---|
| Tyre Front Right Damaged | Replace |

| | Size | Load/Speed Index | Manufacture | Model | Type* | Production Date | Tread Depth (mm) |
|---|---|---|---|---|---|---|---|
| Front Right | 235/50 R19 | 99V | Pirelli | Pzero | V | 0422 | 0 mm |

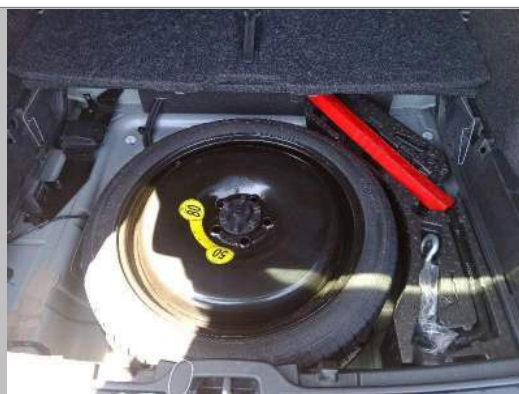
Spare wheel and Accessories

| Damage | Repair Way |
|---|---|
| Jack Missing | Replace |
