## CONDITION REPORT

Report No:  
2017298325  
DATE  
14/09/2026

| Manufacturer | FORD | Registration Number | KG75WLGP |
| Model | FIGO 1.4 AMBIENTE BLUETOOTH 5-DR [2014-2016] | Register Number | |

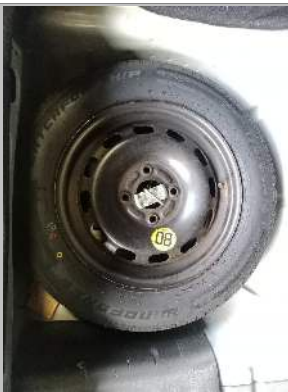
| Damage | Repair Way |
|---|---|
| Rim Spare Wheel Dented | Repair |

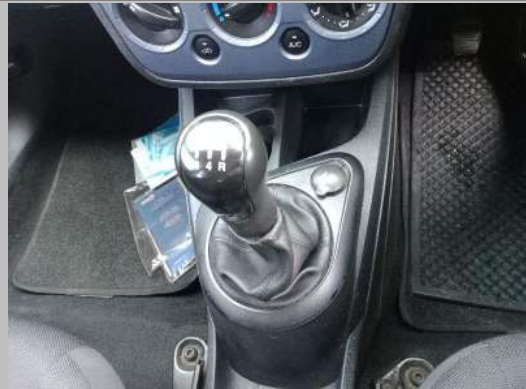
Manual Transmission

| Damage | Repair Way |
|---|---|
| Gearbox Damaged | Repair |
| Gearbox Noise Excessive | Repair |

Undercarriage: Oil leak on gearbox.

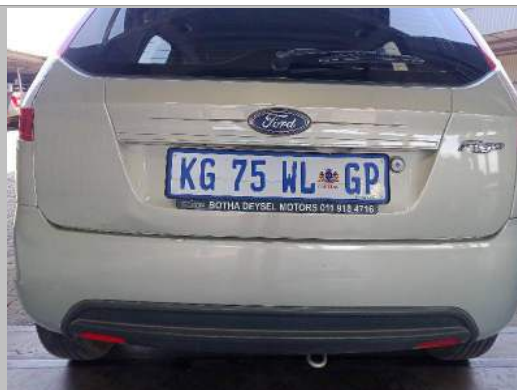
| Damage | Repair Way |
|---|---|
| Rear bumper Damaged | Repair |

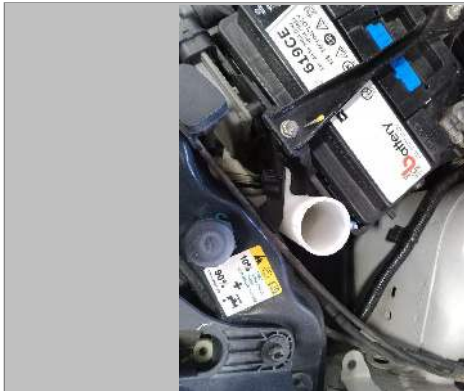
| Damage | Repair Way |
|---|---|
| Caps Missing | Replace |

General Comments: ACCORDING TO AGE AND MILEAGE OF VEHICLE NORMAL WEAR AND TEAR ON INTERIOR, EXTERIOR, ELECTRICAL AND MECHANICAL PARTS.Engine Compartment: Windshield wiper bottle cap missing.
