MFC Auction House  
M57 Pretoria Rd, Glenmarais, KEMPTON PARK  
Gauteng

DEKRA MFC  
M57 Pretoria Rd - 1619  
KEMPTON PARK - GT  
08610 33572

## Vehicle Data

| Manufacturer | FORD | Registration Number | CT97NCGP |

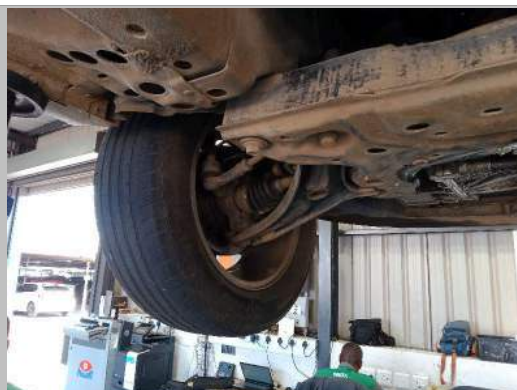
LF TYRE TREAD

| | Size | Load/Speed Index | Manufacture | Model | Type* | Production Date | Tread Depth (mm) |
|---|---|---|---|---|---|---|---|
| Front Left | 205/60R16 | 92V | Apollo | Alnac | V | 5020 | 3 mm |

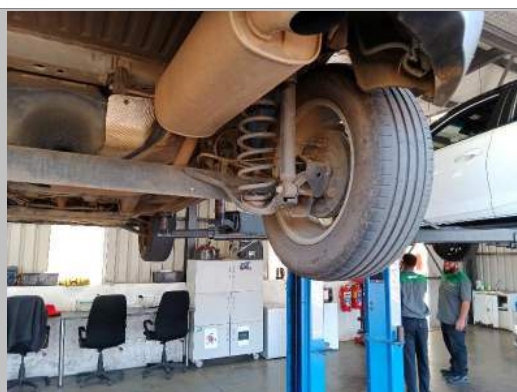
RR TYRE TREAD

| | Size | Load/Speed Index | Manufacture | Model | Type* | Production Date | Tread Depth (mm) |
|---|---|---|---|---|---|---|---|
| Rear Right | 205/60R16 | 92V | Apollo | Alnac | V | 1321 | 3 mm |

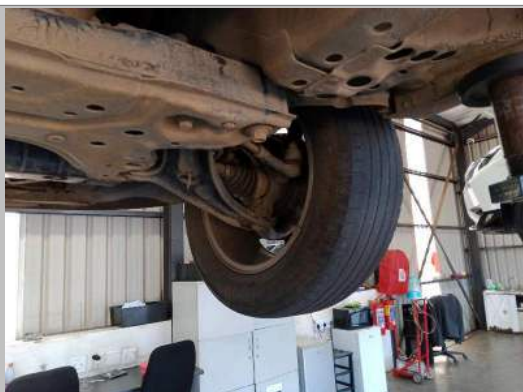
RF TYRE TREAD

| | Size | Load/Speed Index | Manufacture | Model | Type* | Production Date | Tread Depth (mm) |
|---|---|---|---|---|---|---|---|
| Front Right | 205/60R16 | 92V | Apollo | Alnac | V | 0521 | 2 mm |

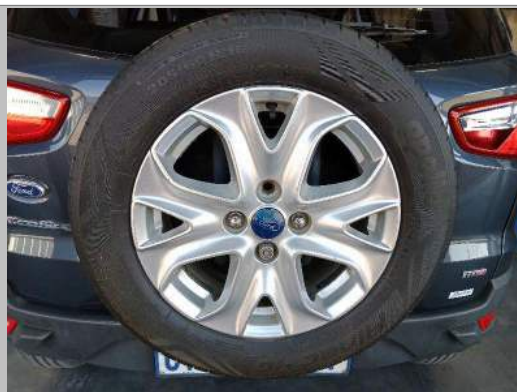
Spare wheel

| | Size | Load/Speed Index | Manufacture | Model | Type* | Production Date | Tread Depth (mm) |
|---|---|---|---|---|---|---|---|
| Spare | 205/60R16 | 92V | Apollo | Alnac | V | 0521 | 3 mm |
