CONDITION REPORT

Report No:  
2017297476  
DATE  
11/09/2026

| Manufacturer | HYUNDAI | Registration Number | JL97JSGP |
| Model | ATOS 1.1 50KW MOTION 5-DR [2019-2024] | Register Number | |

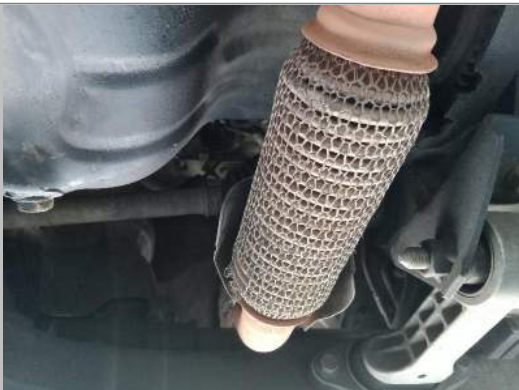
| Damage | Repair Way |
|---|---|
| Engine to silencer pipe Damaged | Repair |
