## CONDITION REPORT

Report No:  
2017297774  
DATE  
11/09/2026

| Manufacturer | HYUNDAI | Registration Number | CL37NCGP |
| Model | I10 1.1 MOTION 5-DR [2011-2018] | Register Number | |

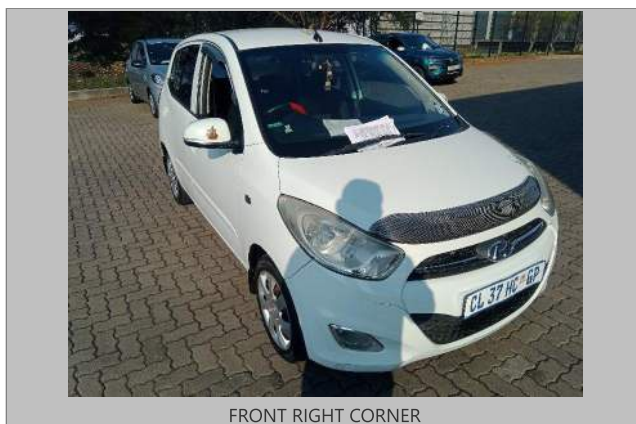
FRONT RIGHT CORNER

Body • Exterior: Minor dents and scratches and stone chips to body panels. Signs of repair work done to body panels. Poor alignment to somebody panels. Repair work done to vehicle below standard. Vehicle body in poor condition.

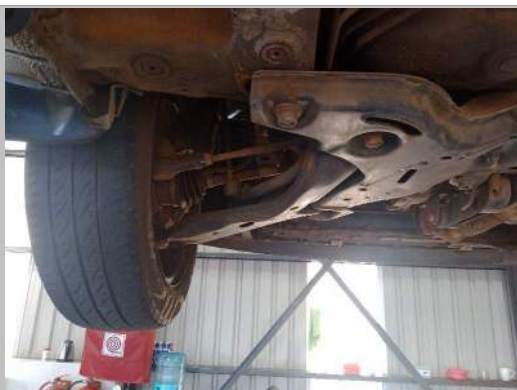
LF TYRE TREAD

| | Size | Load/Speed Index | Manufacture | Model | Type* | Production Date | Tread Depth (mm) |
|---|---|---|---|---|---|---|---|
| Front Left | 165/60R14 | 75H | Hifly | Radial | V | 1923 | 1 mm |

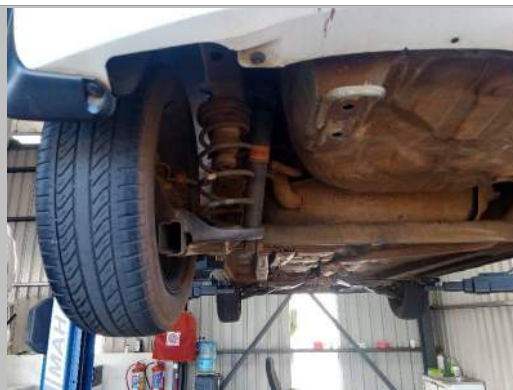
LR TYRE TREAD

| | Size | Load/Speed Index | Manufacture | Model | Type* | Production Date | Tread Depth (mm) |
|---|---|---|---|---|---|---|---|
| Rear Left | 165/60R14 | 75H | Dunlop | Sp | V | 4616 | 1 mm |

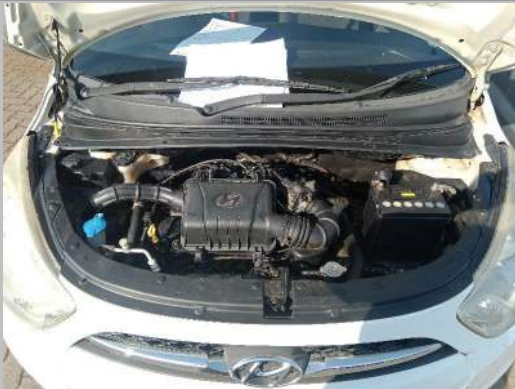
ENGINE 1

General Comments: ACCORDING TO THE AGE AND MILEAGE OF THE VEHICLE, NORMAL WEAR AND TEAR MARKS ARE VISIBLE ON THE INTERIOR, EXTERIOR, ELECTRICAL AND MECHANICAL PARTS. Engine Compartment: Foreign substance on oil filler cap.
