CONDITION REPORT

Report No:  
2017299103  
DATE  
15/09/2026

| Manufacturer | HYUNDAI | Registration Number | LD48ZDGP |
| Model | GRAND I10 1.0 MOTION 5-DR [2020-2024] | Register Number | |

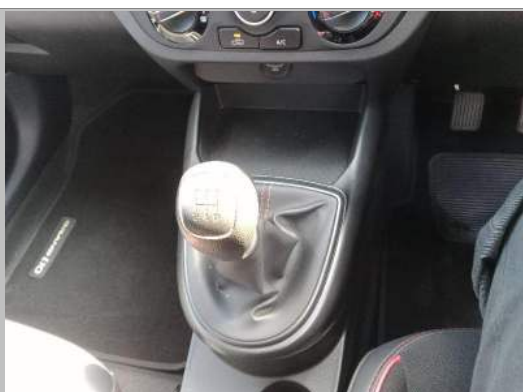
Manual Transmission

| Clutch Operation Insufficient | Repair |

Road Test: Gear selection faulty.

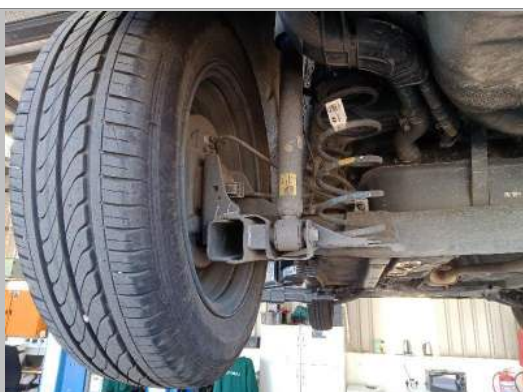
LR TYRE TREAD

| | Size | Load/Speed Index | Manufacture | Model | Type* | Production Date | Tread Depth (mm) |
|---|---|---|---|---|---|---|---|
| Rear Left | 165/70 R14 | 81T | Goodyear | Assurance | V | 5022 | 3 mm |

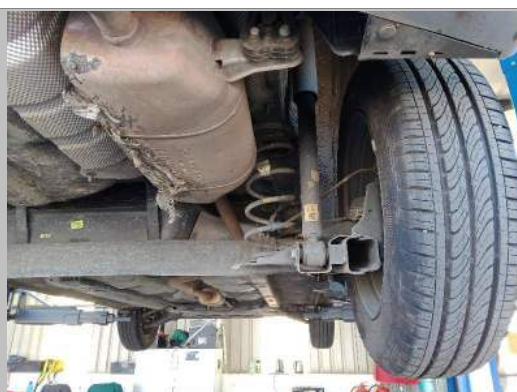
RR TYRE TREAD

| | Size | Load/Speed Index | Manufacture | Model | Type* | Production Date | Tread Depth (mm) |
|---|---|---|---|---|---|---|---|
| Rear Right | 165/70 R14 | 81T | Goodyear | Assurance | V | 5022 | 5 mm |

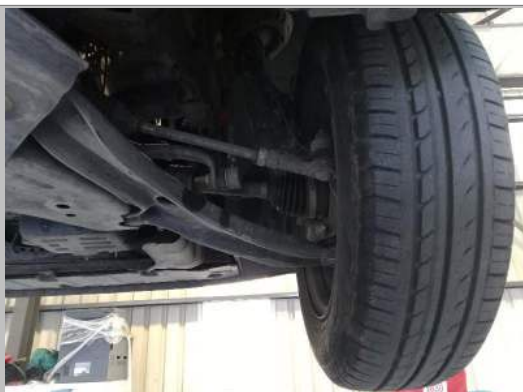
RF TYRE TREAD

| | Size | Load/Speed Index | Manufacture | Model | Type* | Production Date | Tread Depth (mm) |
|---|---|---|---|---|---|---|---|
| Front Right | 165/70 R14 | 81T | Goodyear | Assurance | V | 5022 | 3 mm |

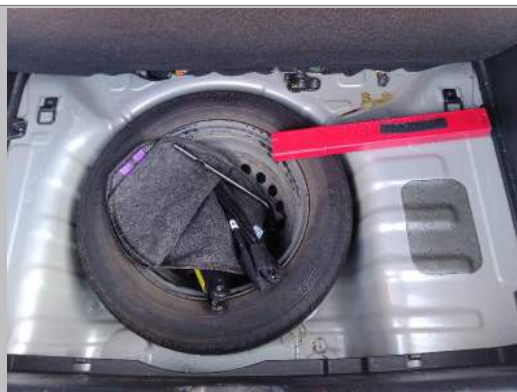
Spare Wheel and Accessories

| | Size | Load/Speed Index | Manufacture | Model | Type* | Production Date | Tread Depth (mm) |
|---|---|---|---|---|---|---|---|
| Spare | 165/70 R14 | 81T | Goodyear | Assurance | V | 5022 | 5 mm |
