## CONDITION REPORT

Report No:  
2017295814  
DATE  
08/09/2026

| Manufacturer | HYUNDAI | Registration Number | KB11VVGP |
| Model | I20 1.2 MOTION 5-DR [2021-2024] | Register Number | |

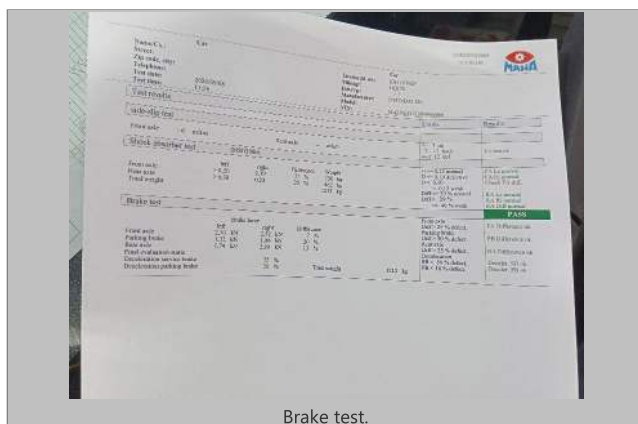
Brake test.

| | Left | Right | | |
|---|---|---|---|---|
| Front | 2.7 | 2.52 | - | |
| Rear | 1.74 | 2.0 | - | |
| Emergency / Parking | 1.32 | 1.06 | - | |

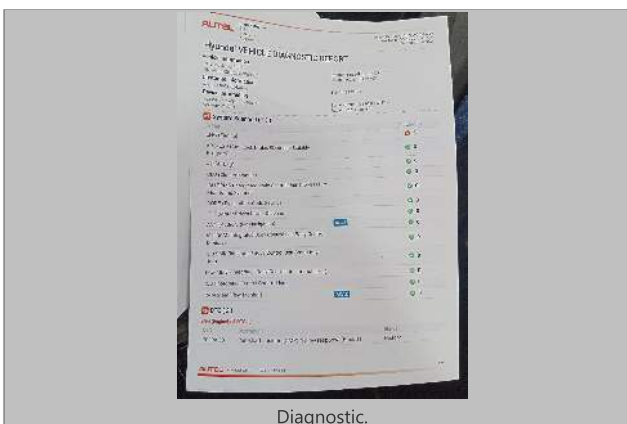
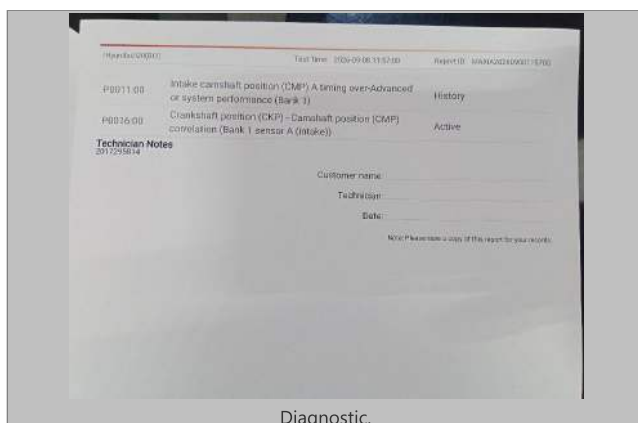
Diagnostic.

| No | System | Code | Description | Status |
|---|---|---|---|---|
| 1 | ENGINE | P000A:00 | CAMSHAFT POSITION A SLOW RESPONSE | |

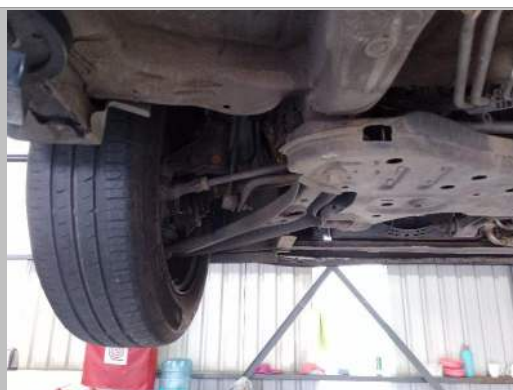
LF TYRE TREAD

| | Size | Load/Speed Index | Manufacture | Model | Type* | Production Date | Tread Depth (mm) |
|---|---|---|---|---|---|---|---|
| Front Left | 185/65R15 | 88H | Powertrac | Radial | V | 3125 | 2 mm |

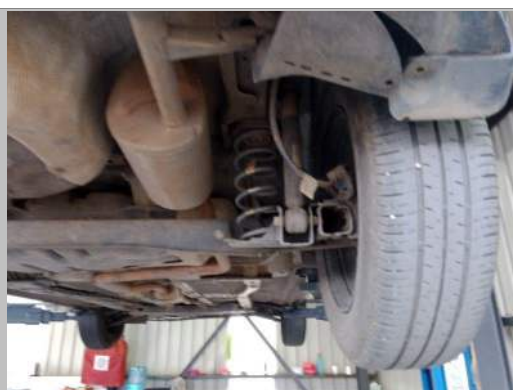
RR TYRE TREAD

| | Size | Load/Speed Index | Manufacture | Model | Type* | Production Date | Tread Depth (mm) |
|---|---|---|---|---|---|---|---|
| Rear Right | 185/65R15 | 88H | Bridgestone | Radial | V | 0321 | 2 mm |

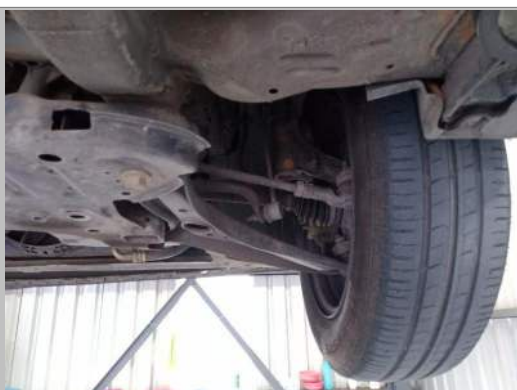
RF TYRE TREAD

| | Size | Load/Speed Index | Manufacture | Model | Type* | Production Date | Tread Depth (mm) |
|---|---|---|---|---|---|---|---|
| Front Right | 185/65R15 | 88H | Powertrac | Radial | V | 3125 | 2 mm |

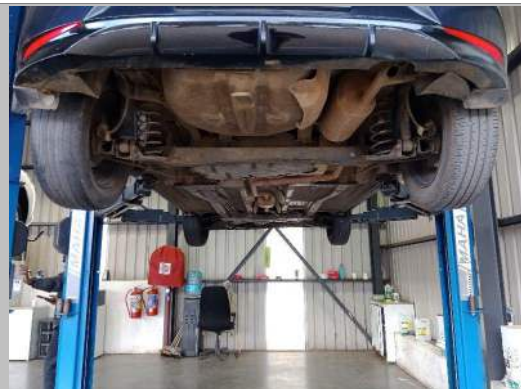
Undercarriage rear.

| Damage | Repair Way |
|---|---|
| Rear Axle Deformed | Replace |
| Sub Frame Damaged | Repair |
