## CONDITION REPORT

Report No:  
2017294622  
DATE  
07/09/2026

| Manufacturer | HYUNDAI | Registration Number | MS63RFGP |
| Model | I20 | Register Number | |

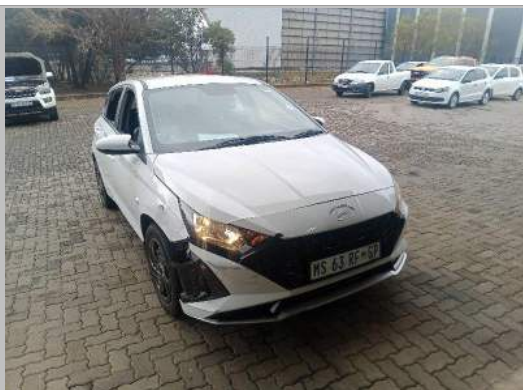
FRONT RIGHT CORNER

| Front Fender Right Dented | Repair |
| Body exterior | Impact damage at right front of vehicle |

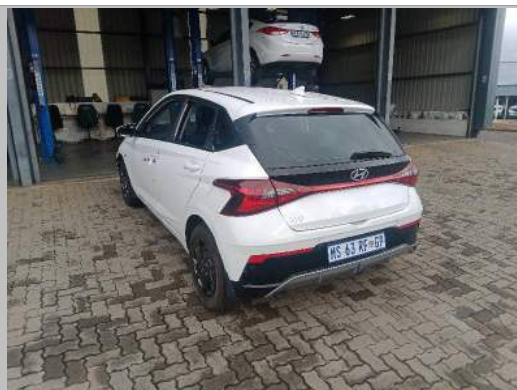
REAR LEFT CORNER

| Rear Fender Left Paintwork • Scratched | Repair |

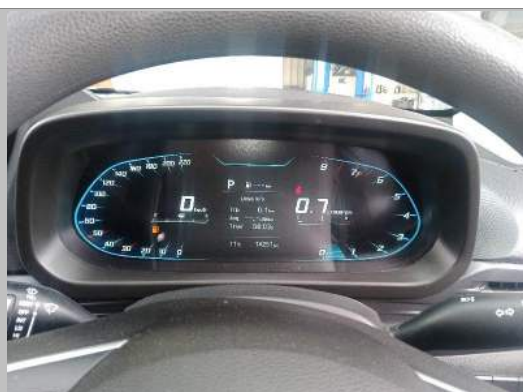
DASHBOARD (W/ ENGINE RUNNING)

| No | System | Code | Description | Status |
|---|---|---|---|---|
| 1 | HISTORY | B1102:00 | BATTERY VOLTAGE LOW | |

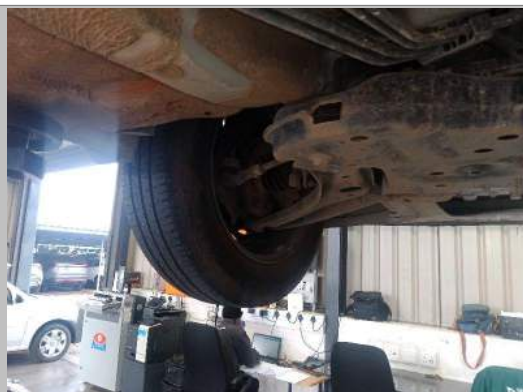
LF TYRE TREAD

| | Size | Load/Speed Index | Manufacture | Model | Type* | Production Date | Tread Depth (mm) |
|---|---|---|---|---|---|---|---|
| Front Left | 185/65R17 | 88H | Bridgestone | Ecopia | V | 2825 | 3 mm |

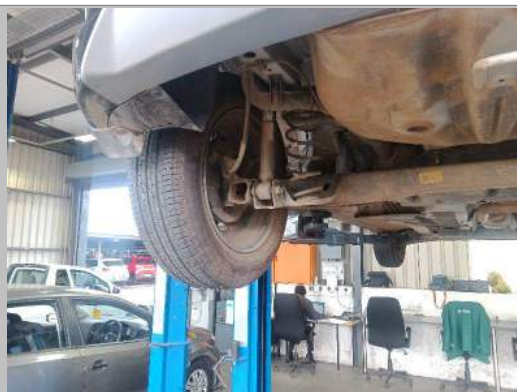
LR TYRE TREAD

| | Size | Load/Speed Index | Manufacture | Model | Type* | Production Date | Tread Depth (mm) |
|---|---|---|---|---|---|---|---|
| Rear Left | 185/65R15 | 88H | Bridgestone | Ecopia | V | 2825 | 3 mm |

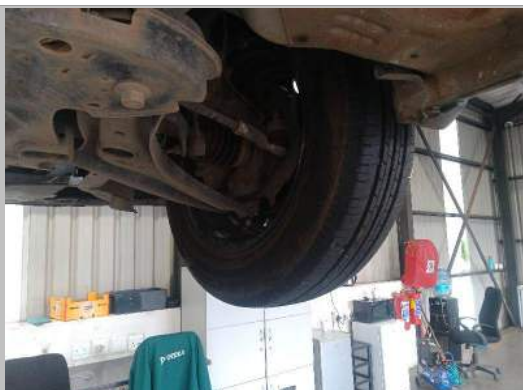
RF TYRE TREAD

| | Size | Load/Speed Index | Manufacture | Model | Type* | Production Date | Tread Depth (mm) |
|---|---|---|---|---|---|---|---|
| Front Right | 185/65R15 | 88H | Bridgestone | Ecopia | V | 2825 | 3 mm |

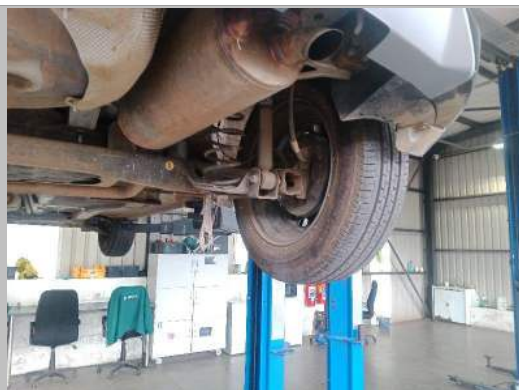
RR TYRE TREAD

| | Size | Load/Speed Index | Manufacture | Model | Type* | Production Date | Tread Depth (mm) |
|---|---|---|---|---|---|---|---|
| Rear Right | 185/65R15 | 88H | Bridgestone | Ecopia | V | 3025 | 3 mm |

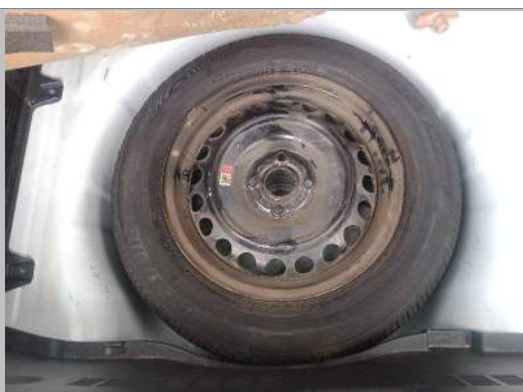
Spare wheel

| | Size | Load/Speed Index | Manufacture | Model | Type* | Production Date | Tread Depth (mm) |
|---|---|---|---|---|---|---|---|
| Spare | 185/65R15 | 88H | Bridgestone | Ecopia | V | 2825 | 4 mm |
