## CONDITION REPORT

Report No:  
2017297487  
DATE  
11/09/2026

| Manufacturer | HYUNDAI | Registration Number | DW28RDGP |
| Model | I20 1.4 FLUID 5-DR [2015-2017] | Register Number | |

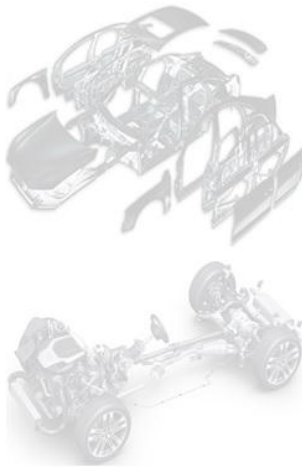
| Damage | Repair Way |
|---|---|
| Switch Electrical Window Winder rear left Defective | Repair |
| Switch Electrical Window Winder rear right Defective | Repair |
| Seat Front Right Dirty | Repair |
| Seat Rear Dirty | Repair |
| Door Handle Front Right Damaged | Replace |
| Door Handle Rear Right Damaged | Replace |
| Side Mirror Right Paintwork • Scratched | Repair |
| Front Bumper Paintwork • Scratched | Repair |
| Bonnet Paintwork • Flaking | Repair |
| Front Fender Left Paintwork • Scratched | Repair |
| Front Fender Right Dented | Repair |
| Rear Fender Left Paintwork • Flaking | Repair |
| Door Front Right Dented | Repair |
| Door Rear Left Paintwork • Flaking | Repair |
| Door Rear Right Dented | Repair |
| Boot Lid / Hatch door Paintwork • Flaking | Repair |
| Rear bumper Paintwork • Scratched | Repair |
| Roof Paintwork • Flaking | Repair |
| Windscreen Cracked | Replace |
| Tyre Front Right Smooth | Replace |
| R/R quarter window broken | Replace |

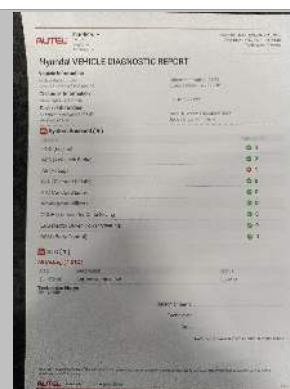
Diagnostics report

| No | System | Code | Description | Status |
|---|---|---|---|---|
| 1 | AIRBAG | B1102:00 | BATTERY VOLTAGE LOW | |

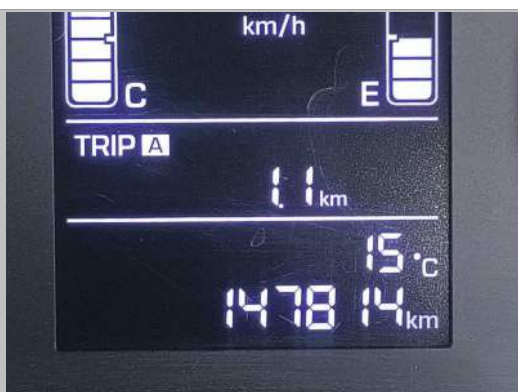
ODOMETER

| Km Reading | 147,814 KM | Fuel | PETROL |

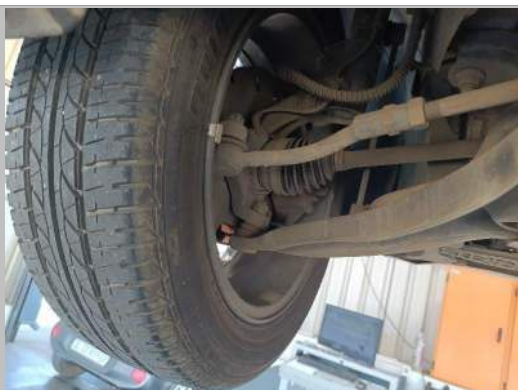
LF TYRE TREAD

| | Size | Load/Speed Index | Manufacture | Model | Type* | Production Date | Tread Depth (mm) |
|---|---|---|---|---|---|---|---|
| Front Left | 195/55R16 | 87V | Bridgestone | B250 | V | 1615 | 5 mm |

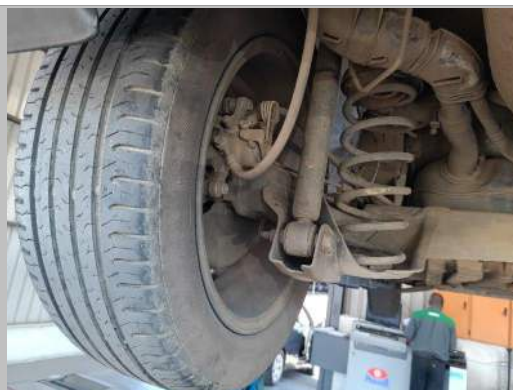
LR TYRE TREAD

| | Size | Load/Speed Index | Manufacture | Model | Type* | Production Date | Tread Depth (mm) |
|---|---|---|---|---|---|---|---|
| Rear Left | 195/55R16 | 87H | Continental | Contact | V | 2719 | 5 mm |

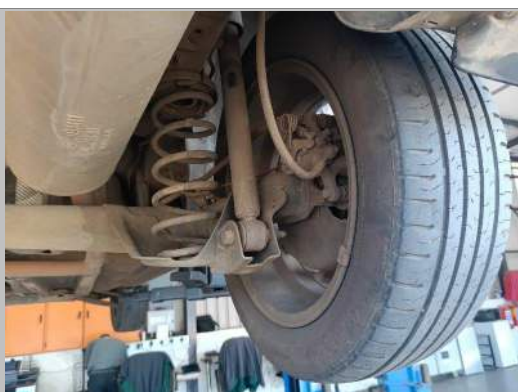
RR TYRE TREAD

| | Size | Load/Speed Index | Manufacture | Model | Type* | Production Date | Tread Depth (mm) |
|---|---|---|---|---|---|---|---|
| Rear Right | 195/55R16 | 87H | Continental | Contact | V | 2619 | 5 mm |

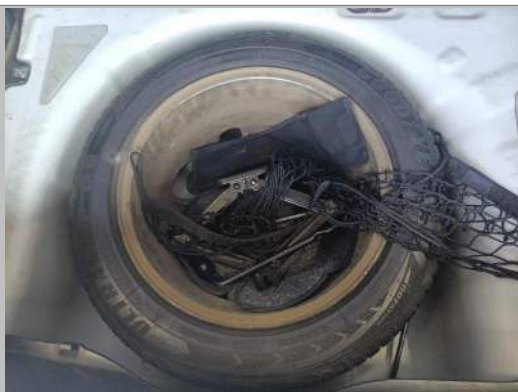
Sparewheel

| | Size | Load/Speed Index | Manufacture | Model | Type* | Production Date | Tread Depth (mm) |
|---|---|---|---|---|---|---|---|
| Spare | 195/55R16 | 87H | Goodyear | Ultragrip | V | 0000 | 5 mm |
