## CONDITION REPORT

Report No: 2016303384

MFC Auction House  
M57 Pretoria Rd, Glenmarais, KEMPTON PARK  
Gauteng

Vehicle Type	PASSENGER VEHICLE	Registered Owner	MFC AUCTION HOUSE
Manufacturer	HYUNDAI	Registration Number	KH57WLGP
Model	i20	Register Number	
VIN	MALBM51CLKM538344	Date Of First Licensing	
Engine Number		Last COR	
Doors	5	License Expiry Date	30/11/2023
Color	RED	Power / Displacement	
Year Model		Paint Finish	TWO COAT UNI
Km Reading	83,010 KM	Fuel	PETROL
Cab / Body Type	HATCHBACK	Transmission	MANUAL

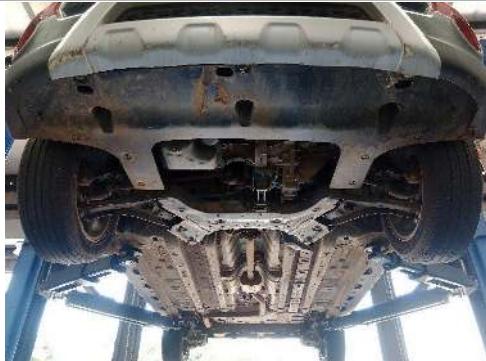
Front chassis

Damage	Repair Way
Battery box Damaged	Replace
Center Console / Cubbyhole + Lid Defective	Repair
Windscreen Wiper Damaged	Replace
Dim Light Left Damaged	Replace
Dim Light Right Damaged	Replace
Bright Light Right Damaged	Replace
Seat Front Left Dirty	Repair
Seat Front Right Damaged	Repair
Seat Rear Dirty	Repair
Boot Carpet Defective	Repair
Front Bumper Paintwork • Scratched	Repair
Bonnet Paintwork • Scratched	Repair
Front Fender Right Paintwork • Scratched	Repair
Door Front Left Dented	Repair
Door Front Right Paintwork • Scratched	Repair
Door Rear Right Paintwork • Scratched	Repair
Rear bumper Paintwork • Scratched	Repair
Inner Boot Floor Pan and Spare Wheel Well Dented	Repair
Sill Panel Right Paintwork • Scratched	Repair
Rocker Panel Left Paintwork • Scratched	Repair
Spare Tyre Damaged	Replace
Rim Front Left Scratched	Repair
Rim Front Right Scratched	Repair
Rim Rear Left Scratched	Repair
Chassis Dented	Repair
Sub Frame Scratched	Replace
