## CONDITION REPORT

Report No:  
2017295103  
DATE  
07/09/2026

| Manufacturer | SUZUKI | Registration Number | FVW994L |
| Model | DZIRE 1.2 GL MC [2020-2025] | Register Number | |

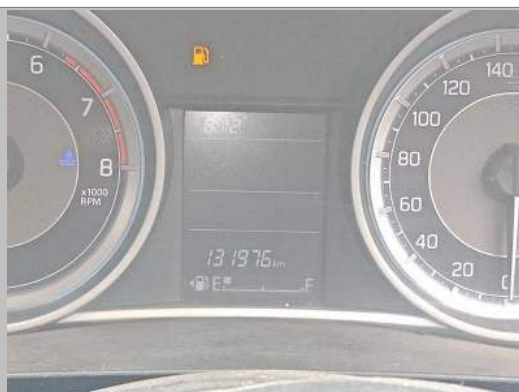
ODOMETER

| Km Reading | 131,976 KM | Fuel | PETROL |

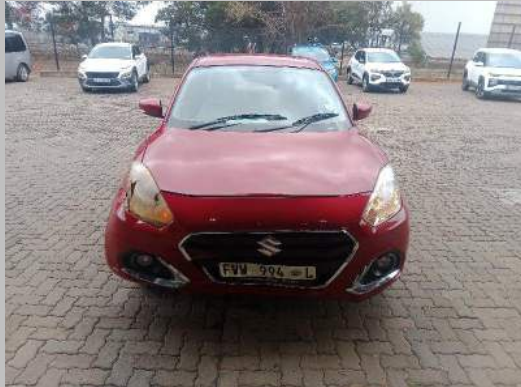
90 DEGREE FRONT

| Headlight Right Damaged | Replace |
| Front Bumper Damaged | Repair |
| Body exterior | Impact damage at front of vehicle |

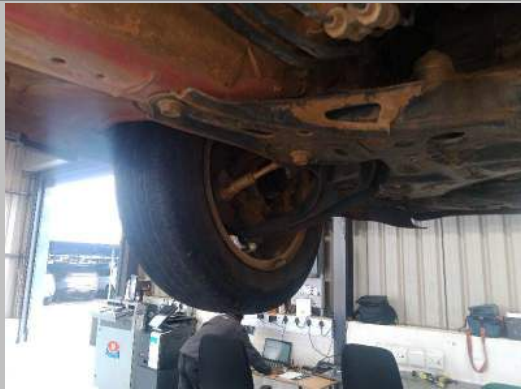
LF TYRE TREAD

| | Size | Load/Speed Index | Manufacture | Model | Type* | Production Date | Tread Depth (mm) |
|---|---|---|---|---|---|---|---|
| Front Left | 185/65R15 | 92T | Dunlop | Sp touring | V | 2024 | 3 mm |

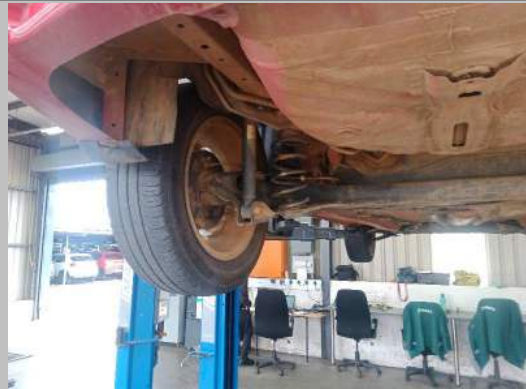
LR TYRE TREAD

| | Size | Load/Speed Index | Manufacture | Model | Type* | Production Date | Tread Depth (mm) |
|---|---|---|---|---|---|---|---|
| Rear Left | 185/65R15 | 92T | Dunlop | Sp touring | V | 1525 | 3 mm |

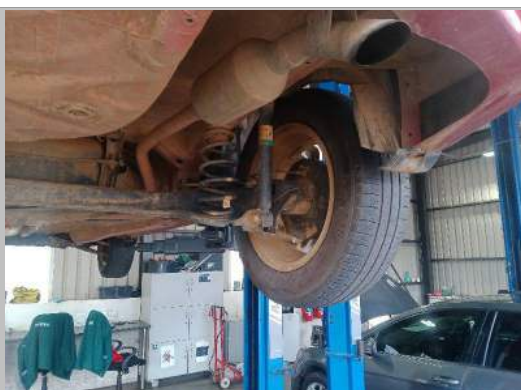
RR TYRE TREAD

| | Size | Load/Speed Index | Manufacture | Model | Type* | Production Date | Tread Depth (mm) |
|---|---|---|---|---|---|---|---|
| Rear Right | 185/65R15 | 92T | Dunlop | Sp touring | V | 1525 | 3 mm |

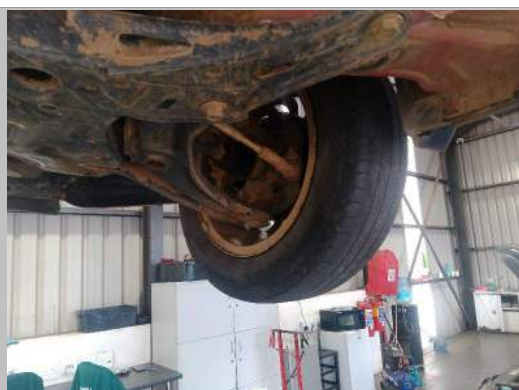
RF TYRE TREAD

| | Size | Load/Speed Index | Manufacture | Model | Type* | Production Date | Tread Depth (mm) |
|---|---|---|---|---|---|---|---|
| Front Right | 185/65R15 | 92T | Dunlop | Sp touring | V | 2024 | 3 mm |

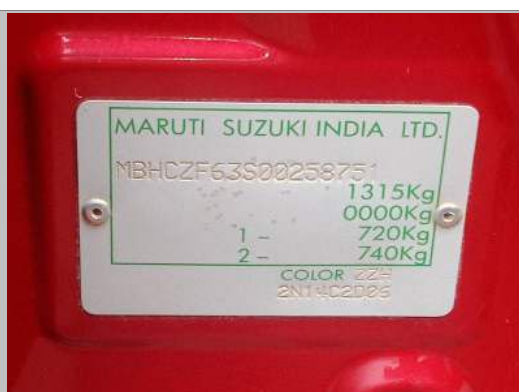
VIN PLATE OR STICKER

| VIN | MBHCZF63S00258751 | Date Of First Licensing | |
