## CONDITION REPORT

Report No:  
2017298575  
DATE  
14/09/2026

| Manufacturer | RENAULT | Registration Number | KNG155MP |
| Model | KWID | Register Number | |

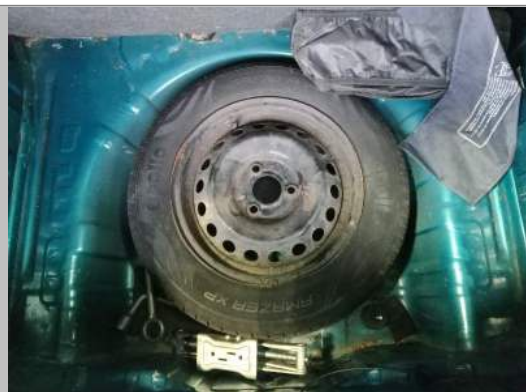
Spare Wheel and Accessories

| Damage | Repair Way |
|---|---|
| Spare Tyre Worn | Replace |
| Triangle Missing | Replace |

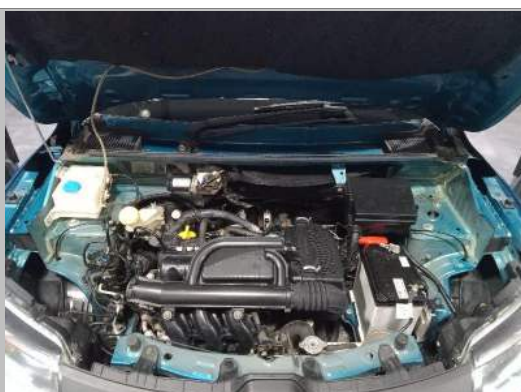
ENGINE 1

| Damage | Repair Way |
|---|---|
| Engine Oil Leak | Repair |
| Engine cover damaged | Replace |
