CONDITION REPORT

Report No:  
2017295665  
DATE  
08/09/2026

| Manufacturer | RENAULT | Registration Number | KD84XHGP |
| Model | KWID | Register Number | |

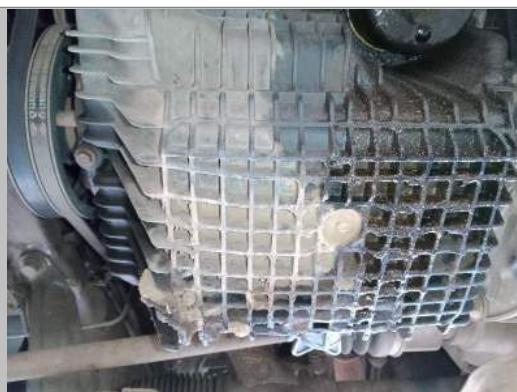
| Damage | Repair Way |
|---|---|
| Engine oil sump damaged | Replace |
