## CONDITION REPORT

Report No:  
2017290034  
DATE  
27/08/2026

MFC Auction House  
M57 Pretoria Rd, Glenmarais, KEMPTON PARK  
Gauteng

| Manufacturer | RENAULT | Registration Number | MC90PDGP |

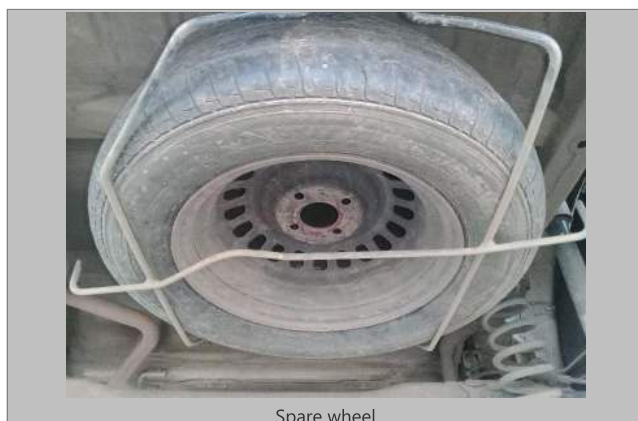
Spare wheel

| | Size | Load/Speed Index | Manufacture | Model | Type* | Production Date | Tread Depth (mm) |
|---|---|---|---|---|---|---|---|
| Spare | 185/65R14 | 86H | Hilo | Genesys xp1 | V | //// | 3 mm |

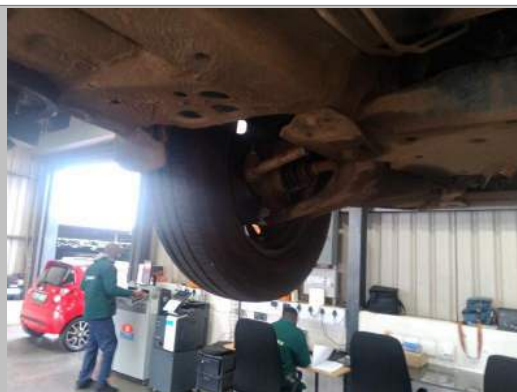
LF TYRE TREAD

| | Size | Load/Speed Index | Manufacture | Model | Type* | Production Date | Tread Depth (mm) |
|---|---|---|---|---|---|---|---|
| Front Left | 175/70R14 | 88T | Fronway | Eco green | V | 1526 | 4 mm |

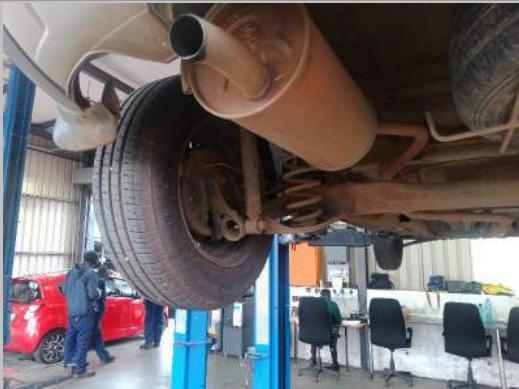
LR TYRE TREAD

| | Size | Load/Speed Index | Manufacture | Model | Type* | Production Date | Tread Depth (mm) |
|---|---|---|---|---|---|---|---|
| Rear Left | 175/70R14 | 88T | Fronway | Eco green | V | 1526 | 4 mm |

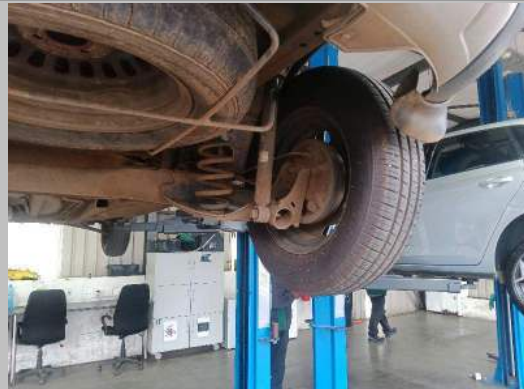
RR TYRE TREAD

| | Size | Load/Speed Index | Manufacture | Model | Type* | Production Date | Tread Depth (mm) |
|---|---|---|---|---|---|---|---|
| Rear Right | 175/70R14 | 88T | Fronway | Eco green | V | 1526 | 4 mm |

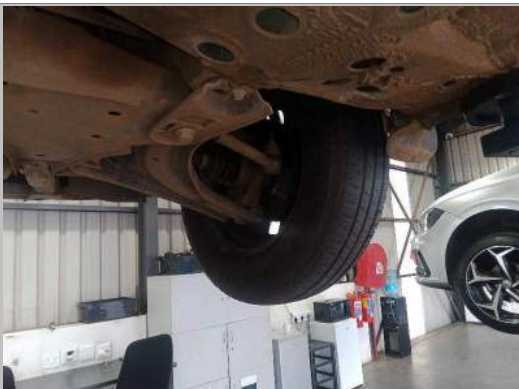
RF TYRE TREAD

| | Size | Load/Speed Index | Manufacture | Model | Type* | Production Date | Tread Depth (mm) |
|---|---|---|---|---|---|---|---|
| Front Right | 175/70R14 | 88T | Fronway | Eco green | V | 1526 | 4 mm |
