CONDITION REPORT

Report No:  
2017298532  
DATE  
14/09/2026

| Manufacturer | TOYOTA | Registration Number | LW80HMGP |
| Model | AGYA 1.0 AUDIO 5-DR [2020-2023] | Register Number | |

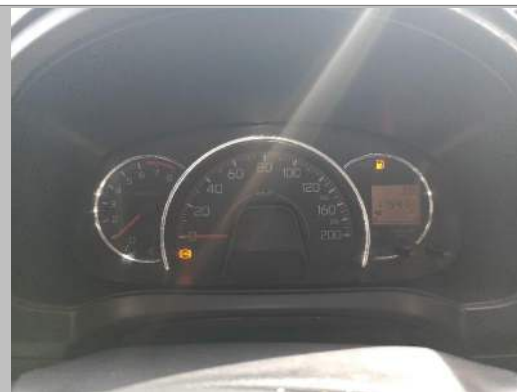
### DASHBOARD (W/ ENGINE RUNNING)

| Warning lights illuminated | Repair |

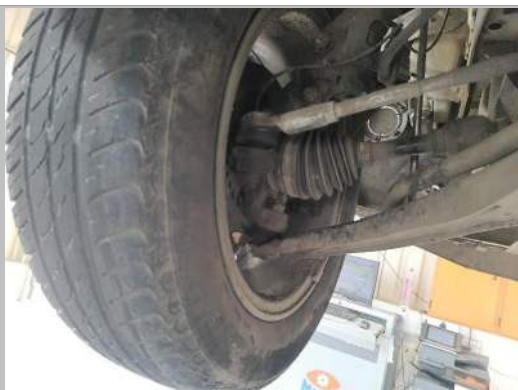
LF TYRE TREAD

| | Size | Load/Speed Index | Manufacture | Model | Type* | Production Date | Tread Depth (mm) |
|---|---|---|---|---|---|---|---|
| Front Left | 175/65R14 | 82T | Velocity | Reacta | V | 2418 | 1 mm |

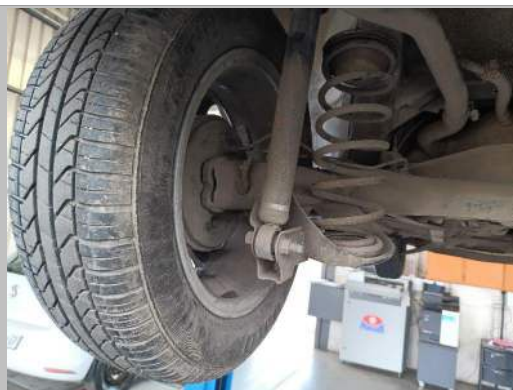
LR TYRE TREAD

| | Size | Load/Speed Index | Manufacture | Model | Type* | Production Date | Tread Depth (mm) |
|---|---|---|---|---|---|---|---|
| Rear Left | 175/65R14 | 82T | Sumitomo | HTR | V | 2524 | 5 mm |

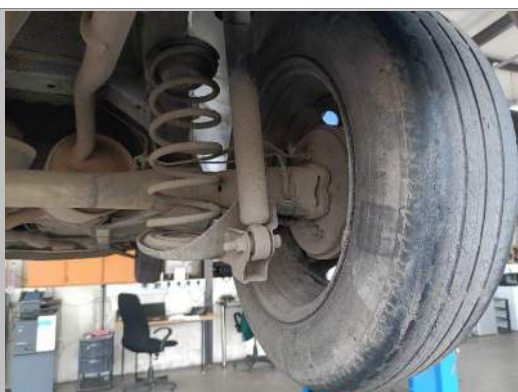
RR TYRE TREAD

| Tyre Rear Right Smooth | Replace |

| | Size | Load/Speed Index | Manufacture | Model | Type* | Production Date | Tread Depth (mm) |
|---|---|---|---|---|---|---|---|
| Rear Right | 165/60R14 | 81S | Bridgestone | B250 | V | 0000 | 0 mm |

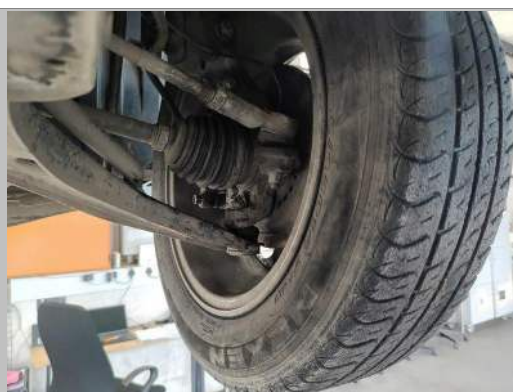
RF TYRE TREAD

| | Size | Load/Speed Index | Manufacture | Model | Type* | Production Date | Tread Depth (mm) |
|---|---|---|---|---|---|---|---|
| Front Right | 165/65R14 | 79H | Nexen | CP661 | V | 3319 | 3 mm |

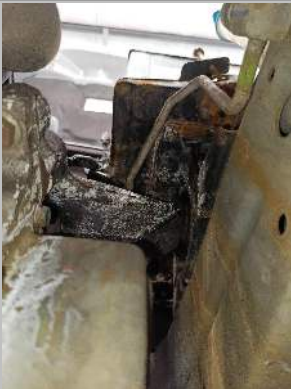
| Battery box Corrosion | Repair |
