## CONDITION REPORT

Report No:  
2017296500  
DATE  
09/09/2026

| Manufacturer | NISSAN | Registration Number | FK52HCGP |
| Model | JUKE 1.6DIG-T TEKNA 5-DR [2016-2019] | Register Number | |

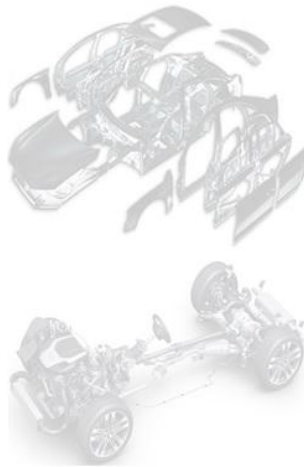
| Damage | Repair Way |
|---|---|
| Windscreen Wiper Damaged | Replace |
| Headlight Right Damaged | Replace |
| Seat Front Right Damaged | Repair |
| Door Handle Front Right Damaged | Replace |
| Front Bumper Damaged | Repair |
| Front Fender Left Damaged | Repair |
| Front Fender Right Damaged | Repair |
| Rear Fender Left Damaged | Repair |
| Rear Fender Right Damaged | Repair |
| Door Front Left Damaged | Repair |
| Door Front Right Damaged | Repair |
| Door Rear Left Damaged | Repair |
| Door Rear Right Damaged | Repair |
| Boot Lid / Hatch door Damaged | Repair |
| Rear bumper Damaged | Repair |
| Windscreen Cracked | Repair |

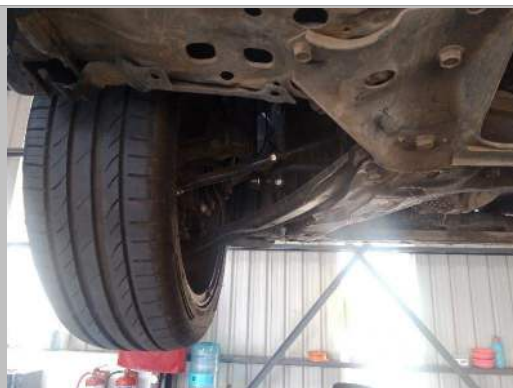
LF TYRE TREAD

| | Size | Load/Speed Index | Manufacture | Model | Type* | Production Date | Tread Depth (mm) |
|---|---|---|---|---|---|---|---|
| Front Left | 225/45R18 | 95Y | Tracmax | Radial | V | 4825 | 3 mm |

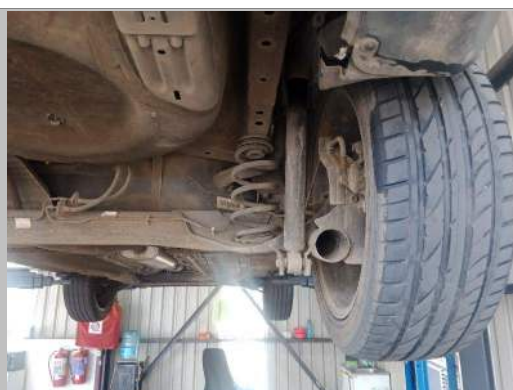
RR TYRE TREAD

| Damage | Repair Way |
|---|---|
| Rear tyres size differs | Replace |

| | Size | Load/Speed Index | Manufacture | Model | Type* | Production Date | Tread Depth (mm) |
|---|---|---|---|---|---|---|---|
| Rear Right | 225/45R18 | 95W | Sailun | Radial | V | 0121 | 2 mm |

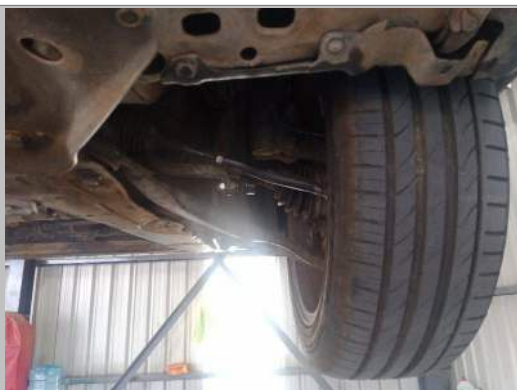
RF TYRE TREAD

| | Size | Load/Speed Index | Manufacture | Model | Type* | Production Date | Tread Depth (mm) |
|---|---|---|---|---|---|---|---|
| Front Right | 225/45R18 | 95Y | Tracmax | Radial | V | 4825 | 3 mm |
