## CONDITION REPORT

Report No:  
2017296281  
DATE  
09/09/2026

MFC Auction House  
M57 Pretoria Rd, Glenmarais, KEMPTON PARK  
Gauteng

| Manufacturer | RENAULT | Registration Number | HD95NTGP |

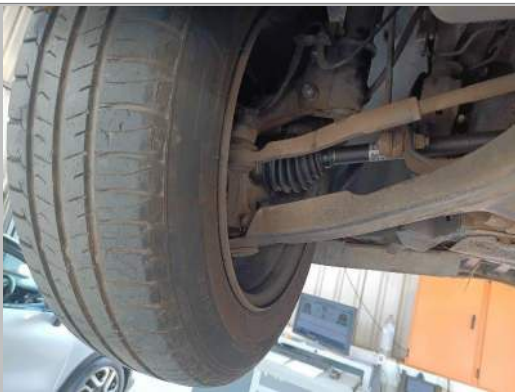
LF TYRE TREAD

| | Size | Load/Speed Index | Manufacture | Model | Type* | Production Date | Tread Depth (mm) |
|---|---|---|---|---|---|---|---|
| Front Left | 185/65R15 | 88H | Invovic | EL601 | V | 3825 | 5 mm |

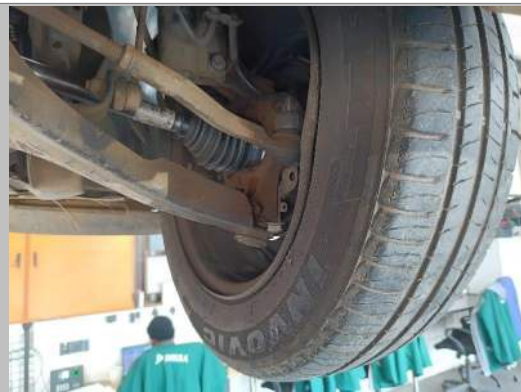
RF TYRE TREAD

| | Size | Load/Speed Index | Manufacture | Model | Type* | Production Date | Tread Depth (mm) |
|---|---|---|---|---|---|---|---|
| Front Right | 185/65R15 | 88H | Invovic | EL601 | V | 3825 | 4 mm |

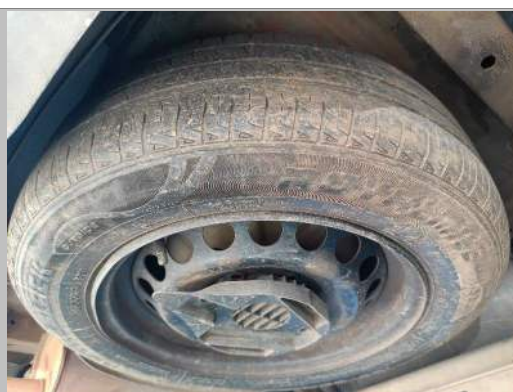
SPARE WHEEL

| | Size | Load/Speed Index | Manufacture | Model | Type* | Production Date | Tread Depth (mm) |
|---|---|---|---|---|---|---|---|
| Spare | 185/65R15 | 88H | Royal black | Royal mile | V | 0000 | 2 mm |
