## CONDITION REPORT

Report No:  
2017293979  
DATE  
03/09/2026

| Manufacturer | OPEL | Registration Number | LBR738NW |
| Model | CORSA 1.2 EDITION 5-DR [2021-2022] | Register Number | |

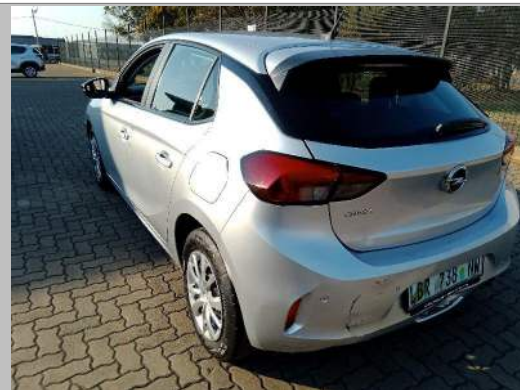
REAR LEFT CORNER

| Damage | Repair Way |
|---|---|
| Tail Light Left Damaged | Replace |
| Rear Fender Left Damaged | Repair |

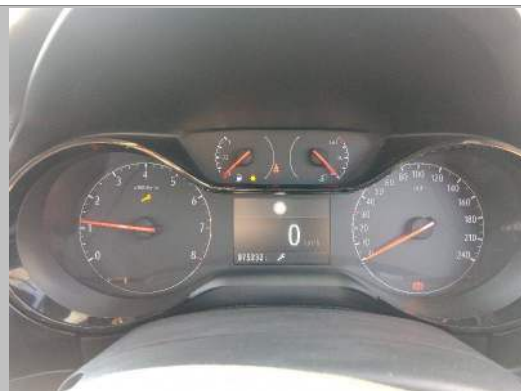
DASHBOARD (W/ ENGINE RUNNING)

| Damage | Repair Way |
|---|---|
| Engine Management Lights Set | Repair |

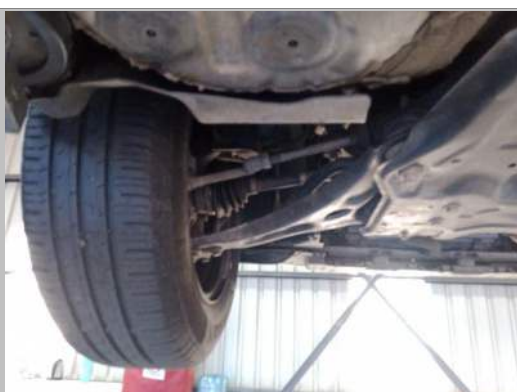
LF TYRE TREAD

| | Size | Load/Speed Index | Manufacture | Model | Type* | Production Date | Tread Depth (mm) |
|---|---|---|---|---|---|---|---|
| Front Left | 185/65R15 | 88H | Continental | Eco | V | 1622 | 2 mm |

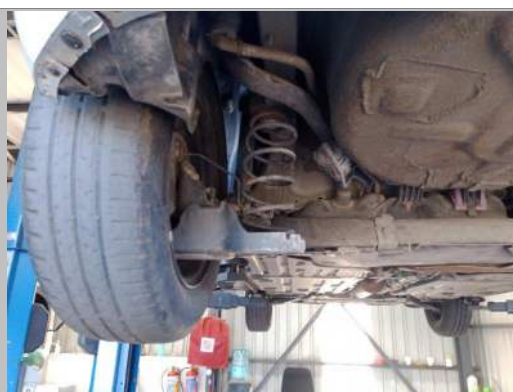
LR TYRE TREAD

| Damage | Repair Way |
|---|---|
| Tyre Rear Left Worn | Replace |

| | Size | Load/Speed Index | Manufacture | Model | Type* | Production Date | Tread Depth (mm) |
|---|---|---|---|---|---|---|---|
| Rear Left | 185/65R15 | 88H | Continental | Eco | V | 1622 | 0 mm |

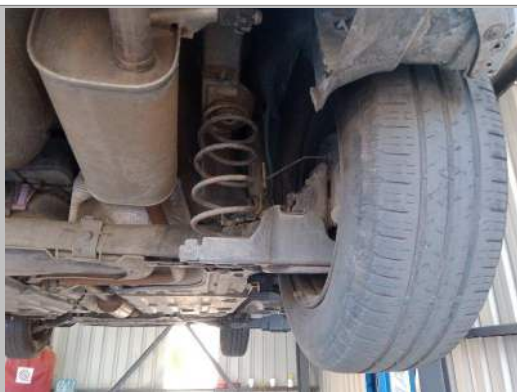
RR TYRE TREAD

| Damage | Repair Way |
|---|---|
| Tyre Rear Right Worn | Replace |

| | Size | Load/Speed Index | Manufacture | Model | Type* | Production Date | Tread Depth (mm) |
|---|---|---|---|---|---|---|---|
| Rear Right | 185/65R15 | 88H | Continental | Eco | V | 1222 | 2 mm |

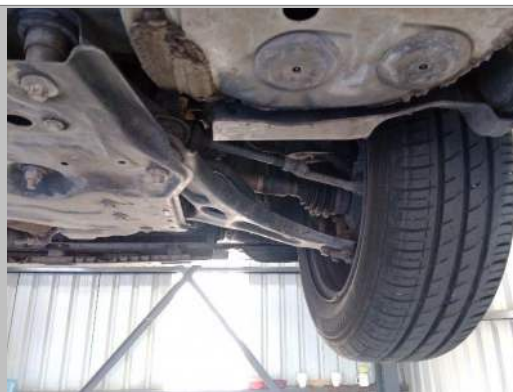
RF TYRE TREAD

| | Size | Load/Speed Index | Manufacture | Model | Type* | Production Date | Tread Depth (mm) |
|---|---|---|---|---|---|---|---|
| Front Right | 185/65R15 | 88H | Rovelo | Radial | V | 2225 | 2 mm |
