CONDITION REPORT

Report No:
2016972411
DATE
07/08/2025

Vehicle Type	PASSENGER VEHICLE	Registered Owner	
Manufacturer	AUDI	Registration Number	DV49SHGP
Model	A6 2.0T FSI MULTITRONIC [2014-2015]	Register Number	
VIN	WAUZZZ4G4EN203974	Date Of First Licensing	
Engine Number		Last COR	
Doors	4	License Expiry Date	30/11/2022
Color	GREY	Power / Displacement	
Year Model	2015	Paint Finish	TWO COAT METALLIC
Km Reading	217,680 KM	Fuel	PETROL
Cab / Body Type	SEDAN	Transmission	AUTOMATIC

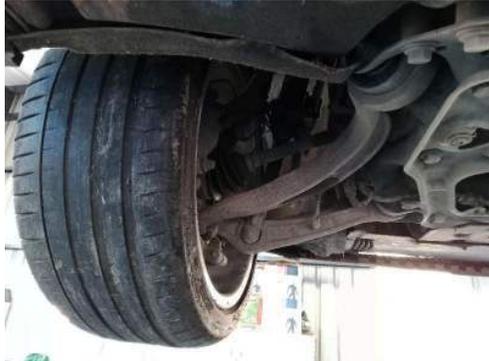
LF TYRE TREAD

Control Arm Bush(es) Front Axle Left Cracked	Replace
Control Arm Bush(es) Front Axle Right Cracked	Replace
Tyre Front Left Worn	Replace
Tyre Front Right Damaged	Replace
Tyre Rear Left Damaged	Replace
Tyre Rear Right Damaged	Replace
Spare Tyre Damaged	Replace
Rim Front Left Scratched	Repair
Rim Rear Left Scratched	Repair
Rim Rear Right Scratched	Repair
Sub Frame Dented	Repair
Belly plates Damaged	Replace
Gearbox Oil Sweat	Repair
Engine Performance Idling / Hunting	Repair
Gear Selections Slippy Hesitation	Repair
Warning lights illuminated on dashboard	Repair
Foreign substance on oil cap	Repair
Aircon condenser dented	Repair
Front left and right tyre sizes different	Replace

Size	Load/Speed Index	Manufacture	Model	Type*	Production Date	Tread Depth (mm)
Front Left	255/35Z R19	96Y	Michelin	Pilot Sport	V	1619	0 mm
Front Right	255/40Z R19	100Y	Hankook	Ventus	V	4618	1 mm
Rear Left	255/40Z R19	96W	Pirelli	Pzero	V	4914	0 mm
Rear Right	255/40Z R19	100Y	Kumho	Ecsta	V	5217	0 mm
Spare	T145/60 R20	105M	Hankook	Temporary	V	2914	0 mm
