MFC Auction House  
M57 Pretoria Rd, Glenmarais, KEMPTON PARK  
Gauteng

Vehicle Type	PASSENGER VEHICLE	Registered Owner	MFC AUCTION HOUSE
Manufacturer	AUDI	Registration Number	CD57MPGP
Model	A4	Register Number	
VIN	WAUZZZ8K8DA111853	Date Of First Licensing	
Engine Number		Last COR	
Doors	4	License Expiry Date	31/10/2023
Color	WHITE	Power / Displacement	
Year Model		Paint Finish	C - COMMON
Km Reading	217,350 KM	Fuel	PETROL
Cab / Body Type	SEDAN	Transmission	AUTOMATIC

## CONDITION REPORT

Report No: 2016335030

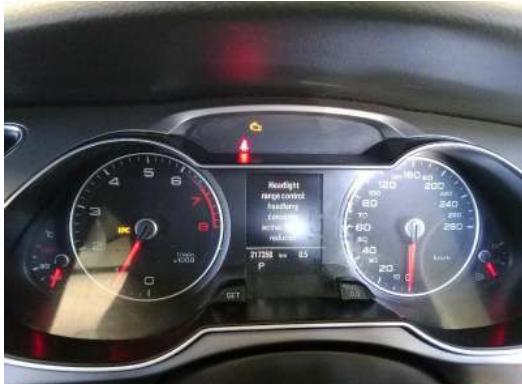
DASHBOARD (W/ ENGINE RUNNING)

Damage	Repair Way
Seat Front Right Torn / Cut	Repair
Front Bumper Paintwork • Scratched	Repair
A • Pillar Right Paintwork • Scratched	Repair
Front Fender Left Paintwork • Pitmarks	Repair
Front Fender Right Paintwork • Pitmarks	Repair
Rear Fender Right Paintwork • Scratched	Repair
Door Front Right Paintwork • Scratched	Repair
Door Rear Right Paintwork • Scratched	Repair
Rear bumper Paintwork • Scratched	Repair
Engine to silencer pipe Welded	Repair
Gearbox Oil Leak	Repair
Engine Performance Idling / Hunting	Repair
Gear Selections Insufficient	Repair
None standard exhaust fitted	Repair
Engine management lights illuminated	Repair
