## CONDITION REPORT

2017299072

MFC Auction House  
M57 Pretoria Rd, Glenmarais, KEMPTON PARK  
Gauteng

| Manufacturer | AUDI | Registration Number | CK43BHGP |

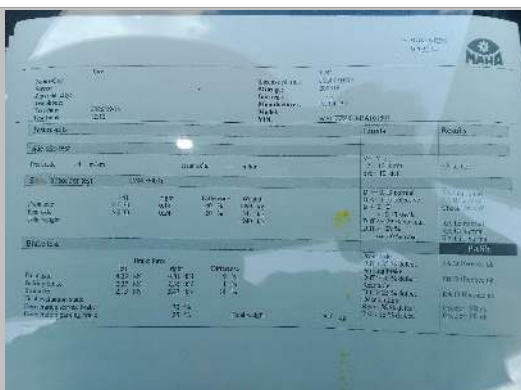
Shock and brake report

| | Left | Right | | |
|---|---|---|---|---|
| Front | 4.3 | 4.8 | - | |
| Rear | 2.1 | 2.4 | - | |
| Emergency / Parking | 2.3 | 2.3 | - | |

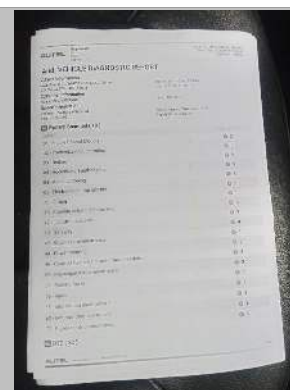
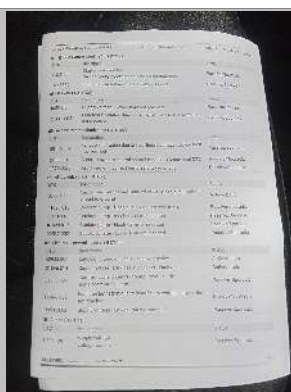
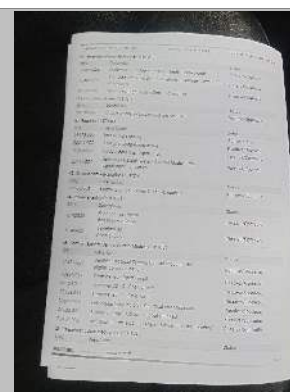
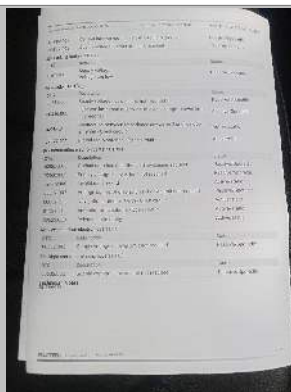
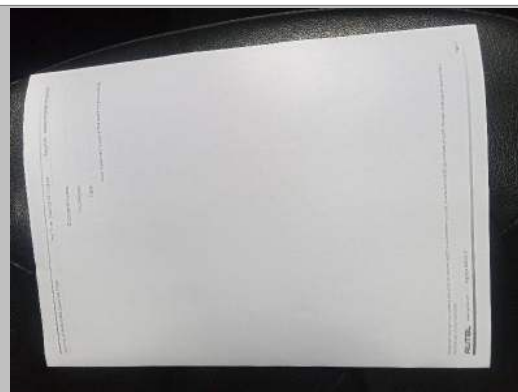
Diagnostic report

| No | System | Code | Description | Status |
|---|---|---|---|---|
| 1 | PASSIVE SPORADIC | U101100 | SUPPLY VOLTAGE VOLTAGE TOO LOW | |

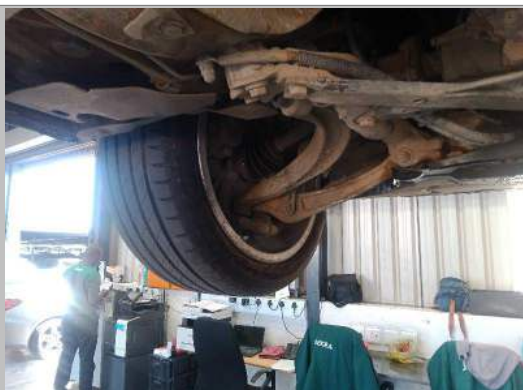
LF TYRE TREAD

| | Size | Load/Speed Index | Manufacture | Model | Type* | Production Date | Tread Depth (mm) |
|---|---|---|---|---|---|---|---|
| Front Left | 245/40R18 | 97Y | Bridgestone | Turanza | V | 4325 | 3 mm |

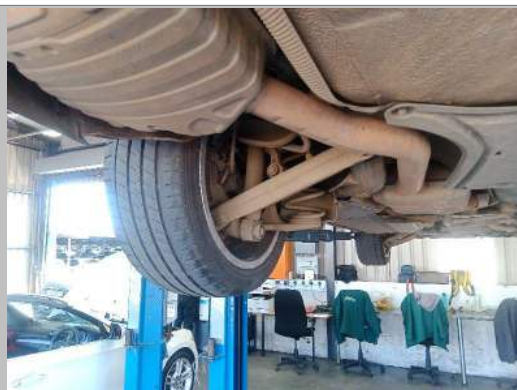
LR TYRE TREAD

| | Size | Load/Speed Index | Manufacture | Model | Type* | Production Date | Tread Depth (mm) |
|---|---|---|---|---|---|---|---|
| Rear Left | 245/40R18 | 93W | Dunlop | Sp sport | V | 0923 | 3 mm |

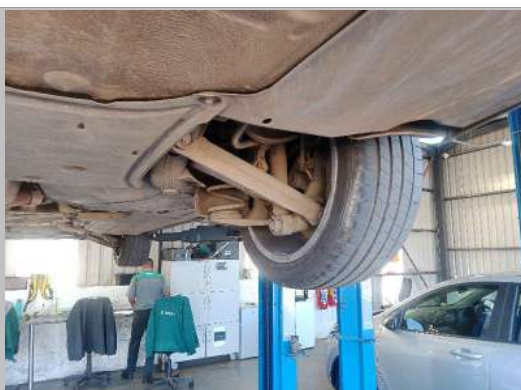
RR TYRE TREAD

| | Size | Load/Speed Index | Manufacture | Model | Type* | Production Date | Tread Depth (mm) |
|---|---|---|---|---|---|---|---|
| Rear Right | 245/40R18 | 93W | Dunlop | Sp sport | V | 0923 | 3 mm |

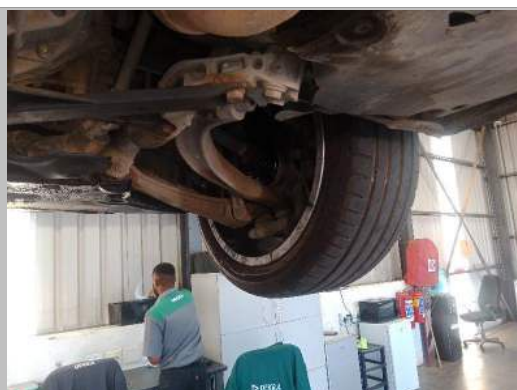
RF TYRE TREAD

| | Size | Load/Speed Index | Manufacture | Model | Type* | Production Date | Tread Depth (mm) |
|---|---|---|---|---|---|---|---|
| Front Right | 245/40R18 | 97Y | Bridgestone | Turanza | V | 4125 | 3 mm |

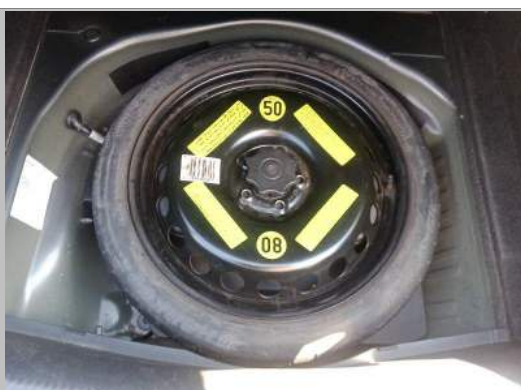
Spare wheel

| | Size | Load/Speed Index | Manufacture | Model | Type* | Production Date | Tread Depth (mm) |
|---|---|---|---|---|---|---|---|
| Spare | T125/70R19 | 100M | Hankook | Temporary | V | 2812 | 4 mm |
