CONDITION REPORT

Report No: 2016204208

MFC Auction House  
M57 Pretoria Rd, Glenmarais, KEMPTON PARK  
Gauteng

| Manufacturer | BMW | Registration Number | HV42SJGP |

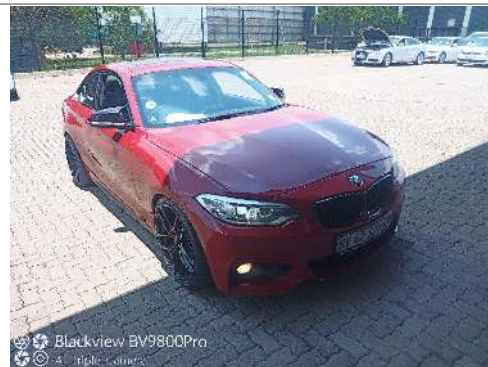
FRONT RIGHT CORNER

| Damage | Repair Way |
|---|---|
| Door Front Right Paintwork • Scratched | Repair |
| Bolt(s) / Nut(s) Front Wheel Right Missing | Replace |

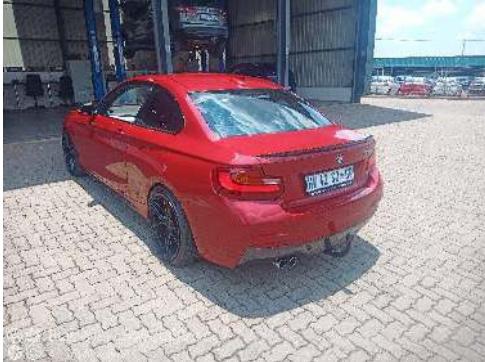
REAR LEFT CORNER

| Damage | Repair Way |
|---|---|
| Rear Fender Left Paintwork • Chipmarks | Repair |

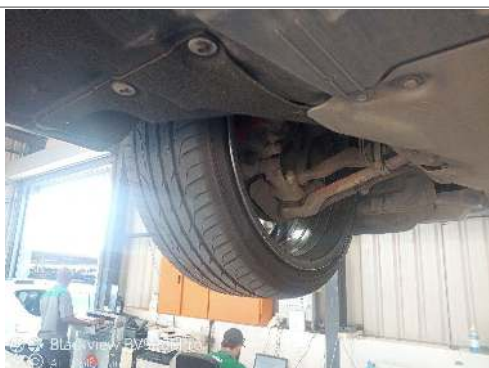
LF TYRE TREAD

| | Size | Load/Speed Index | Manufacture | Model | Type* | Production Date | Tread Depth (mm) |
|---|---|---|---|---|---|---|---|
| Front Left | 225/35R19 | 88W | Three-a | P606 | V | 2321 | 4 mm |

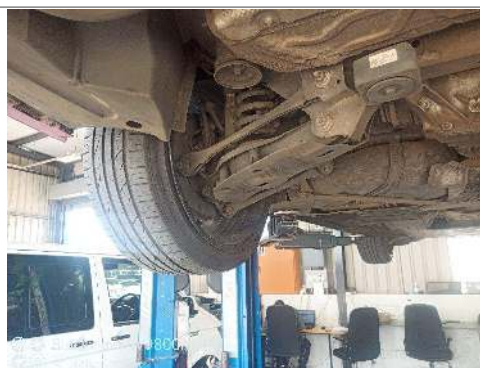
LR TYRE TREAD

| | Size | Load/Speed Index | Manufacture | Model | Type* | Production Date | Tread Depth (mm) |
|---|---|---|---|---|---|---|---|
| Rear Left | 235/35R19 | 91Y | Viento | Fortune | V | 4022 | 4 mm |

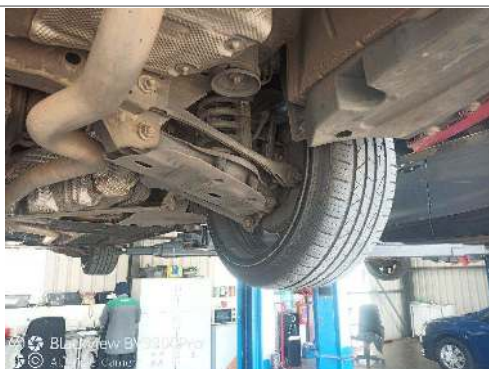
RR TYRE TREAD

| | Size | Load/Speed Index | Manufacture | Model | Type* | Production Date | Tread Depth (mm) |
|---|---|---|---|---|---|---|---|
| Rear Right | 235/35R19 | 91Y | Viento | Fortune | V | 4022 | 4 mm |

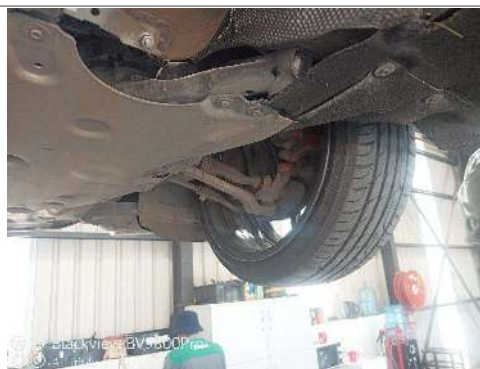
RF TYRE TREAD

| | Size | Load/Speed Index | Manufacture | Model | Type* | Production Date | Tread Depth (mm) |
|---|---|---|---|---|---|---|---|
| Front Right | 225/35R19 | 88W | Three-a | P606 | V | 2321 | 4 mm |
