## CONDITION REPORT

Report No:  
2017297947  
DATE  
11/09/2026

| Manufacturer | MERCEDES-BENZ | Registration Number | CBS56453 |
| Model | C320 CDI ELEGANCE 7-SP DSL AT [2007-2009] | Register Number | |

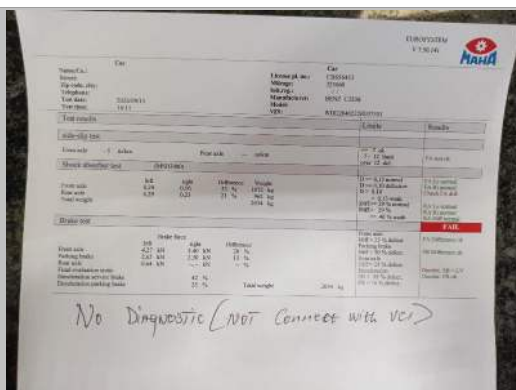
Shock and brake report

| Service Brake Performance Rear Axle Left / Right | Repair |
| Difference out of legal range | Repair |

| | Left | Right | | |
|---|---|---|---|---|
| Rear | 0.6 | 0.0 | - | |

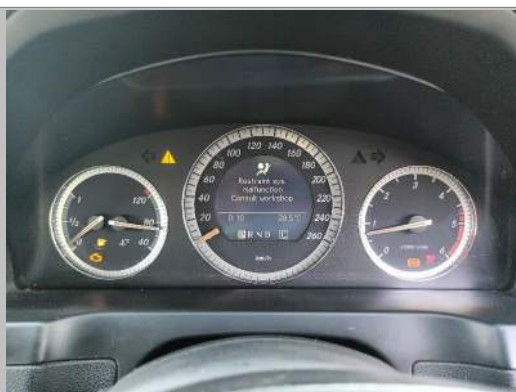
DASHBOARD (W/ ENGINE RUNNING)

| Warning lights illuminated | Repair |

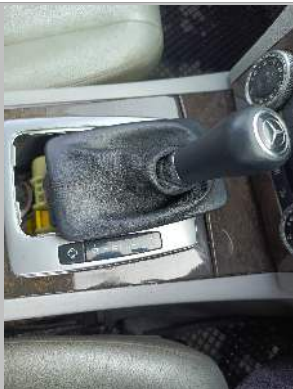
Automatic transmission

| Gearbox Oil Leak | Repair |
| Gear Selections Malfunction | Repair |

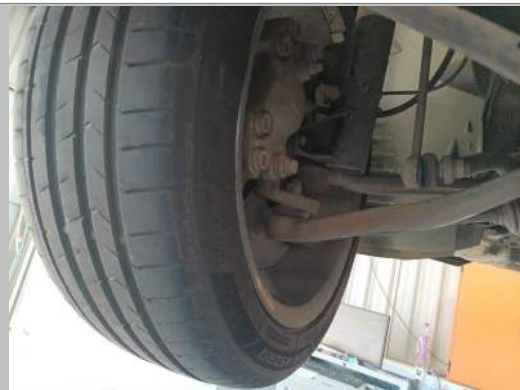
LF TYRE TREAD

| Tyre Front Left Torn / Cut | Replace |

| | Size | Load/Speed Index | Manufacture | Model | Type* | Production Date | Tread Depth (mm) |
|---|---|---|---|---|---|---|---|
| Front Left | 225/45R17 | 94W | Royal black | Mile | V | 4628 | 4 mm |

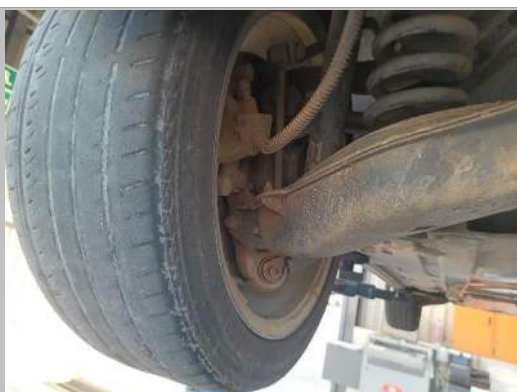
LR TYRE TREAD

| Tyre Rear Left Smooth | Replace |

| | Size | Load/Speed Index | Manufacture | Model | Type* | Production Date | Tread Depth (mm) |
|---|---|---|---|---|---|---|---|
| Rear Left | 225/45R17 | 94W | Goodride | SA | V | 3024 | 0 mm |

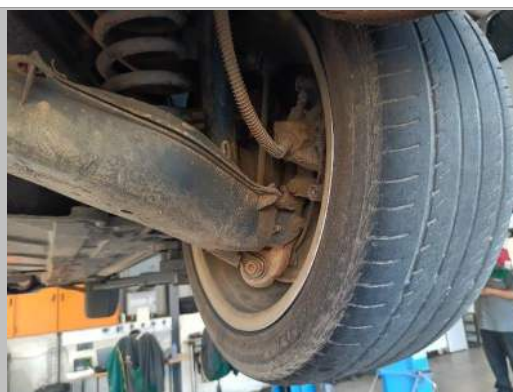
RR TYRE TREAD

| | Size | Load/Speed Index | Manufacture | Model | Type* | Production Date | Tread Depth (mm) |
|---|---|---|---|---|---|---|---|
| Rear Right | 225/45R17 | 94W | Goodride | SA | V | 1524 | 1 mm |

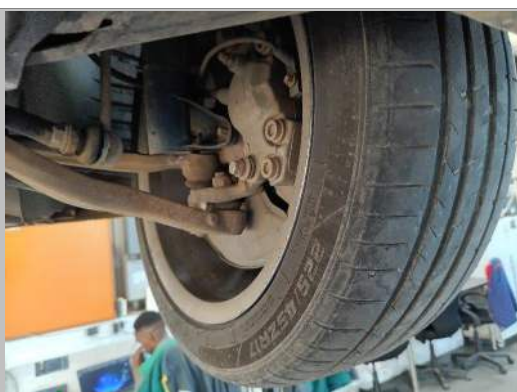
RF TYRE TREAD

| Tyre Front Right Damaged | Replace |

| | Size | Load/Speed Index | Manufacture | Model | Type* | Production Date | Tread Depth (mm) |
|---|---|---|---|---|---|---|---|
| Front Right | 225/45R17 | 94W | Royal black | Mile | V | 3523 | 0 mm |

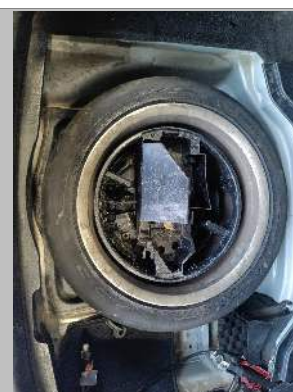
Sparewheel

| | Size | Load/Speed Index | Manufacture | Model | Type* | Production Date | Tread Depth (mm) |
|---|---|---|---|---|---|---|---|
| Spare | 225/45R17 | 94W | Durun | L919 | V | 0000 | 1 mm |

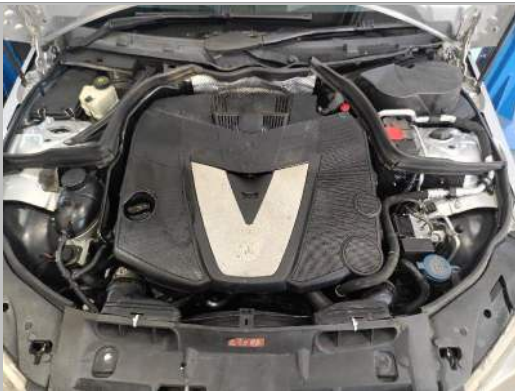
ENGINE 1

| Engine Oil Leak | Repair |
| Alternator Damaged | Repair |
