## CONDITION REPORT

Report No:  
2017286376  
DATE  
20/08/2026

| Manufacturer | FORD | Registration Number | FT37DDGP |
| Model | FOCUS 2.0 ECOBOOST ST3 5-DR [2015-2019] | Register Number | |

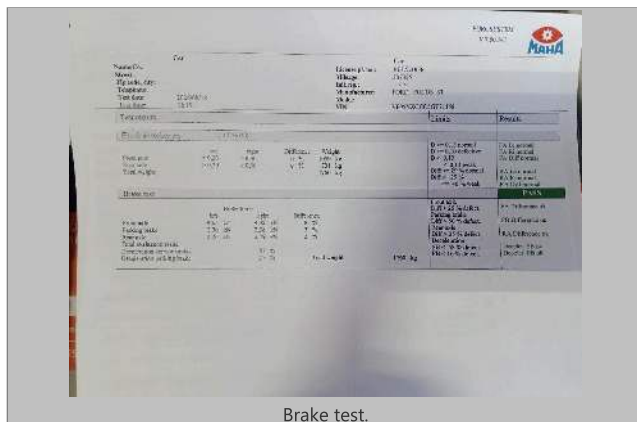
Brake test.

| | Left | Right | | |
|---|---|---|---|---|
| Front | 4.05 | 4.42 | - | |
| Rear | 2.7 | 2.79 | - | |
| Emergency / Parking | 2.3 | 2.38 | - | |

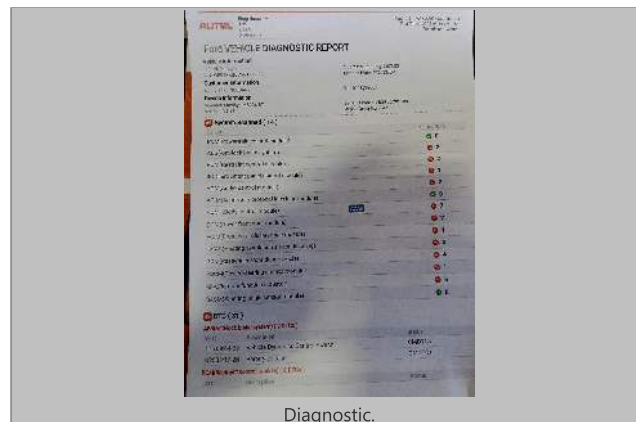
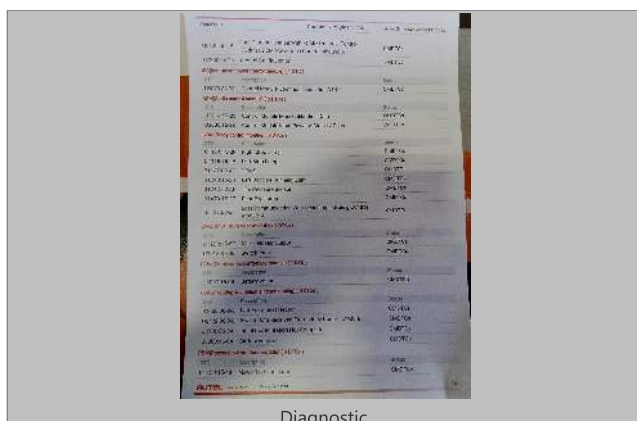
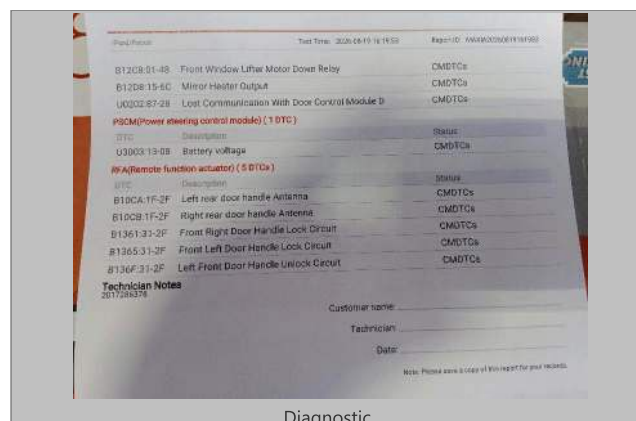
Diagnostic.

During the diagnostic no active error messages were detected. (See also attached Diagnostic Report. For more information regarding the Fault Codes (DTC) and the recommended rectifications please contact the workshops of the vehicle manufacture).

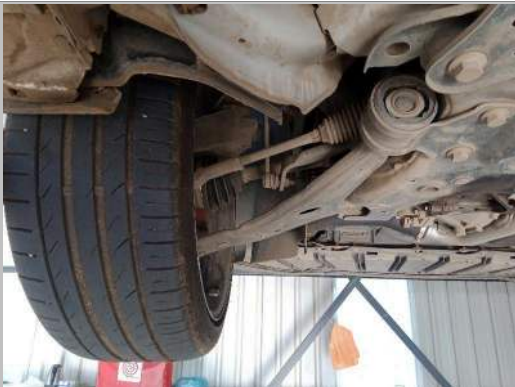
LF TYRE TREAD

| | Size | Load/Speed Index | Manufacture | Model | Type* | Production Date | Tread Depth (mm) |
|---|---|---|---|---|---|---|---|
| Front Left | 235/35R19 | 91W | King | Radial | V | 0225 | 3 mm |

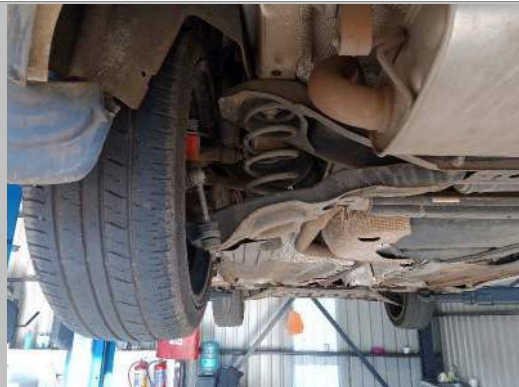
LR TYRE TREAD

| | Size | Load/Speed Index | Manufacture | Model | Type* | Production Date | Tread Depth (mm) |
|---|---|---|---|---|---|---|---|
| Rear Left | 235/35R19 | 91W | Royal black | Radial | V | 1623 | 3 mm |

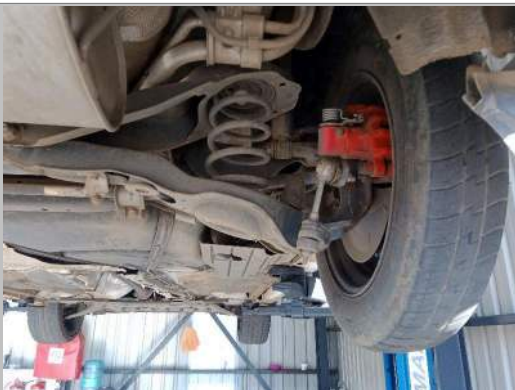
RR TYRE TREAD

| | Size | Load/Speed Index | Manufacture | Model | Type* | Production Date | Tread Depth (mm) |
|---|---|---|---|---|---|---|---|
| Rear Right | T125/90R16 | 98M | Hankook | Temporary | V | 2716 | 1 mm |

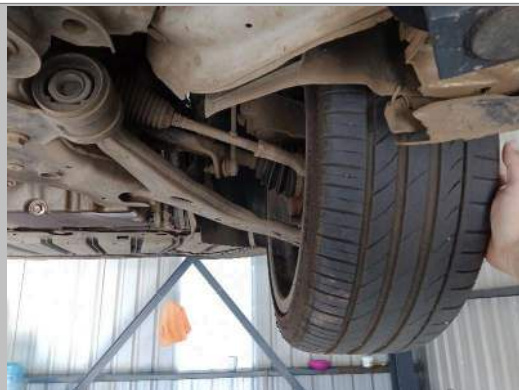
RF TYRE TREAD

| | Size | Load/Speed Index | Manufacture | Model | Type* | Production Date | Tread Depth (mm) |
|---|---|---|---|---|---|---|---|
| Front Right | 235/35R19 | 91W | King | Radial | V | 0325 | 3 mm |

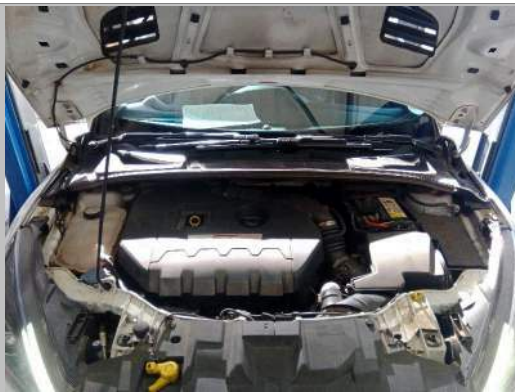
ENGINE 1

General Comments: ACCORDING TO THE AGE AND MILEAGE OF THE VEHICLE, NORMAL WEAR AND TEAR MARKS ARE VISIBLE ON THE INTERIOR, EXTERIOR, ELECTRICAL AND MECHANICAL PARTS. Engine Compartment: signs of aftermarket performance done to vehicle.  
Electrical Components and Instruments: Vehicle struggles to start.  
Body • Exterior: Minor dents and scratches and stone chips to body panels. Signs of repair work done to body panels. Repair work done to vehicle below standard.  
Poor alignment to somebody panels.
