MFC Auction House  
M57 Pretoria Rd, Glenmarais, KEMPTON PARK  
Gauteng

DEKRA MFC  
M57 Pretoria Rd - 1619  
KEMPTON PARK - GT  
08610 33572

Report No: 2016347139

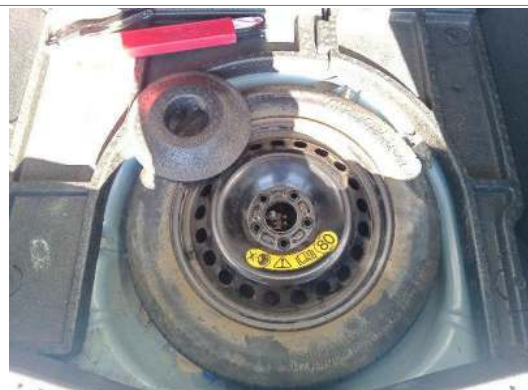
Sparewheel

| | Size | Load/Speed Index | Manufacture | Model | Type* | Production Date | Tread Depth (mm) |
|---|---|---|---|---|---|---|---|
| Spare | T125/90R19 | 98M | Hankook | Temporary | V | //////77 | 1 mm |

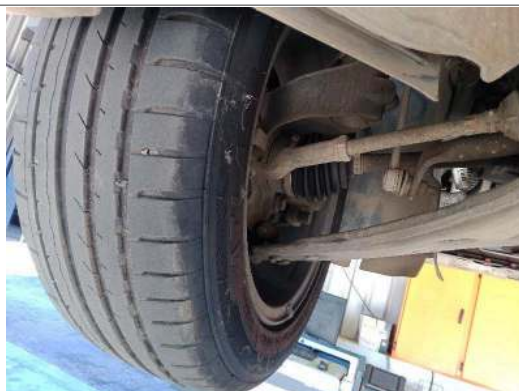
LF TYRE TREAD

| | Size | Load/Speed Index | Manufacture | Model | Type* | Production Date | Tread Depth (mm) |
|---|---|---|---|---|---|---|---|
| Front Left | 205/55R16 | 91W | Atlas | Sport | V | 1622 | 5 mm |

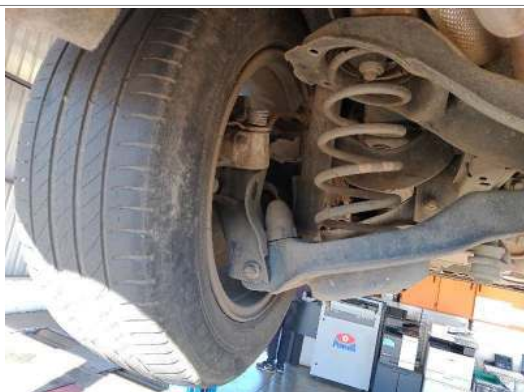
LR TYRE TREAD

| | Size | Load/Speed Index | Manufacture | Model | Type* | Production Date | Tread Depth (mm) |
|---|---|---|---|---|---|---|---|
| Rear Left | 205/60R16 | 96H | Michelin | Primacy | V | 3618 | 2 mm |

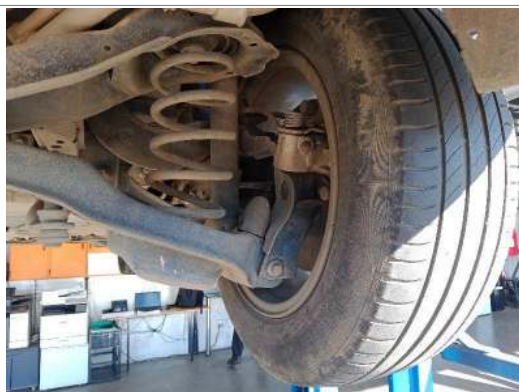
RR TYRE TREAD

| | Size | Load/Speed Index | Manufacture | Model | Type* | Production Date | Tread Depth (mm) |
|---|---|---|---|---|---|---|---|
| Rear Right | 205/60R16 | 96H | Michelin | Primacy | V | 3618 | 3 mm |

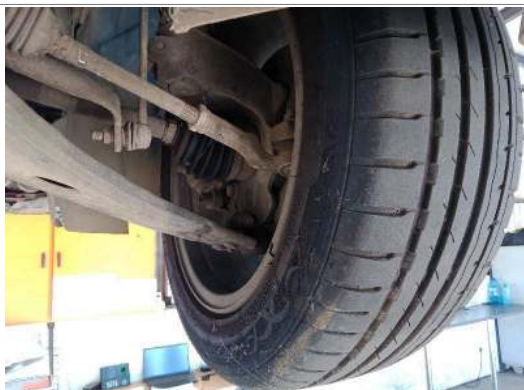
RF TYRE TREAD

| | Size | Load/Speed Index | Manufacture | Model | Type* | Production Date | Tread Depth (mm) |
|---|---|---|---|---|---|---|---|
| Front Right | 205/55R16 | 91W | Atlas | Sport | V | 1622 | 5 mm |
