Client	MFC Auction House	Inspection Location	MFC M57 Pretoria Road - 1619 Kempton Park - GT
Requested Date	26/01/2024		
Inspection Date	26/01/2024

Vehicle Type	PASSENGER VEHICLE	Registered Owner	MFC AUCTION HOUSE
Manufacturer	MINI	Registration Number	HZ62SVP
Model	JOHN COOPER WALKS	Register Number	
VIN	WMWXM920902F19959	Date Of First Licensing	
Engine Number		Last COR	
Doors	3	License Expiry Date	31/08/2024
Color	RED	Power / Displacement	
Year Model		Paint Finish	TWO COAT METALLIC
Km Reading	236,883 KM	Fuel	PETROL
Cab / Body Type	HATCHBACK	Transmission	AUTOMATIC

CONDITION REPORT

Report No: 2016244402

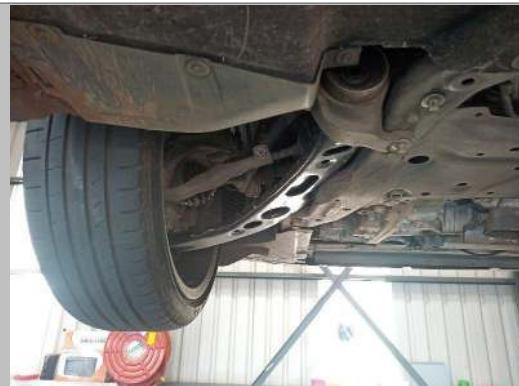
LF TYRE TREAD

Size	Load/Speed Index	Manufacture	Model	Type*	Production Date	Tread Depth (mm)
Front Left	205/40R18	86W	Pirelli	Radial	V	1623	4 mm
Front Right	205/40R18	86W	Pirelli	Radial	V	0923	4 mm
Rear Left	205/40R18	86W	Pirelli	Radial	V	0522	4 mm
Rear Right	205/40R18	86W	Pirelli	Radial	V	3719	4 mm

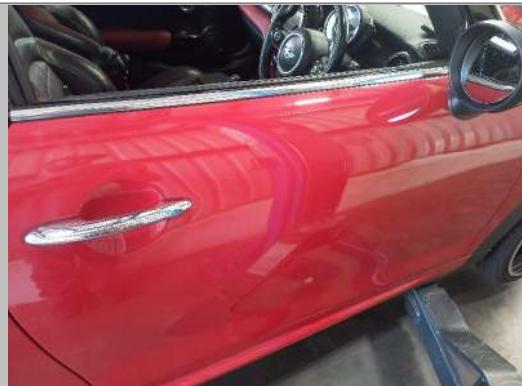
Damage	Repair Way
Engine Oil Sweat	Repair
Center Console / Cubbyhole + Lid Damaged	Repair
Windscreen Wiper Damaged	Replace
Seat Front Right Worn	Repair
Front Bumper Damaged	Repair
Bonnet Damaged	Repair
Front Fender Left Damaged	Repair
Front Fender Right Damaged	Repair
Rear Fender Right Damaged	Repair
Door Front Left Damaged	Repair
Door Front Right Damaged	Repair
Boot Lid / Hatch door Damaged	Repair
Rear bumper Damaged	Repair
Windscreen Damaged	Replace
Parking Brake Performance Left / Right Difference out of legal range	Repair
