CONDITION REPORT

Report No:  
2017297776  
DATE  
11/09/2026

MFC Auction House  
M57 Pretoria Rd, Glenmarais, KEMPTON PARK  
Gauteng

| Manufacturer | VOLKSWAGEN | Registration Number | LX15HYGP |

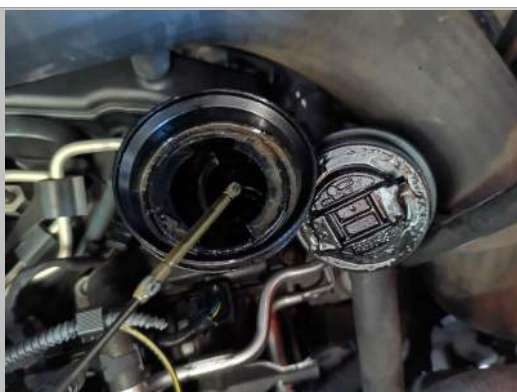
Dipstick location

| Engine Oil Sweat | Repair |

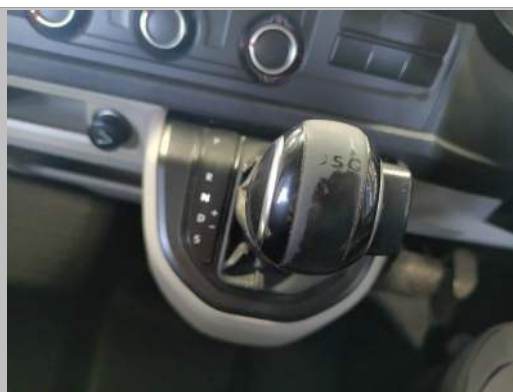
Automatic transmission

| Gearbox Oil Sweat | Repair |

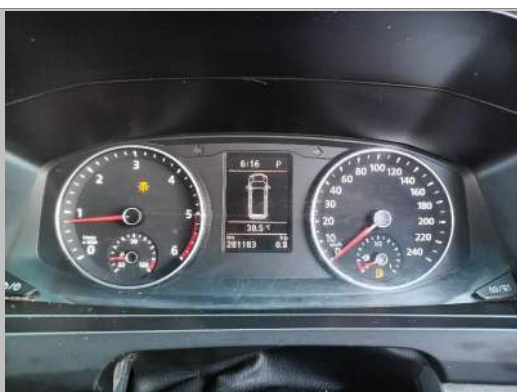
DASHBOARD (W/ ENGINE RUNNING)

| Warning lights illuminated | Repair |

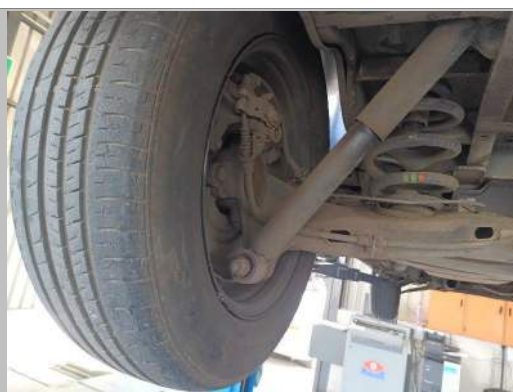
LR TYRE TREAD

| Tyre Rear Left Smooth | Replace |

| | Size | Load/Speed Index | Manufacture | Model | Type* | Production Date | Tread Depth (mm) |
|---|---|---|---|---|---|---|---|
| Rear Left | 205/65R16 | 95H | Royal black | Mile | V | 4923 | 0 mm |

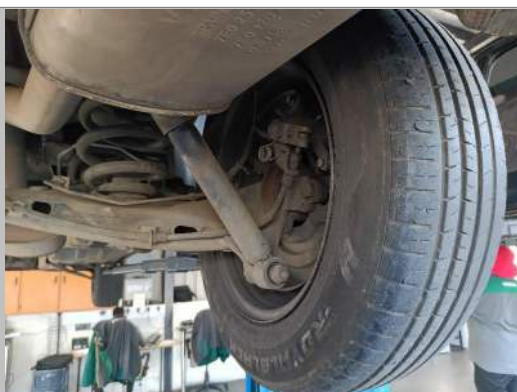
RR TYRE TREAD

| Tyre Rear Right Smooth | Replace |

| | Size | Load/Speed Index | Manufacture | Model | Type* | Production Date | Tread Depth (mm) |
|---|---|---|---|---|---|---|---|
| Rear Right | 205/65R16 | 95H | Royal black | Mile | V | 4923 | 0 mm |

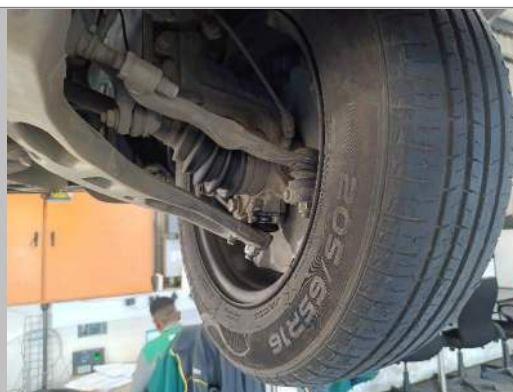
RF TYRE TREAD

| | Size | Load/Speed Index | Manufacture | Model | Type* | Production Date | Tread Depth (mm) |
|---|---|---|---|---|---|---|---|
| Front Right | 205/65R16 | 95H | Royal black | Mile | V | 4923 | 3 mm |
