## CONDITION REPORT

Report No:  
2017300402  
DATE  
17/09/2026

MFC Auction House  
M57 Pretoria Rd, Glenmarais, KEMPTON PARK  
Gauteng

| Model | TIGUAN 2.0 TDI SPORT&STYLE DSL 4MOTION DSG [2011-2015] | Register Number | |

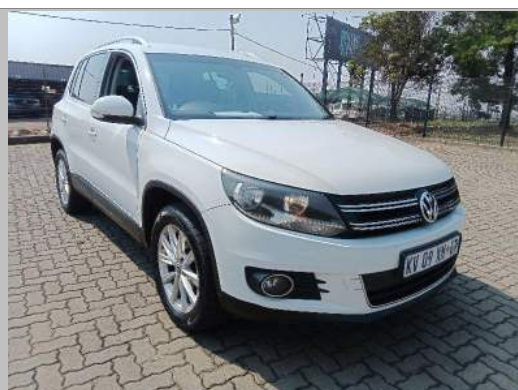
FRONT RIGHT CORNER

| Damage | Repair Way |
|---|---|
| Front Fender Right Residual Traces of Repair | Repair |
| Front Fender Right / Inner Tray Damaged | Replace |

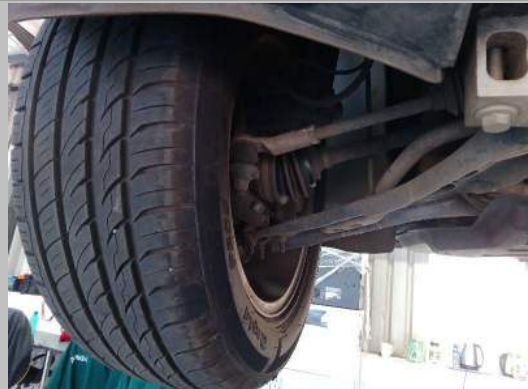
LF TYRE TREAD

| | Size | Load/Speed Index | Manufacture | Model | Type* | Production Date | Tread Depth (mm) |
|---|---|---|---|---|---|---|---|
| Front Left | 235/55Z R17 | 103W | Rapid | P609 | V | 3525 | 5 mm |

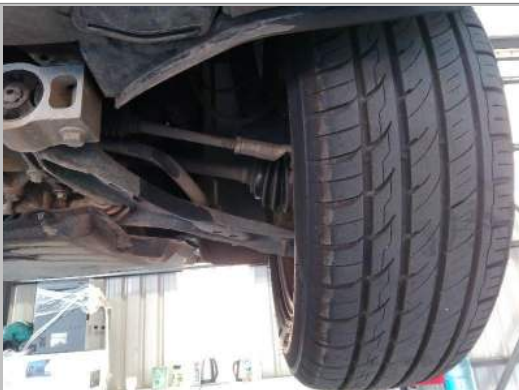
RF TYRE TREAD

| | Size | Load/Speed Index | Manufacture | Model | Type* | Production Date | Tread Depth (mm) |
|---|---|---|---|---|---|---|---|
| Front Right | 235/55Z R17 | 103W | Rapid | P609 | V | 3525 | 5 mm |

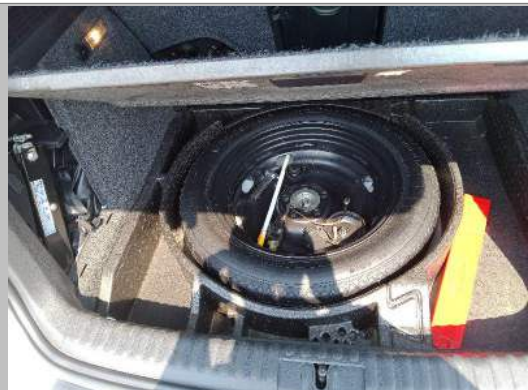
Spare Wheel and Accessories

| | Size | Load/Speed Index | Manufacture | Model | Type* | Production Date | Tread Depth (mm) |
|---|---|---|---|---|---|---|---|
| Spare | T145/80 R18 | 99M | Continental | Temporary | V | 0714 | 3 mm |
