## CONDITION REPORT

Report No:  
2017295899  
DATE  
08/09/2026

| Manufacturer | VOLKSWAGEN | Registration Number | MN06MNGP |
| Model | GOLF 7 2.0 TSI GTI 5-DR DSG [2013-2016] | Register Number | |

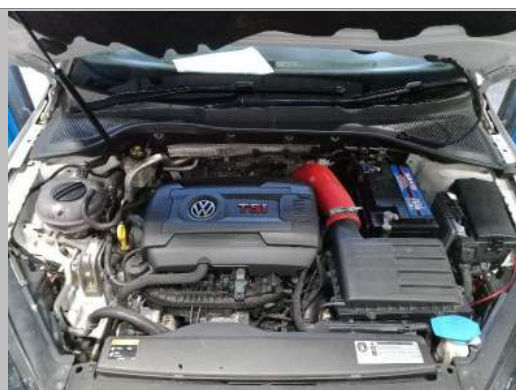
ENGINE 1

General Comments: ACCORDING TO THE AGE AND MILEAGE OF THE VEHICLE, NORMAL WEAR AND TEAR MARKS ARE VISIBLE ON THE INTERIOR, EXTERIOR, ELECTRICAL AND MECHANICAL PARTS. Engine Compartment: Signs of Aftermarket performance parts fitted to vehicle.

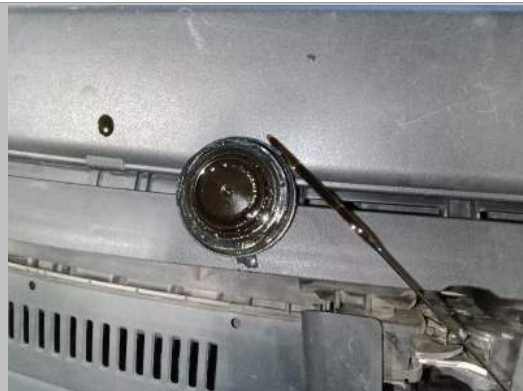
Oil cap and dipstick

| Engine Oil Leak | Repair |
