## CONDITION REPORT

Report No:  
2017213531  
DATE  
09/04/2026

MFC Auction House  
M57 Pretoria Rd, Glenmarais, KEMPTON PARK  
Gauteng

| Model | GOLF 7 R 2.0 TSI 206KW 4MOTION 5-DR DSG [2015-2017] | Register Number | |

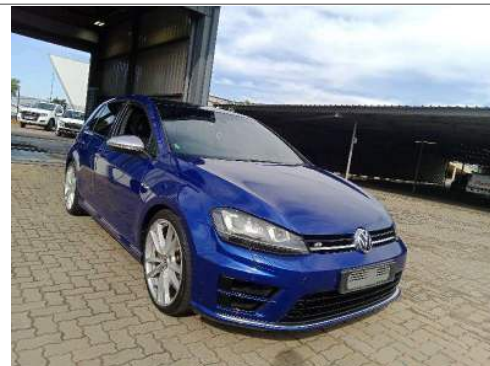
FRONT RIGHT CORNER

| | Damage | Repair Way |
|---|---|---|
| | Front Bumper Damaged | Repair |
| | Grill Damaged | Replace |
| | Front Fender Right Residual Traces of Repair | Repair |
| | Front Fender Right / Inner Tray Damaged | Replace |

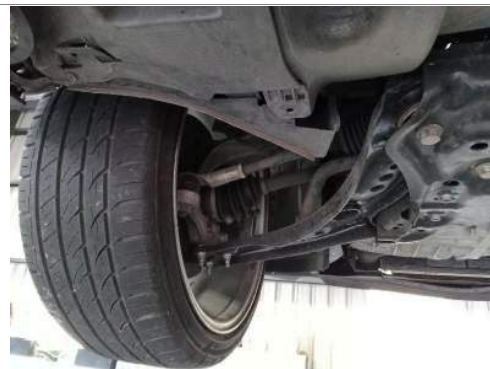
LF TYRE TREAD

| | Size | Load/Speed Index | Manufacture | Model | Type* | Production Date | Tread Depth (mm) |
|---|---|---|---|---|---|---|---|
| Front Left | 235/35Z R19 | 91W | Rapid | P609 | V | 2122 | 3 mm |

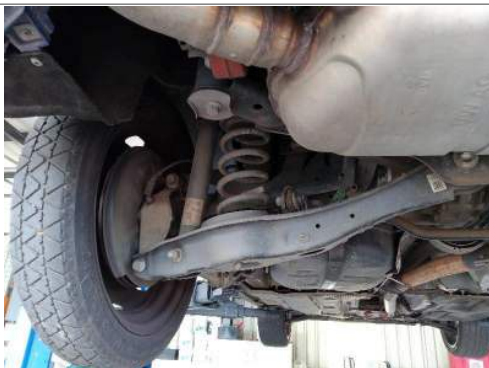
LR TYRE TREAD

| | Damage | Repair Way |
|---|---|---|
| | Tyres and rims | Rear left and right tyre sizes different. |

| | Size | Load/Speed Index | Manufacture | Model | Type* | Production Date | Tread Depth (mm) |
|---|---|---|---|---|---|---|---|
| Rear Left | T125/70 R18 | 99M | Continental | Temporary | V | 3915 | 2 mm |

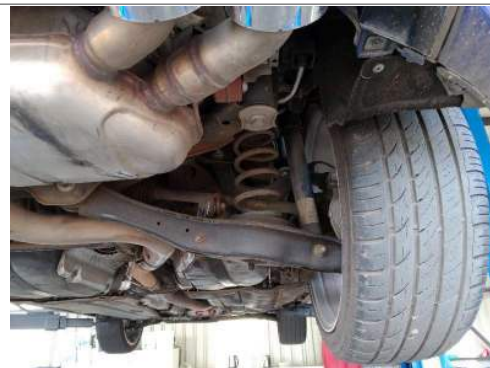
RR TYRE TREAD

| | Size | Load/Speed Index | Manufacture | Model | Type* | Production Date | Tread Depth (mm) |
|---|---|---|---|---|---|---|---|
| Rear Right | 235/35Z R19 | 91W | Rapid | P609 | V | 4420 | 2 mm |

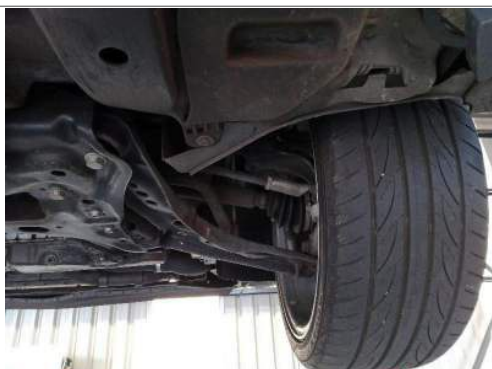
RF TYRE TREAD

| | Size | Load/Speed Index | Manufacture | Model | Type* | Production Date | Tread Depth (mm) |
|---|---|---|---|---|---|---|---|
| Front Right | 235/35 R19 | 91W | Yokohama | Advan | V | 5022 | 2 mm |

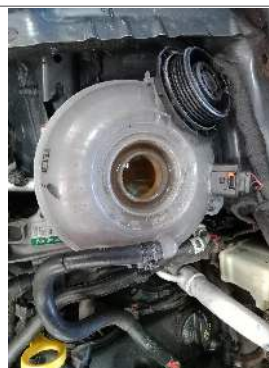
Water level

| | Damage | Repair Way |
|---|---|---|
| | Engine | Signs of vehicle overheating |
