## CONDITION REPORT

2017299095

| Manufacturer | FORD | Registration Number | HBJ404L |
| Model | RANGER 3.2 TDCI WILDTRAK D-CAB DSL PU AT [2017-2020] | Register Number | |

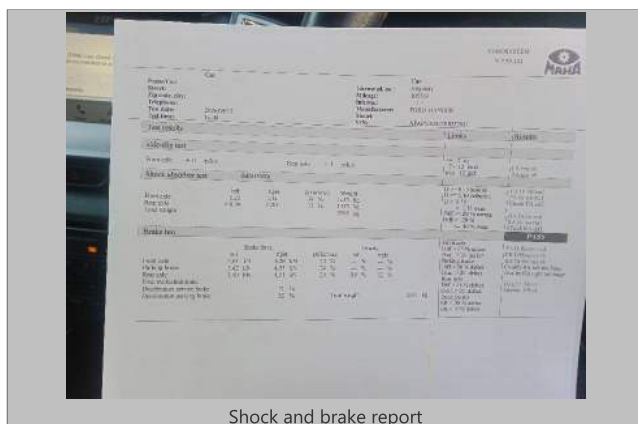
Shock and brake report

| | Left | Right | | |
|---|---|---|---|---|
| Front | 4.6 | 5.2 | - | |
| Rear | 3.4 | 4.5 | - | |
| Emergency / Parking | 3.4 | 4.5 | - | |

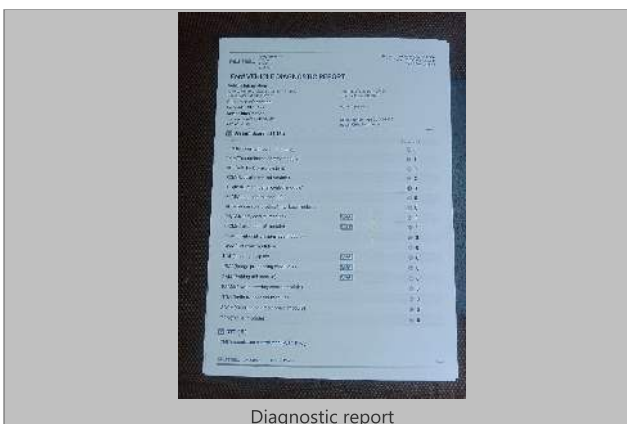
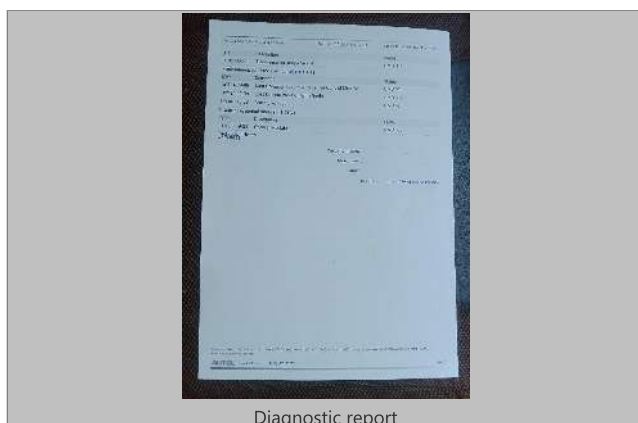
Diagnostic report

| No | System | Code | Description | Status |
|---|---|---|---|---|
| 1 | CMDTCS | U3003:16-08 | BATTERY VOLTAGE | |

Battery Flat

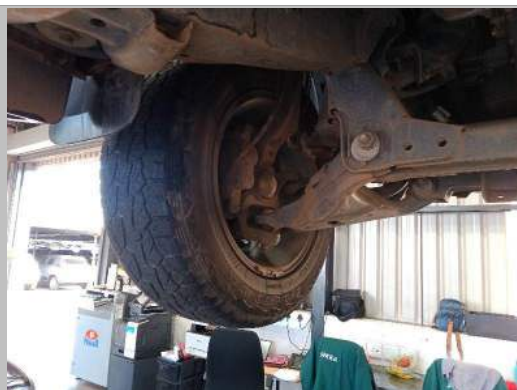
LF TYRE TREAD

| | Size | Load/Speed Index | Manufacture | Model | Type* | Production Date | Tread Depth (mm) |
|---|---|---|---|---|---|---|---|
| Front Left | 265/60R18 | 114T | Hankook | Dynapro | V | 2418 | 2 mm |

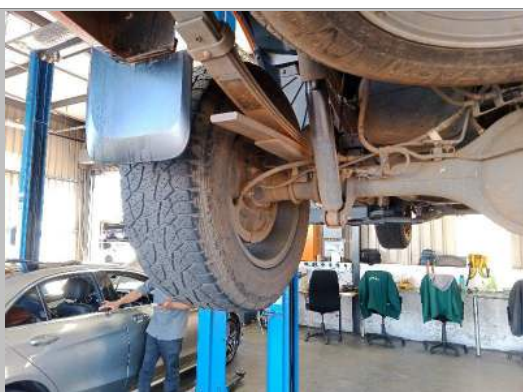
LR TYRE TREAD

| | Size | Load/Speed Index | Manufacture | Model | Type* | Production Date | Tread Depth (mm) |
|---|---|---|---|---|---|---|---|
| Rear Left | 265/60R18 | 114T | Hankook | Dynapro | V | 2418 | 3 mm |

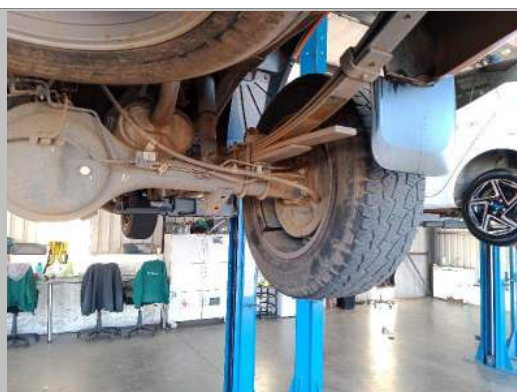
RR TYRE TREAD

| | Size | Load/Speed Index | Manufacture | Model | Type* | Production Date | Tread Depth (mm) |
|---|---|---|---|---|---|---|---|
| Rear Right | 265/60R18 | 114T | Hankook | Dynapro | V | 2418 | 3 mm |

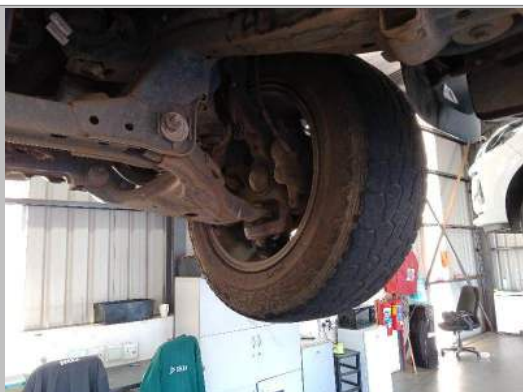
RF TYRE TREAD

| | Size | Load/Speed Index | Manufacture | Model | Type* | Production Date | Tread Depth (mm) |
|---|---|---|---|---|---|---|---|
| Front Right | 265/60R18 | 114T | Hankook | Dynapro | V | 2418 | 1 mm |

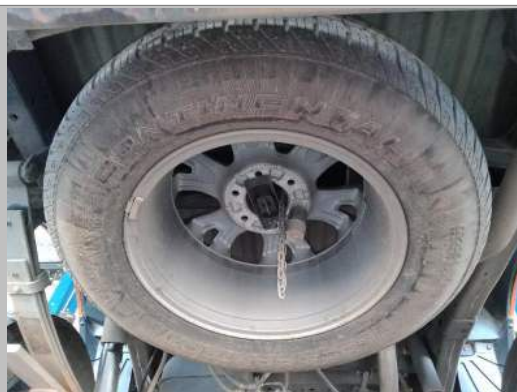
Spare wheel

| | Size | Load/Speed Index | Manufacture | Model | Type* | Production Date | Tread Depth (mm) |
|---|---|---|---|---|---|---|---|
| Spare | 265/60R18 | 110T | Continental | Contact | V | 0000 | 4 mm |
