## CONDITION REPORT

Report No:  
2017296379  
DATE  
09/09/2026

| Manufacturer | VOLKSWAGEN | Registration Number | MS95SSGP |
| Model | POLO VIVO 1.4 55KW TRENDLINE 5-DR [2019-2021] | Register Number | |

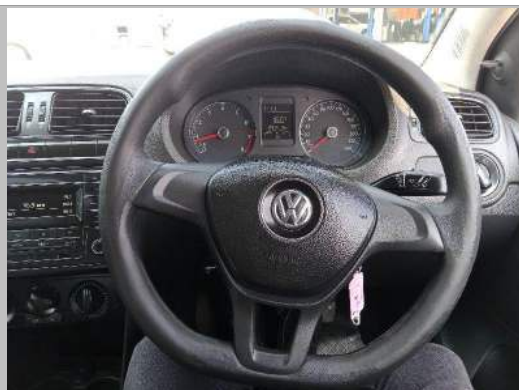
| Damage | Repair Way |
|---|---|
| Steering Wheel Trim Damaged | Repair |

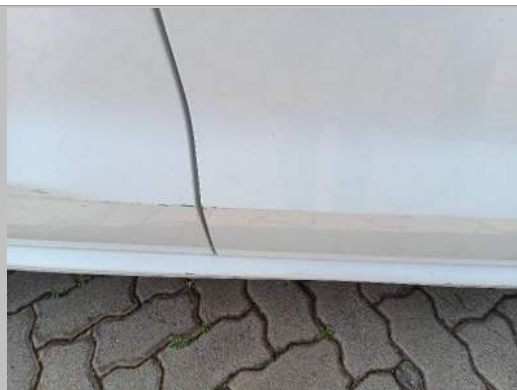
| Damage | Repair Way |
|---|---|
| Door Front Right Paintwork • Scratched | Repair |

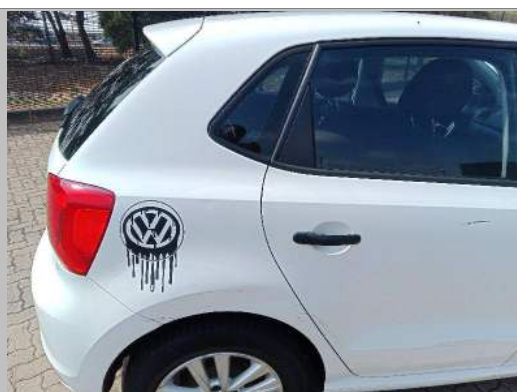
| Damage | Repair Way |
|---|---|
| Rear Fender Right Damaged | Repair |

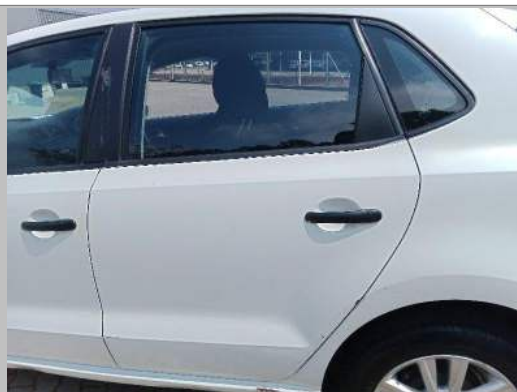
| Damage | Repair Way |
|---|---|
| Door Rear Left Paintwork • Scratched | Repair |

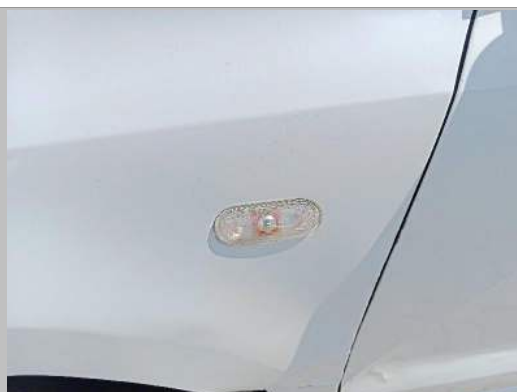
| Damage | Repair Way |
|---|---|
| Indicator Light Front Left Damaged | Replace |

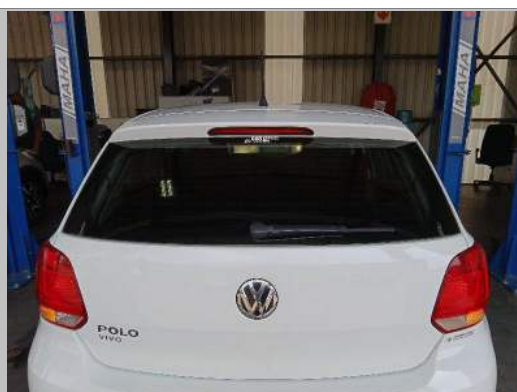
| Damage | Repair Way |
|---|---|
| Boot Lid / Hatch door Dented | Repair |

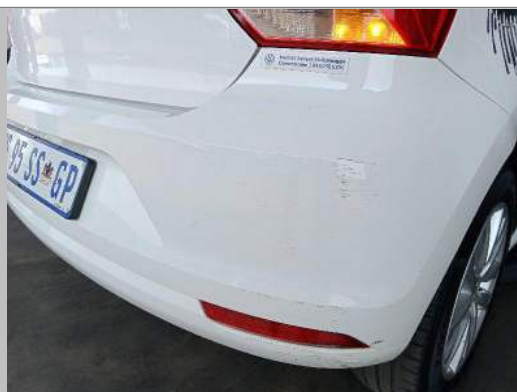
| Damage | Repair Way |
|---|---|
| Rear bumper Paintwork • Scratched | Repair |

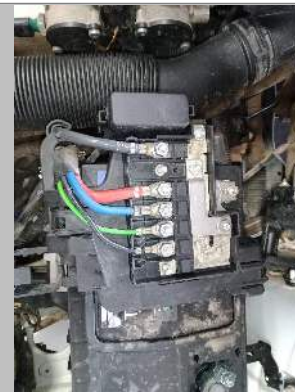
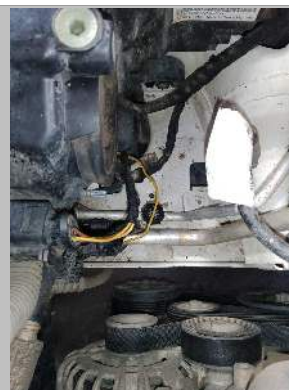
## Engine Wiring

| Damage | Repair Way |
|---|---|
| Engine Wiring Defective | Repair |

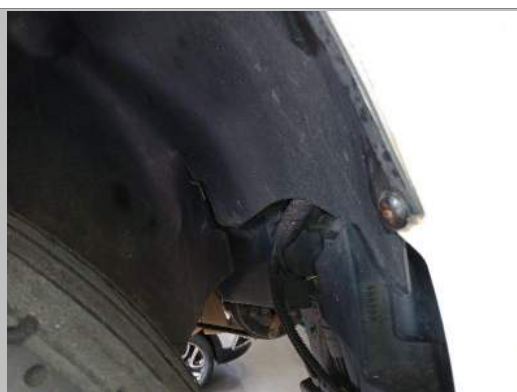
| Damage | Repair Way |
|---|---|
| Front Fender Right / Inner Tray Damaged | Replace |

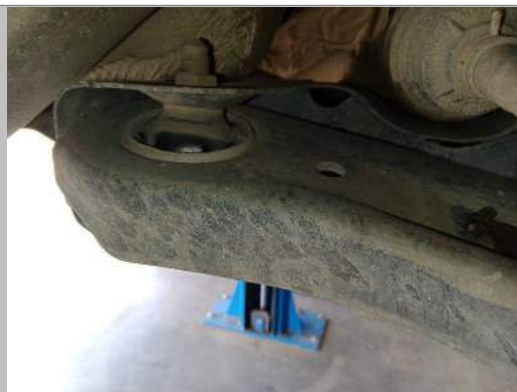
| Damage | Repair Way |
|---|---|
| Control Arm Bush(es) Front Axle Right Cracked | Replace |

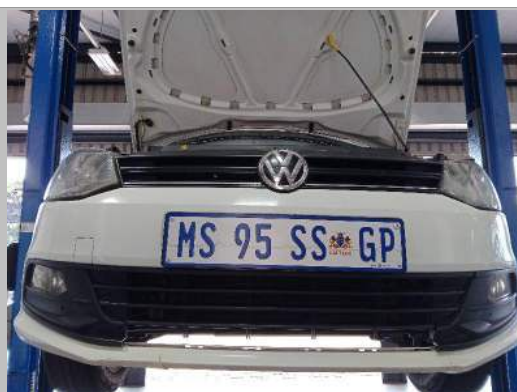
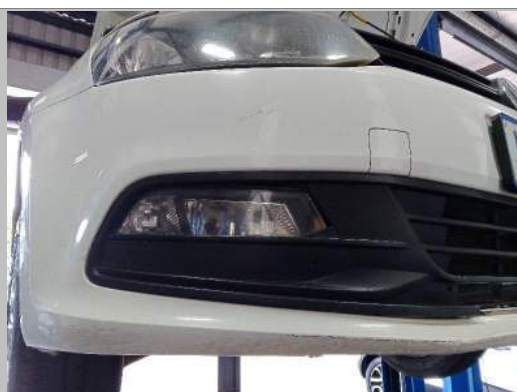
| Damage | Repair Way |
|---|---|
| Front Bumper Damaged | Repair |

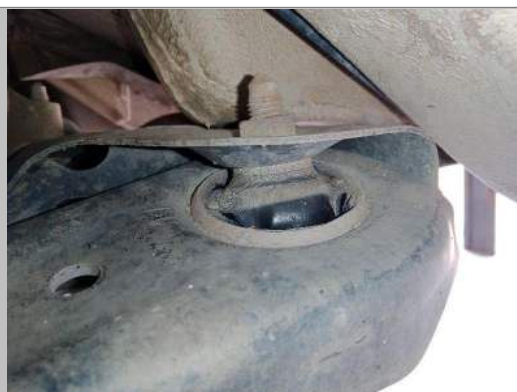
| Damage | Repair Way |
|---|---|
| Control Arm Bush(es) Front Axle Left Cracked | Replace |

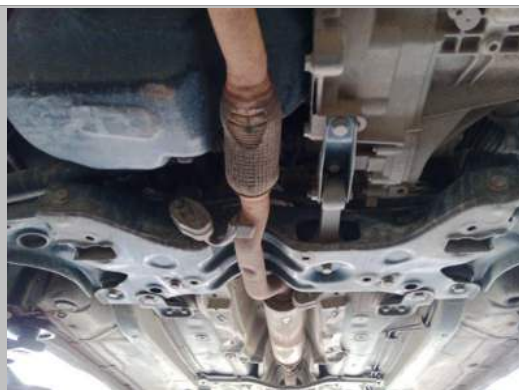
| Damage | Repair Way |
|---|---|
| Engine to silencer pipe Damaged | Repair |

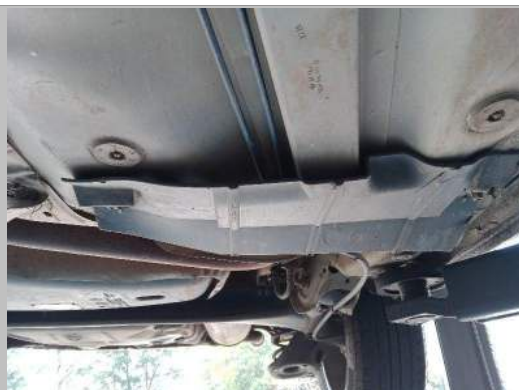
| Damage | Repair Way |
|---|---|
| Chassis Damaged | Repair |
